SERVICE BULLETIN

NUMBER: 15-236-18R

SUBJECT: Reprogramming File Availability for Optimization of
 Harman Gen 3.1 and Gen 3.1α Audio and Navigation
 Head Units

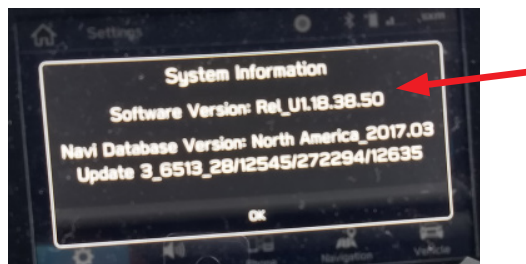
- The currently installed software version will be displayed. If the Software Version is **Rel_UA.20.38.70**, (or before), proceed to **Step 2**. This version number is the same for all 4 levels of head unit.

VERY IMPORTANT: If the current version is **Rel_UA.20.38.70**, **STOP** as the latest version has already been installed and no update is required at this time.

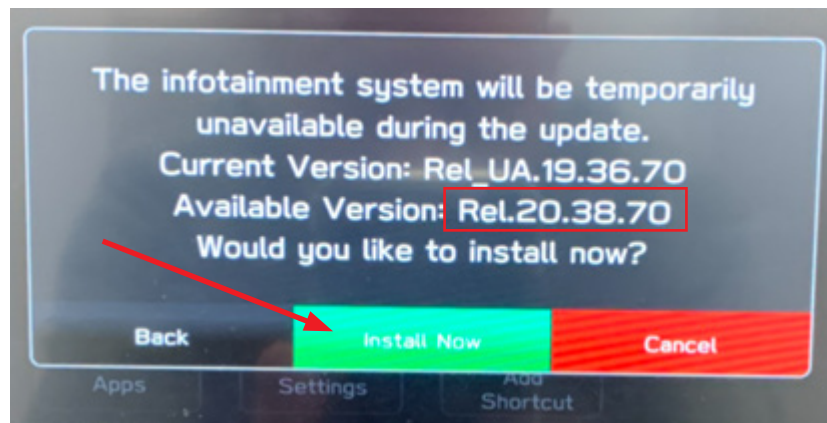
- The current and available software version information will be displayed. The Available Version I.D should be **Rel.20.38.70**.

- After confirming the Available Version, press “Install Now” to start the reprogramming process. The screen will go blank (black) for a brief period after installation begins.
- Each of the updates (Base, Mid and High) should take less than 10 minutes to install.

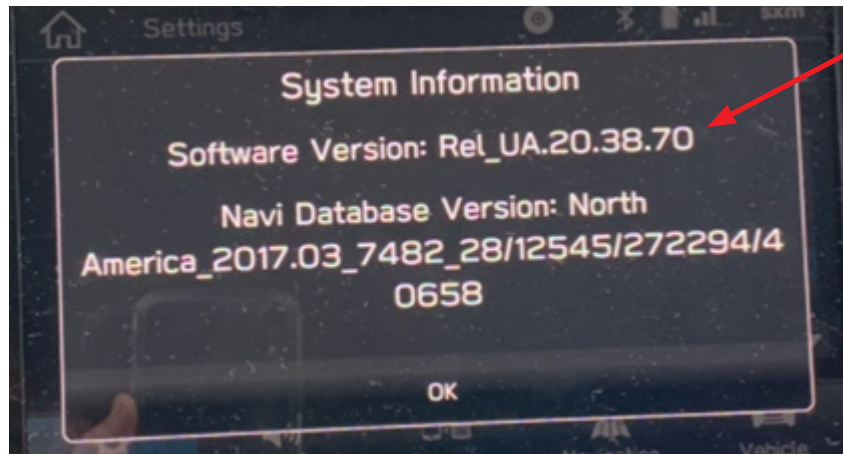
- Confirm Software Version is now “**Rel_UA.20.38.70**”.

IMPORTANT: If during this procedure, the screen goes blank (black) and the STARLINK screen does not appear, the head unit must be replaced. **THIS SHOULD BE A VERY RARE OCCURRENCE.** Contact SOA Techline should this condition occur.

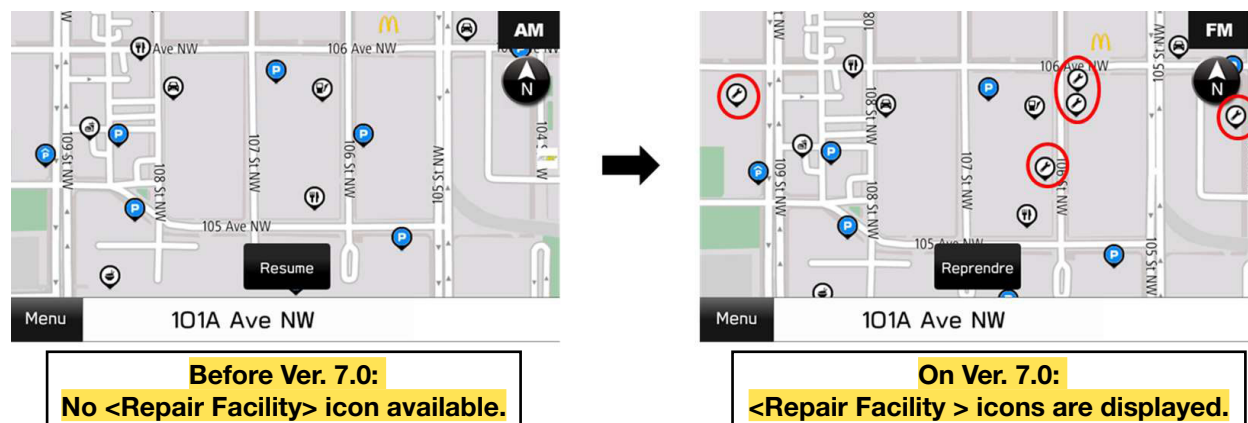
NOTE 4: Displaying <Repair Facility> POI Icon.

<Repair Facility> Icon can be displayed in the NAVI Map.

<Repair Facility> Icon can be turned On or OFF at; Settings > Navigation > POI Icons.
