# QUALITY ACTION

## CAMPAIGN BULLETIN

### Front Turn Signal Lamp Dealer Inventory

Reference: PM965  
Date: December 23, 2020

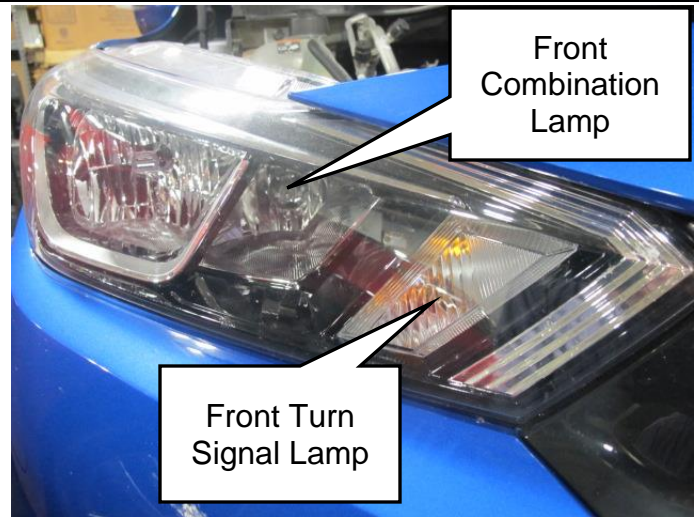
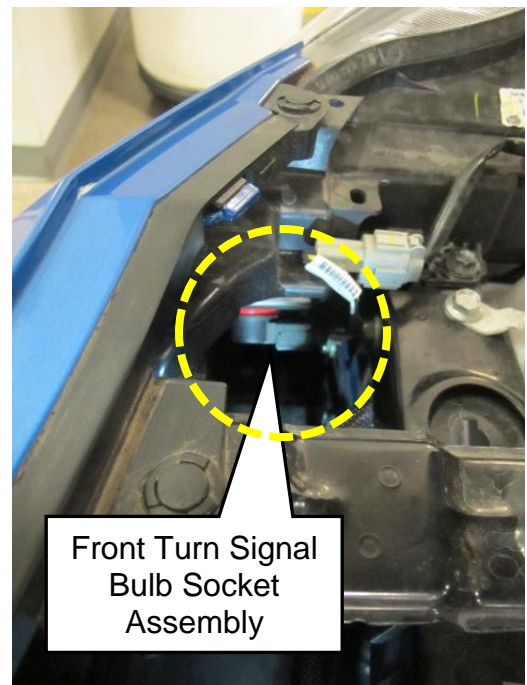
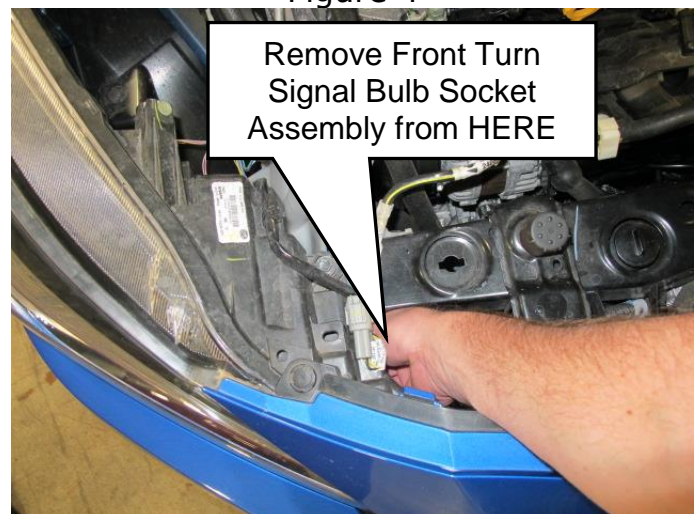
3. Locate left and right front turn signal lamp bulb and socket assemblies in the front combination lamps (Figures 3, 4 and 5).

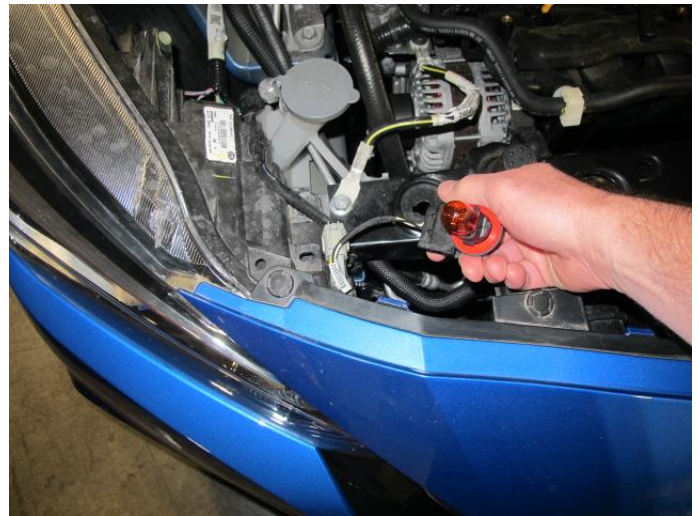
Figure 6

4. Remove left and right front turn signal lamp bulb and socket assemblies from the front combination lamps (Figure 6).
