NUMBER: 08-068-20 REV. C

GROUP: 08 - Electrical

UGQ Radio Enhancements

Jeep Compass

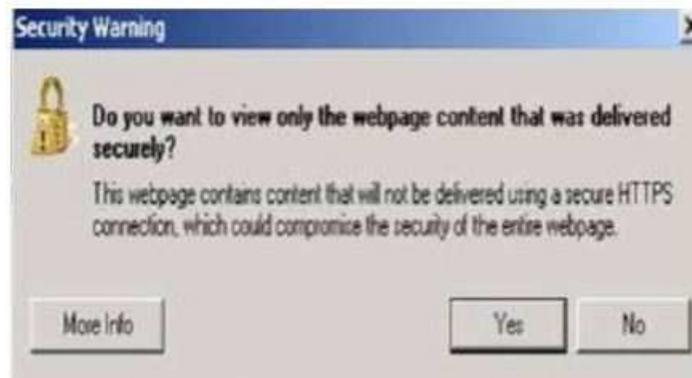
Fig. 2
Pop-Up Security Message

3. Go to DealerCONNECT>Service>Uconnect Command Center>Uconnect>More Information >Dealer software downloads to download the files.
4. If a security message appears “Do you want to view only the web page content that was delivered securely?” ([Fig. 2](#)) . Press “No” to continue.

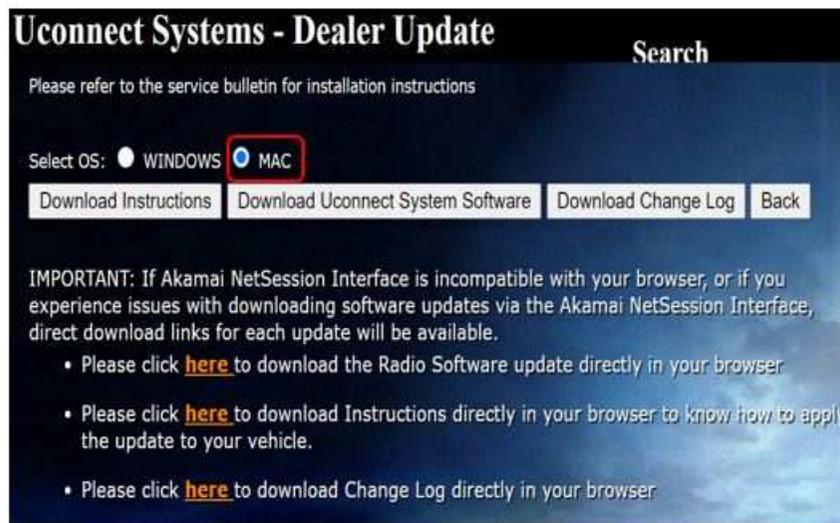
Fig. 3

6. Download the software update file to your local PC's desktop. Make sure to select the "MAC" radial button for all downloads (Fig. 3) .

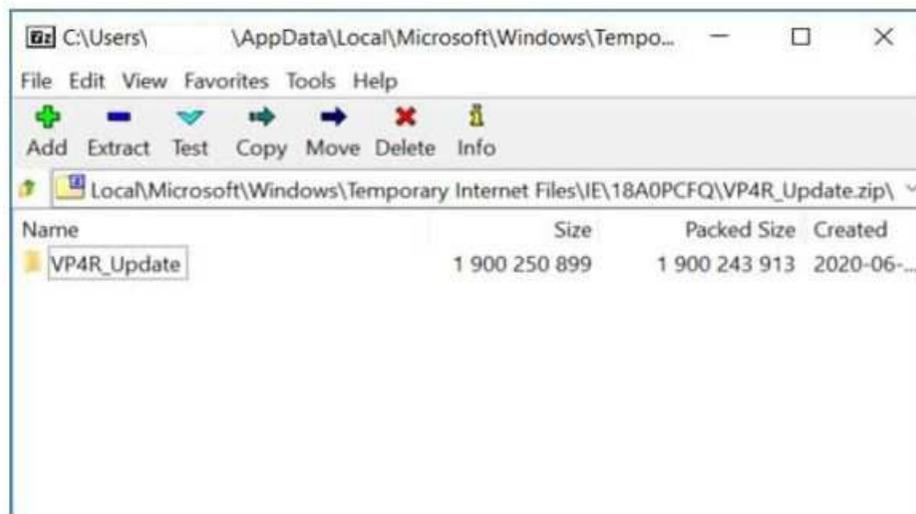
Fig. 4

8. Unzip all the files to the root folder of USB flash drive. Files should not be within a zip folder. Your USB files should look like (Fig. 4) when you open it.

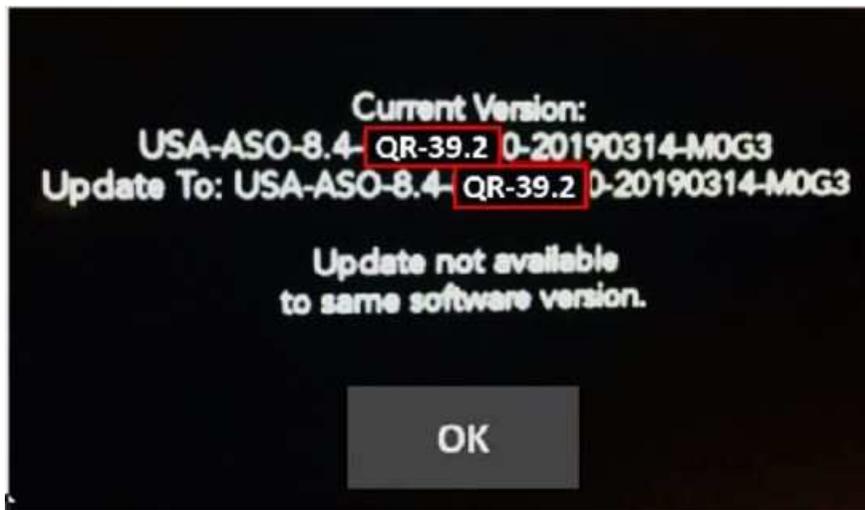
Fig. 6
Screen Displayed When Radio Software Level Is Up To Date

12. If the radio software is already up to date, the screen in (Fig. 6) will be displayed. Press "OK" and remove the USB flash drive.

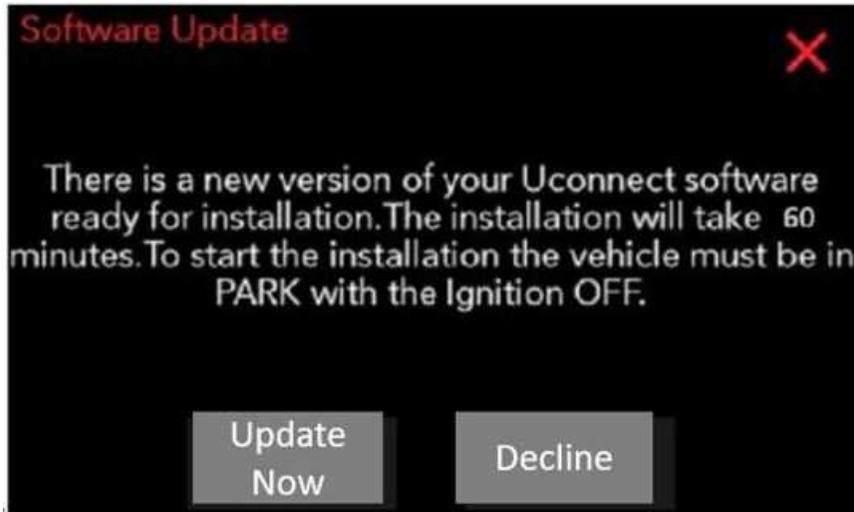
Fig. 7
Software Update Is Available

- 13. Once the system has verified there is an available update, press the “Update Now” button. Make sure the vehicle is in park, **DO NOT turn off the ignition (Fig. 7) .**

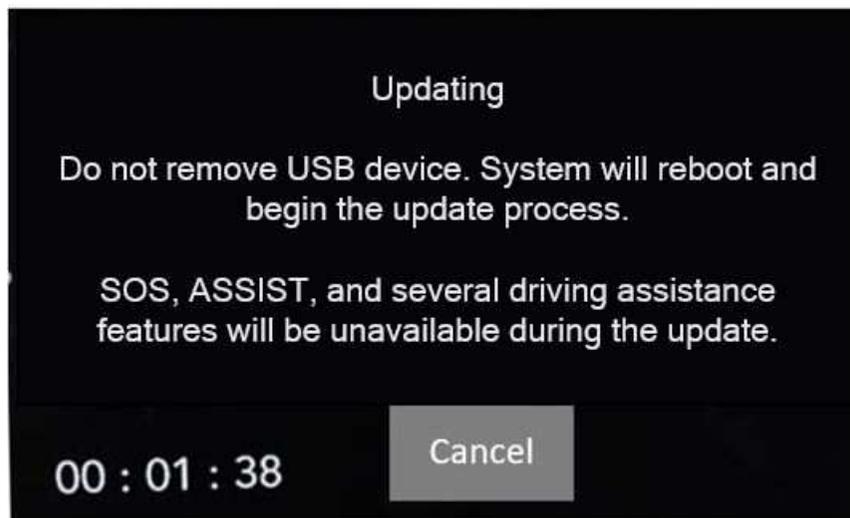
Fig. 8
Updating Screen

NOTE: If the ignition is turned off before the two minutes has expired, the software update will be canceled. The ignition does not have to be turned off to perform this updated. (Fig. 8) .

- 14. When the radio starts updating, the screen in (Fig. 8) will be displayed.
