NUMBER: 08-109-20

GROUP: 08 - Electrical

UGQ Radio Enhancements

2021	(JL)	Jeep Wrangler
2021	(JT)	Jeep Gladiator

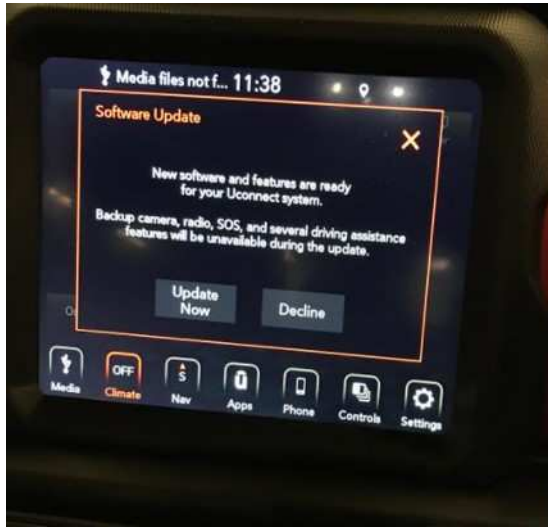
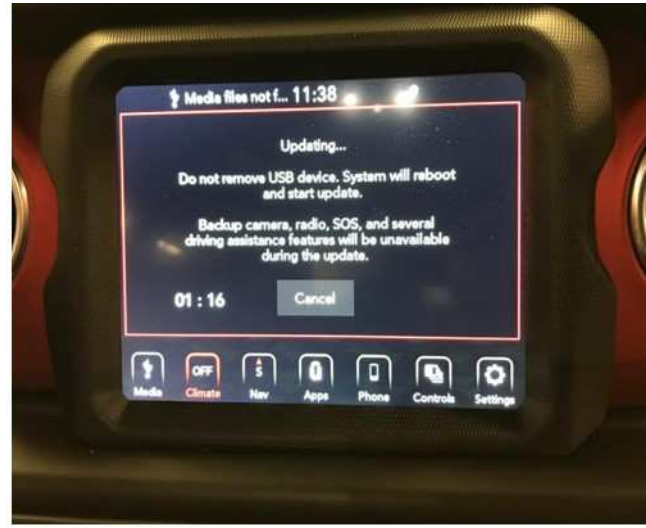
Fig. 8

Software Update Is Available

12. Once the system has verified there is an available update, press the "Update Now" button. Make sure the vehicle is in park. **Do NOT turn off the ignition until the two minute timer has expired. The ignition doesn't have to be turned off to update the radio's software. (Fig. 8) .**

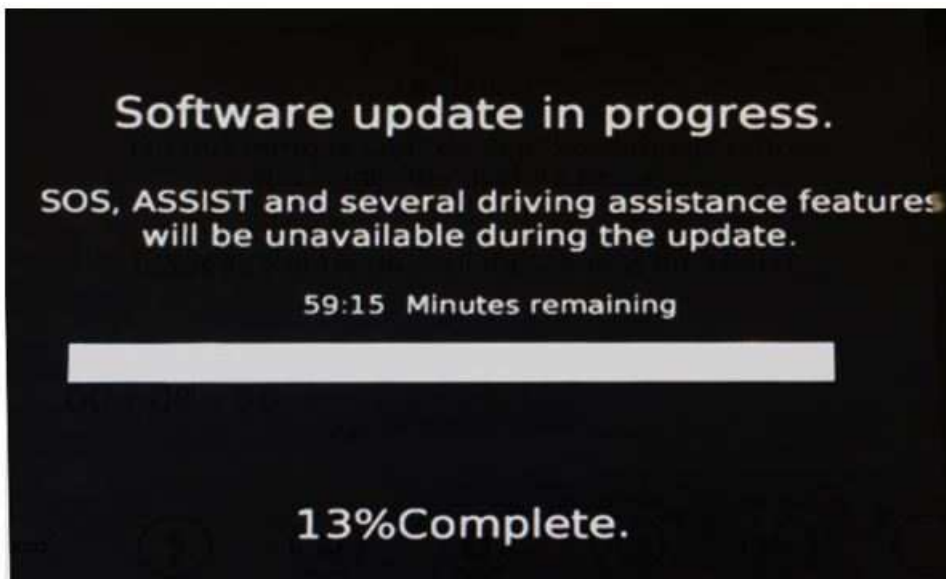
Fig. 9

Software Update In Progress

13. When the radio starts updating, the screen in (Fig. 8) will be displayed.
14. The radio will reboot and the update will begin. The update should only take 30 minutes, the timer on the screen may display the incorrect time remaining, (Fig. 9) .

NOTE: The completion indicator may not reach 100%, even though the software update has been completed. Once the software update has finished, the radio and display screen will turn off.
