Volvo Chassis - Air Leak At Wet Tank - Model VNL

QJ 1-12337163670

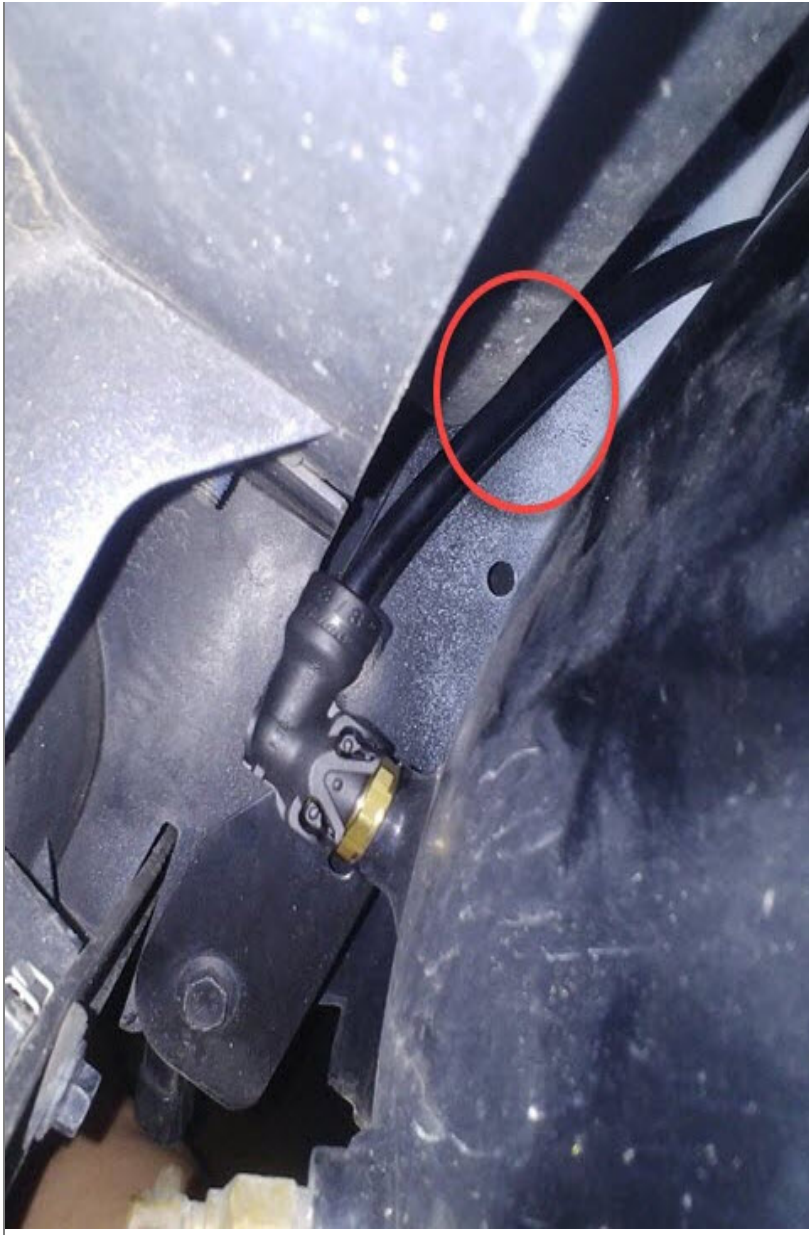
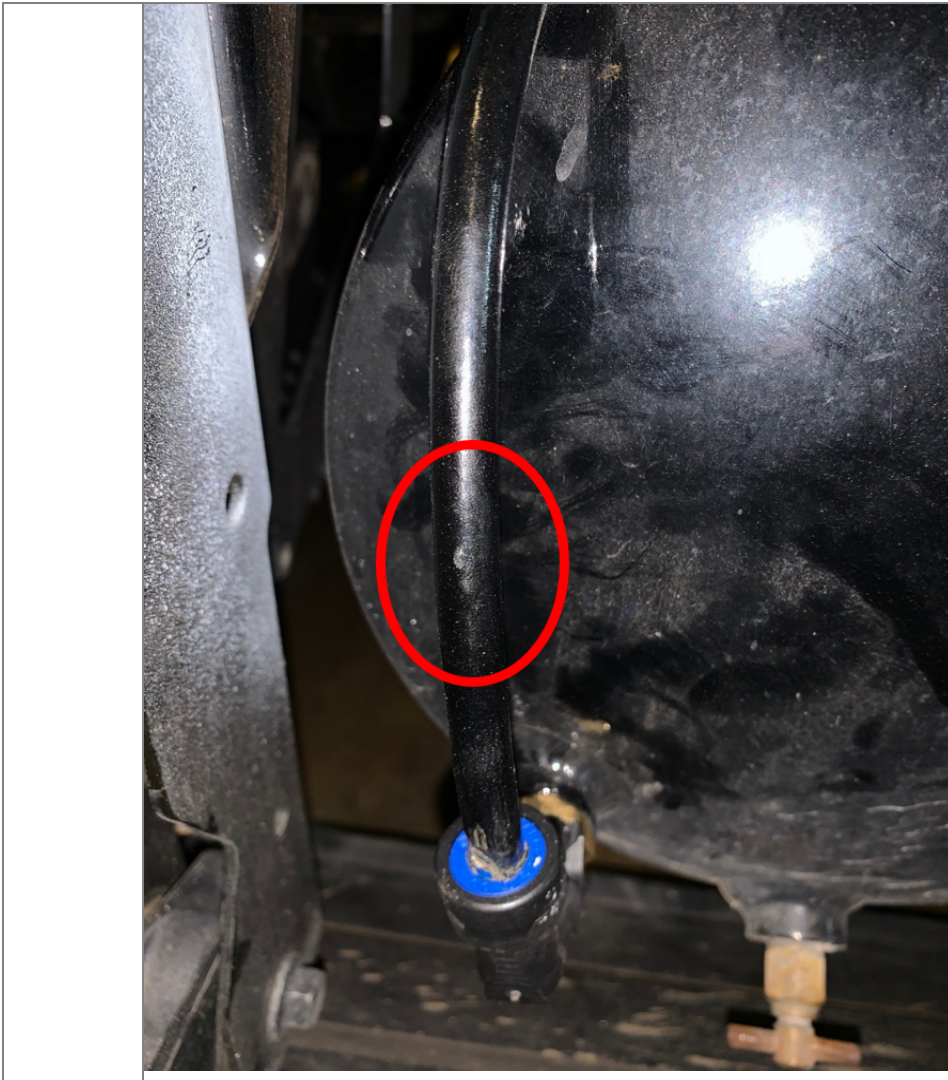
Volvo VN models have been reported having the wet tank, located on the front (outside) side of the wet tank, air line rub the chassis fairing. If the truck was built starting March 11, 2019 with air tank 22945941 and air fittings 991083 or 991965, in the front port of the air tank, this issue is possible. To correct this issue, replace fittings 991083 or 991965 with fitting 20999390.

QJ Solution: Proposed solution is to S-Note the old metric fitting onto about 95 trucks. Plan is to use the S-Notes until the end of spec week 20W16 (no longer needed starting 20W17).
