Rattling or Clicking from the Panoramic Glass Roof

AFFECTED VEHICLES

Year	Model	Trim Level	VIN Range
2019	RDX	AWD	5J8TC2***KL000001 to 5J8TC2***KL043969
2019	RDX	2WD	5J8TC1***KL000001 to 5J8TC1***KL025375

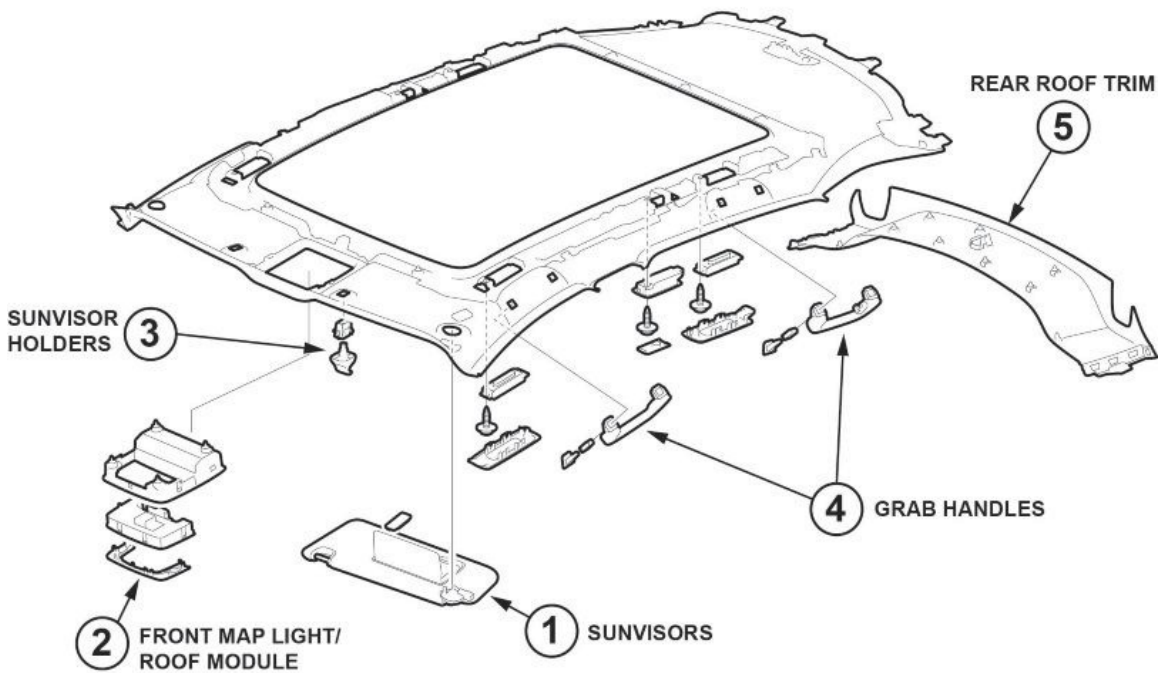
Step	Component	Exploded View Location	Service Manual Letter Reference
1	Sunvisors	Headliner Area (Image #1)	C
2	Front Individual Map Light /Roof Module		A,B
3	Sunvisor Holders		E
4	Grab Handles		F
5	Rear Roof Trim		I

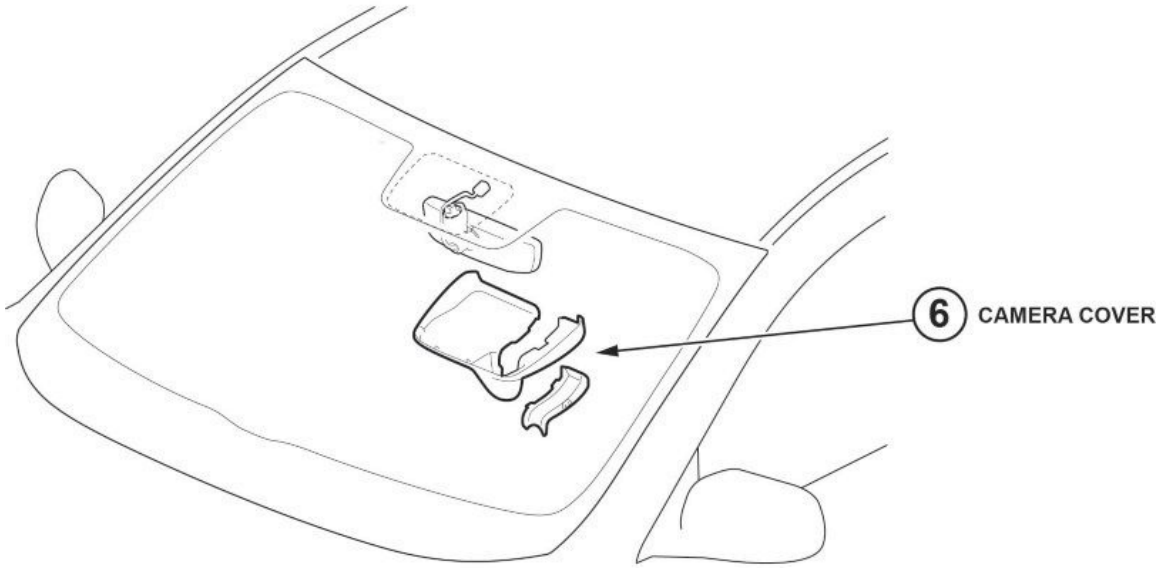
Step	Component	Exploded View Location	Service Manual Letter Reference
6	Camera Cover	Windshield Area	B,C

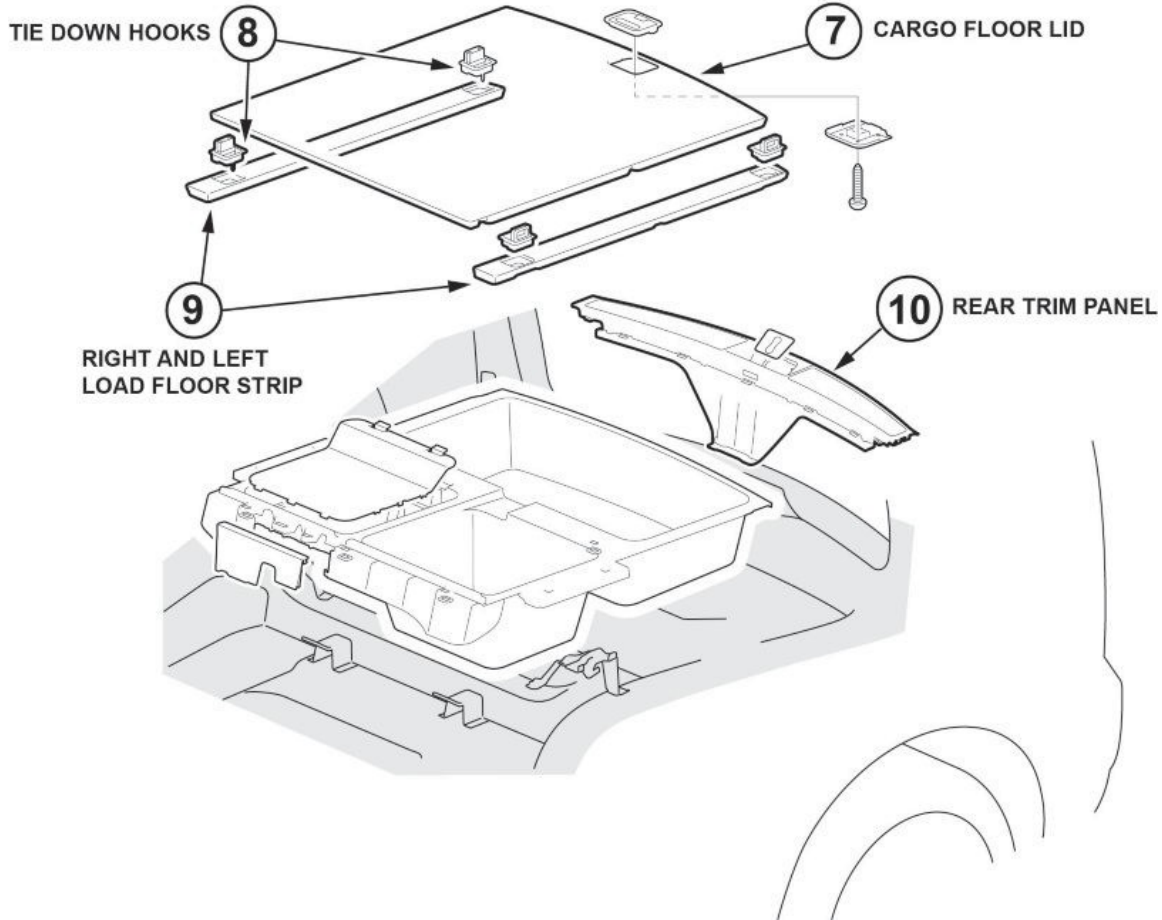
Step	Component	Exploded View Location	Service Manual Letter Reference
7	Cargo Floor Lid	Interior Trim Area (Image #2)	O
8	Tie Down Hooks		M
9	Right and Left Load Floor Strip		N
10	Rear Trim Panel		R

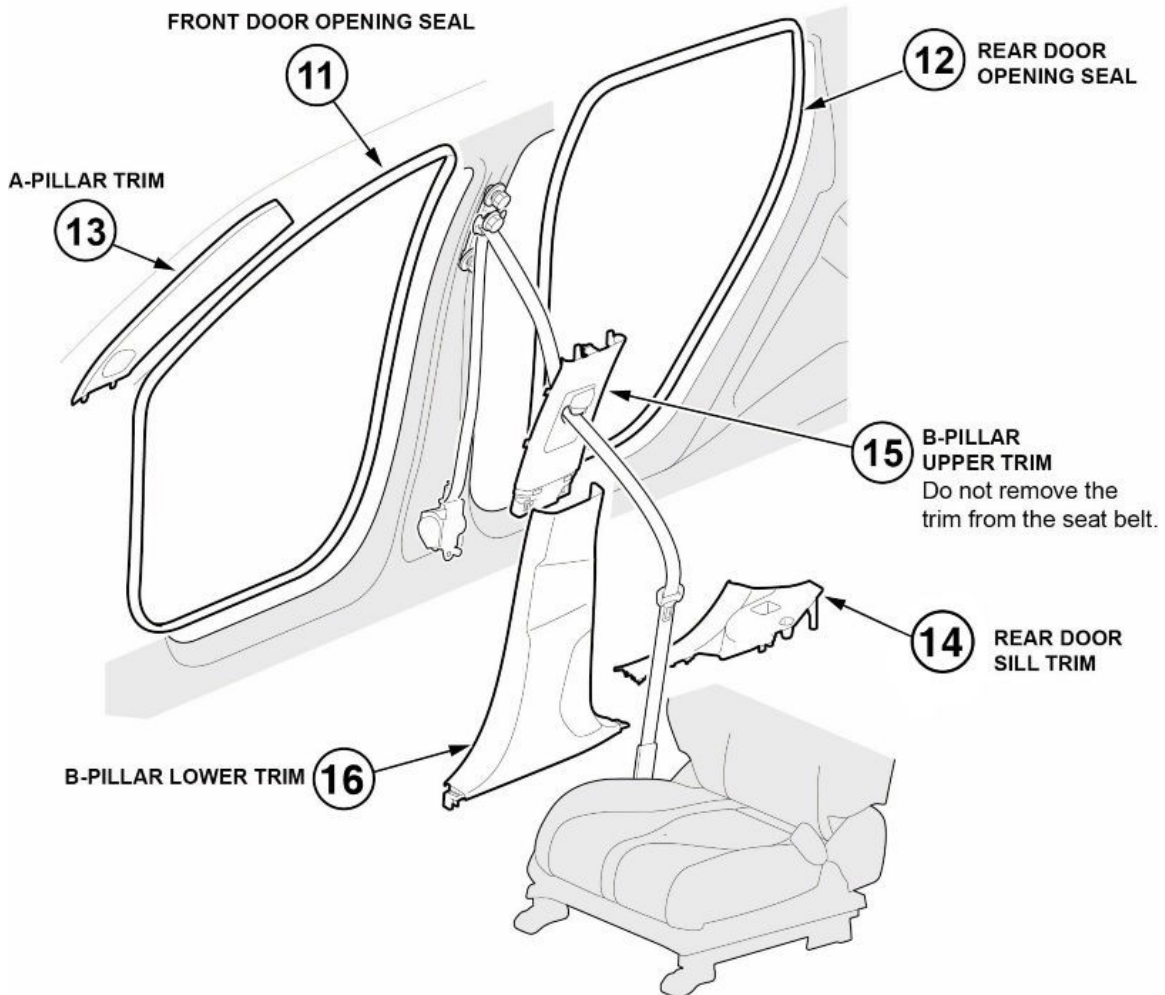
Step	Component	Exploded View Location	Service Manual Letter Reference
11	Front Door Opening Seal (as needed)	Interior Trim Area (Image #1)	C
12	Rear Door Opening Seal (as needed)		H
13	A-Pillar Trim		A
14	Rear Door Sill Trim		G
15	B-Pillar Upper Trim NOTE Do not remove the trim from the seat belt.		J
16	B-Pillar Lower Trim		F

Do steps 11 thru 16 for both sides.

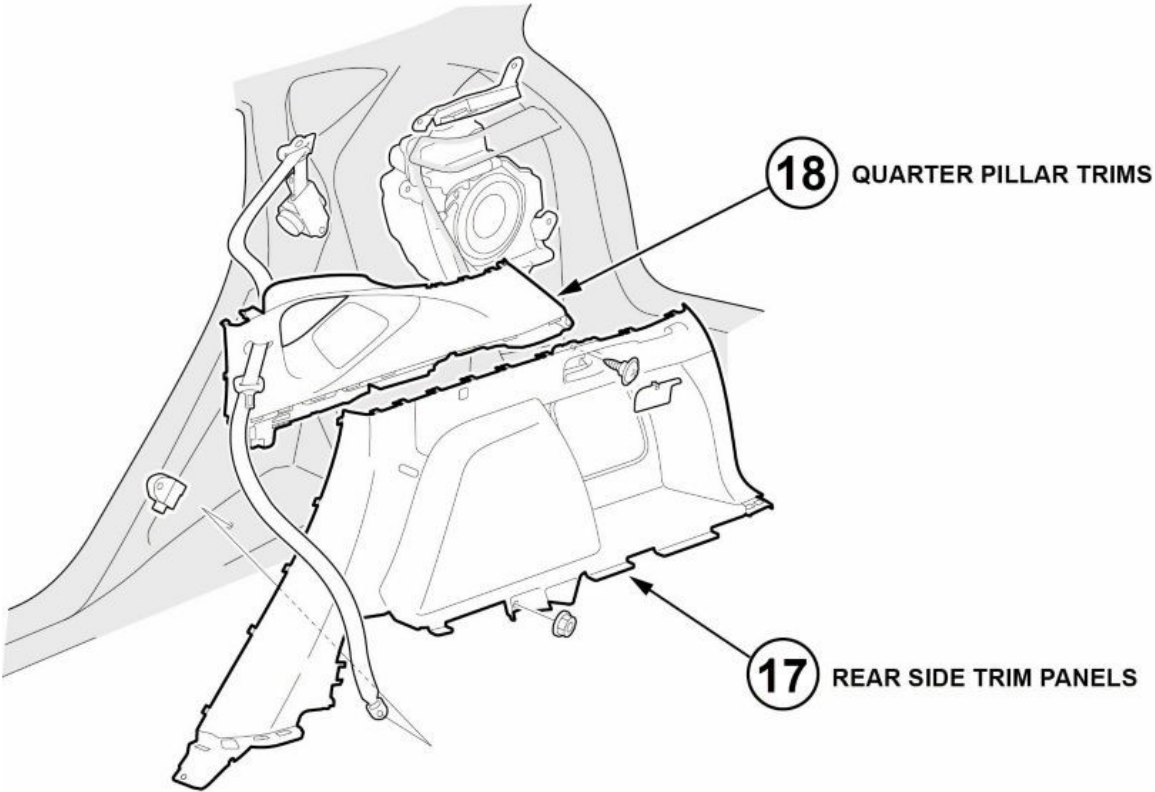
Step	Component	Exploded View Location	Service Manual Letter Reference
17	Rear Side Trim Panels	Interior Trim Area (Image #2)	U
18	Quarter Pillar Trims		W

Do steps 17 and 18 for both sides.

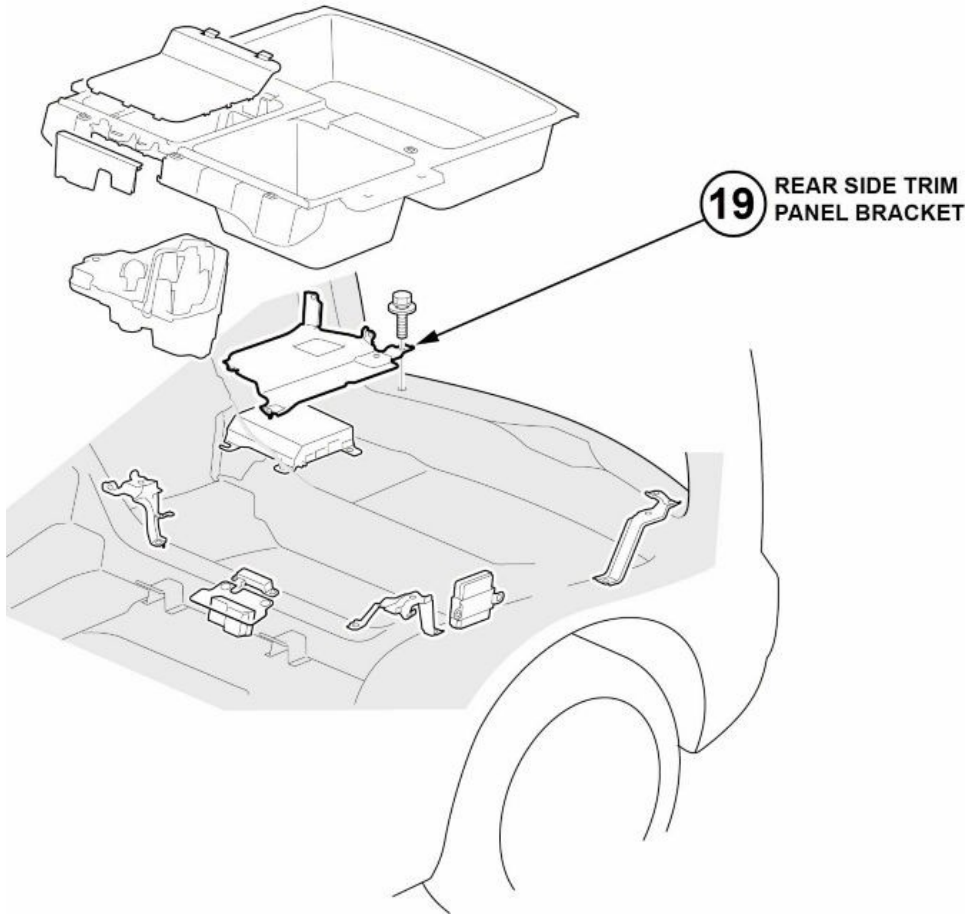
Step	Component	Exploded View Location	Service Manual Letter Reference
19	Rear Side Trim Panel Bracket	Interior Trim Area	Not Available

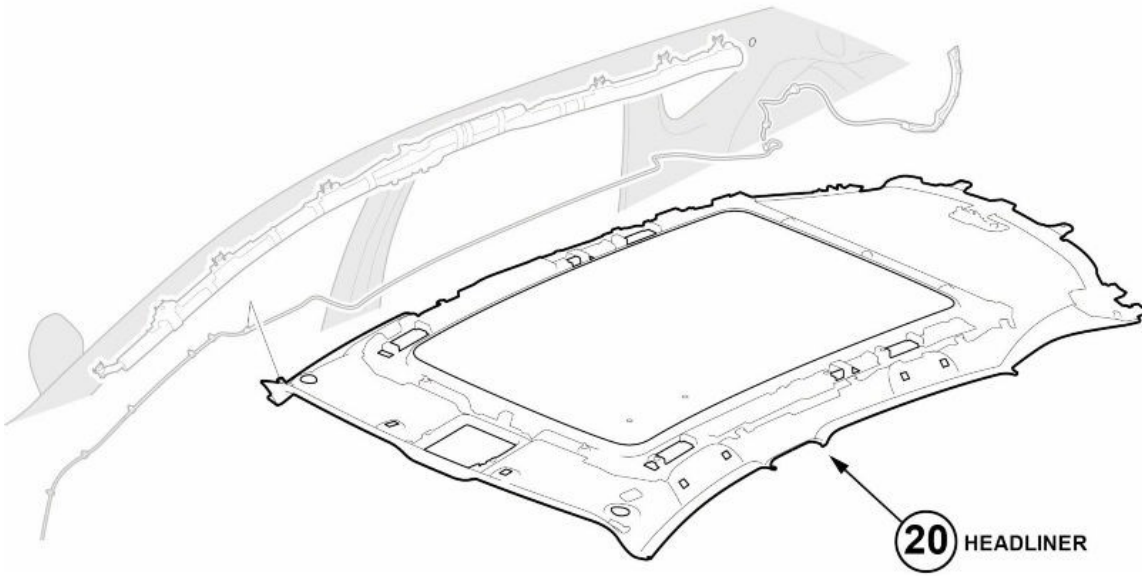
Step	Component	Exploded View Location	Service Manual Letter Reference
20	Headliner	Headliner Area (Image #1)	J

To remove the headliner from the vehicle without damage, the right rear damper gusset must be removed. To do this, roll the vehicle onto a lift or jack up the right rear of the vehicle and place it on safety stands. Refer to the service information for more information.
