GROUP
ELE
NUMBER
213 (Rev 2, 01/06/2021)

MODEL
2020-2021MY
Telluride (ON)
DATE
October 2020

TECHNICAL SERVICE BULLETIN

SUBJECT: SVM/AVM CAMERA DISPLAY IMAGE QUALITY
AND TPMS LIGHT ON

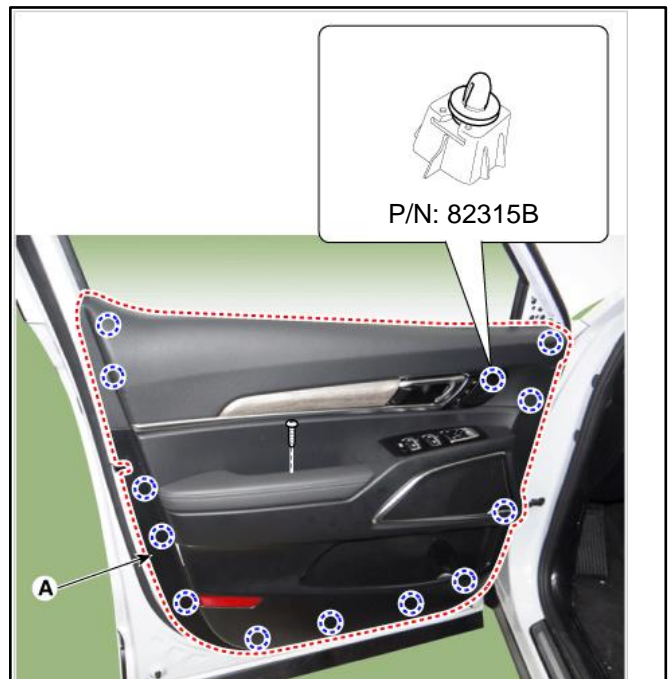
3. Remove the Passenger or Driver door panel (A) by referring to the "Body (Interior and Exterior) → Front Door → Front Door Trim → Repair Procedures" chapter in the applicable Shop Manual on KGIS.
