MODEL
2021MY
Sorento (MQ4 HEV)

NUMBER
225

TECHNICAL SERVICE BULLETIN

SUBJECT: **SERVICE ACTION: CENTER AND REAR MUFFLER
INSPECTION AND REPAIR (SA461)**

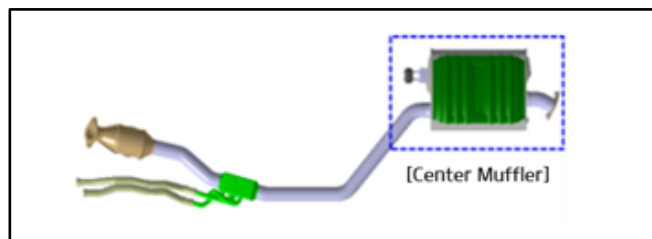
This bulletin provides the procedure to inspect the center muffler on some 2021MY Sorento (MQ4a HEV) vehicles equipped with 1.6L T-GDI engine, produced from September 02, 2020 through December 30, 2020, which may exhibit a poor engine start up due to freezing of condensation in the muffler(s) after parking the vehicle for an extended period of time in cold/freezing temperature. The issue does not affect drivability once the vehicle is started. Follow the procedure outlined in this bulletin to inspect the center muffler and drill a 3/16" hole on both the center and rear mufflers to improve condensation drainage. Before conducting the procedure, verify that the vehicle is included in the list of affected VINs.
