# Technical Service Bulletin

## 15 Oil leak from the cylinder head - 2.9 and 3.0TFSI only

15 21 36 2053278/5 January 29, 2021. Supersedes Technical Service Bulletin Group 15 number 20-35 dated October 8, 2020 for reasons listed below.

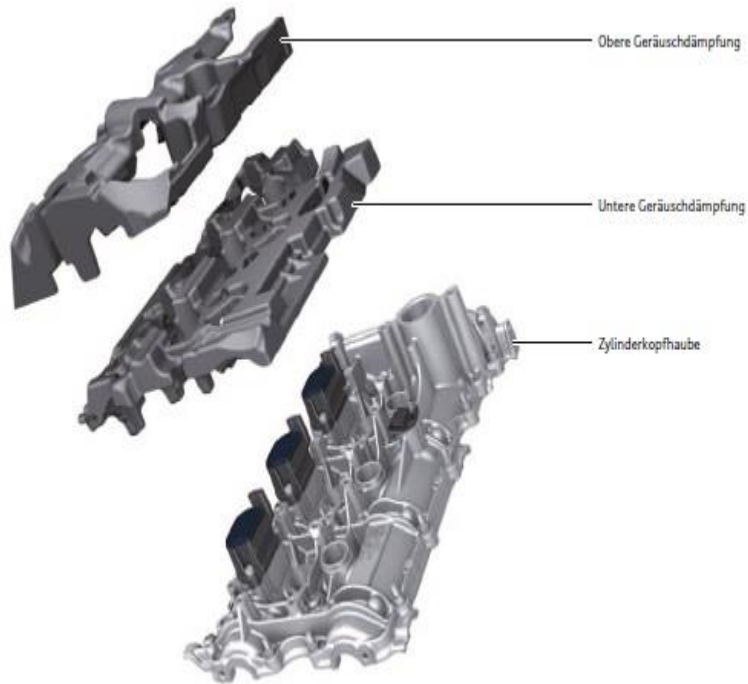
**Figure 1.** Removing the upper noise insulation.

2. Remove the upper noise insulation of the affected cylinder bank (Figure 1).

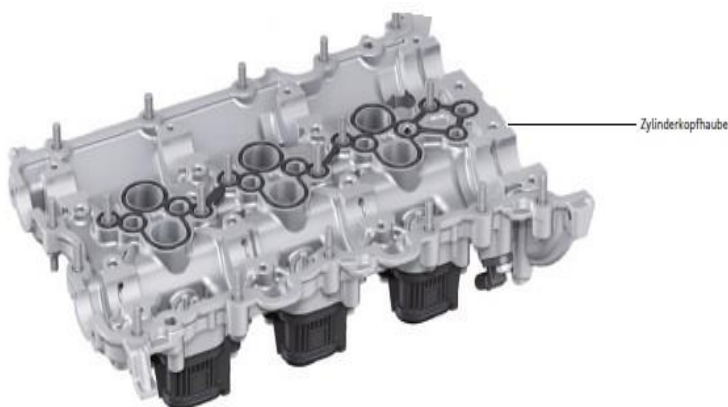
**Figure 4.** Remove the cylinder head cover and gasket.

6. Remove the cylinder head cover and the seal (Figure 4).

8. Install a new seal, re-assemble the camshaft cover, clean the engine compartment, and if necessary replace the noise insulation (if it is full of oil).
