# Technical Service Bulletin

## 91 Parking assistance provides false warnings

91 21 64 2024323/7 January 25, 2021. Supersedes Technical Service Bulletin Group 91 number 19-88 dated September 12, 2019 for reasons listed below.

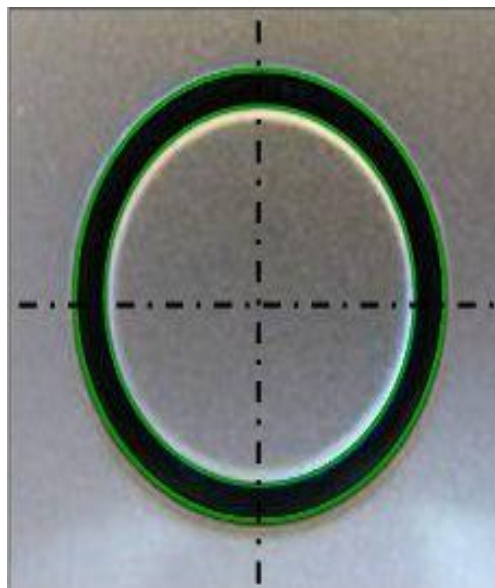
**Figure 8.** A correctly centered parking aid sensor.

8. Verify that the sensor is centered inside of the mounting hole (Figures 8 - 9). If the sensor is mounted off-center, remove the bumper and reinstall the sensor.

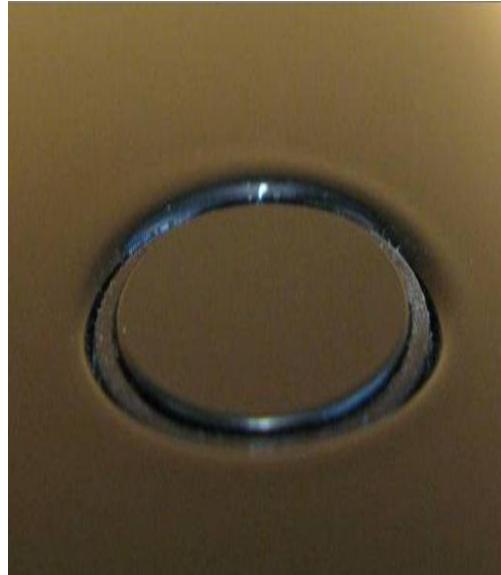
**Figure 10.** A correctly installed parking aid sensor.

9. Ensure the sensor sits flush with the bumper (Figures 10 - 11). If the sensor is recessed or bulging, remove the bumper and reinstall the sensor.

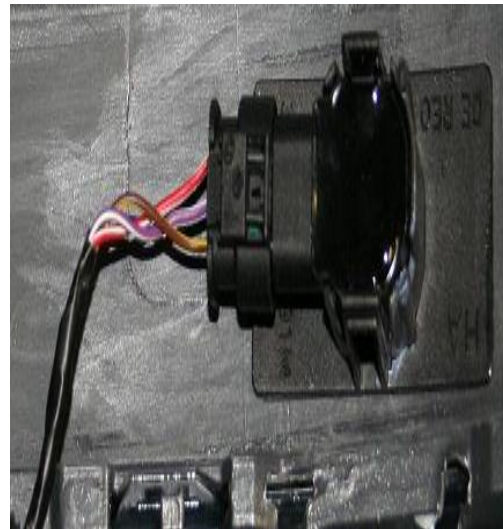
**Figure 12.** A correctly installed cable with sufficient length.

12. Check the cables in the bumper for damage and sufficient length (Figures 12 - 13). Cables that are too short can cause damage to the harness.
- If the cable is damaged, repair the cable using VAS Repair Kit 1978.
  - If the cable is too tight, correct the routing by moving the support clip so the cable is no longer under tension.

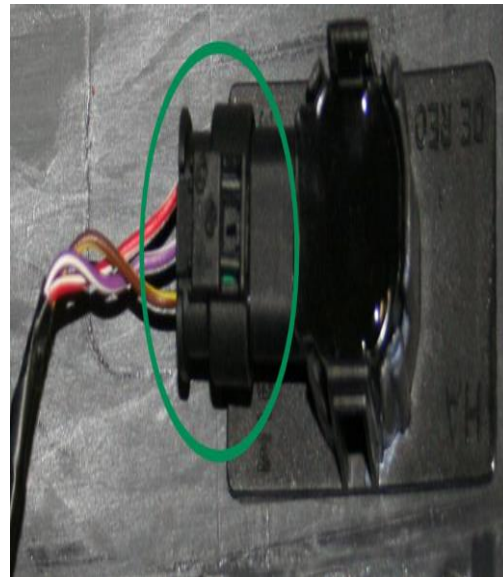
**Figure 14.** A correctly installed parking aid sensor connector.

13. Check the connectors on the parking sensors and the socket box for correct installation (Figures 14 - 15). If the connectors are not installed properly, reinstall.
