SERVICE BULLETIN

Classification: BT18-008b	Reference: NTB18-042b	Date: January 21, 2021
------------------------------	--------------------------	---------------------------

KICKS, LEAF, SENTRA AND VERSA; FRONT DOOR WILL NOT OPEN

APPLIED VEHICLES: 2018-2020 Kicks (P15)
2018-2021 LEAF (ZE1)
2020 Sentra (B18)
2020 Versa Sedan (N18)

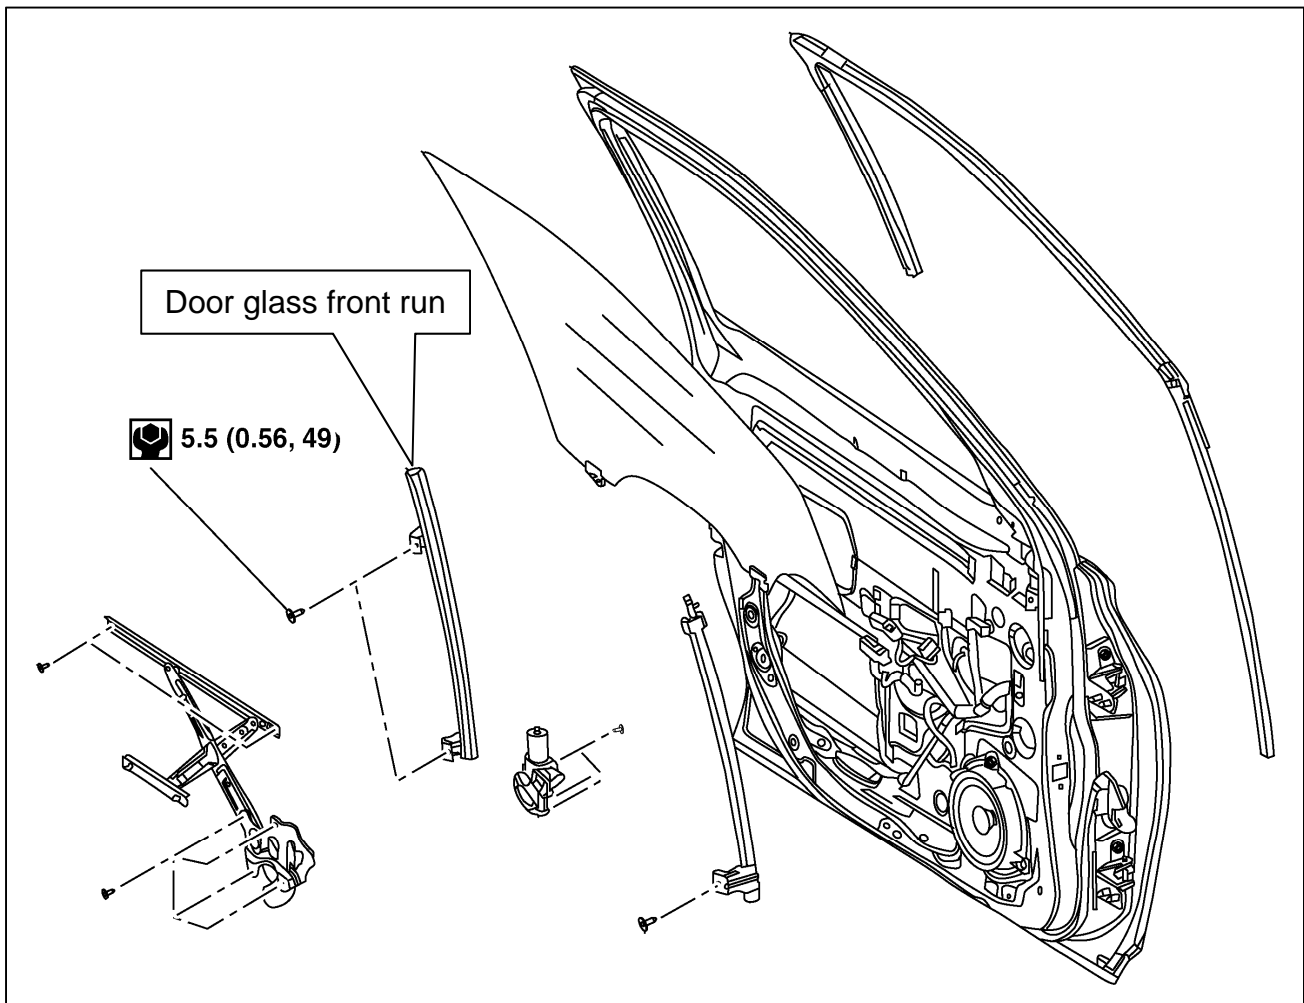
Figure 1

1. Remove the front door finisher of the affected door.
 - Refer to the Electronic Service Manual (ESM); section **BODY INTERIOR > INTERIOR > REMOVAL AND INSTALLATION > FRONT DOOR FINISHER.**
- NOTE:** It may be intermittent that the door will not open. Attempt to open the door multiple times with both handles. If the door does not open normally, follow normal repair procedures for consequential damage during front door finisher removal.
2. Connect the power window switch, and then close (roll up) the door glass.
 3. Remove the door glass front run.
 - Refer to the ESM; section **BODY EXTERIOR, DOORS, ROOF & VEHICLE SECURITY > GLASS & WINDOW SYSTEM > REMOVAL AND INSTALLATION > FRONT DOOR GLASS.**

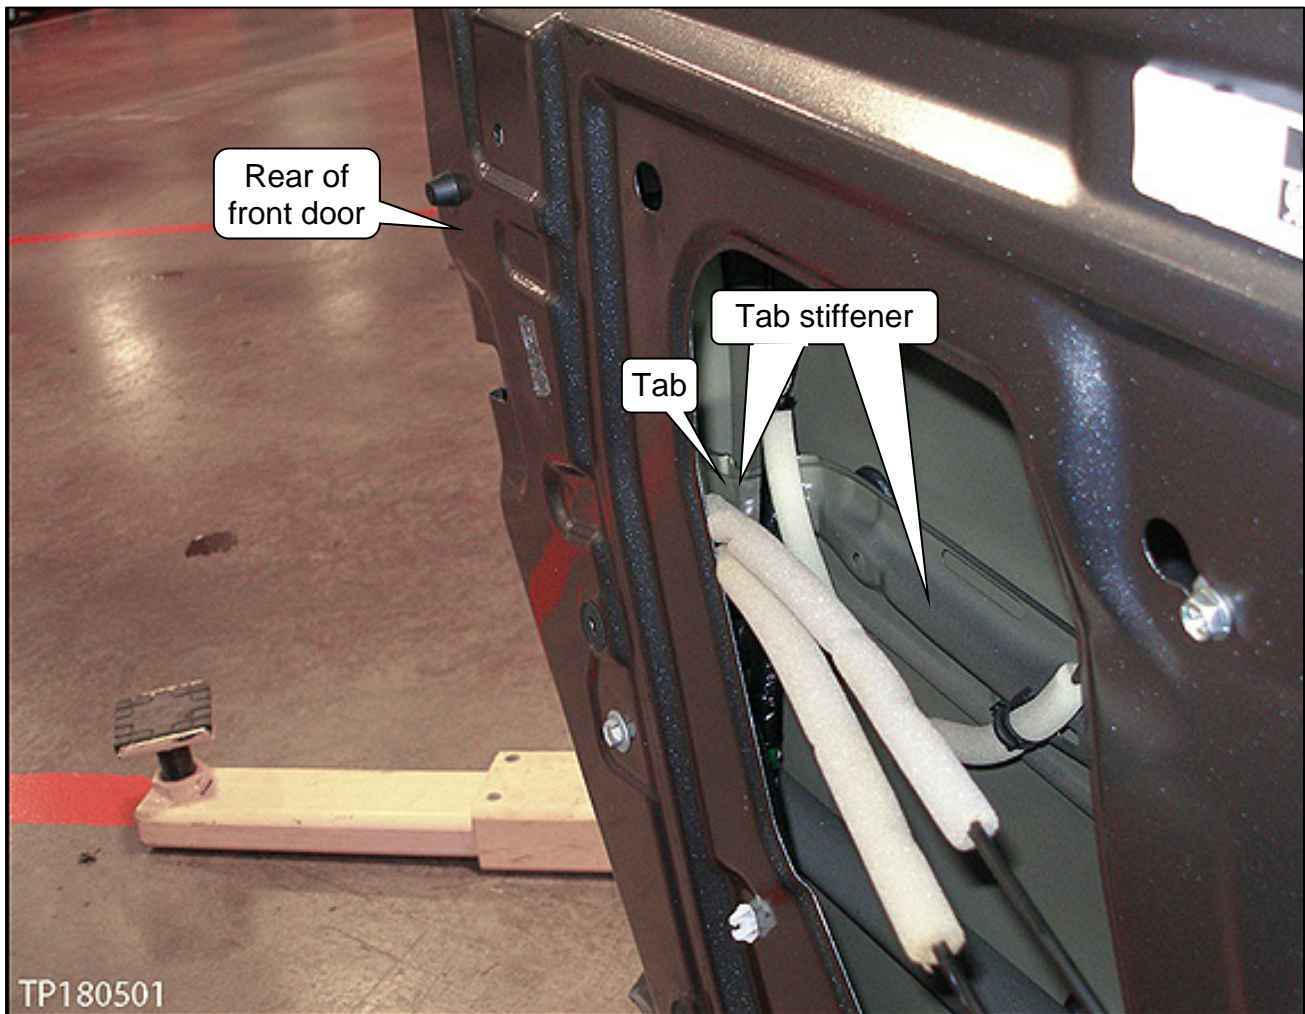
NOTE: It may be intermittent that the door will not open. Attempt to open the door multiple times with both handles. If the door does not open normally, follow normal repair procedures for consequential damage during front door finisher removal.
10. Connect the power window switch, and then close (roll up) the door glass.
11. Access the tab stiffener and door latch lever.
 - Refer to Figure 5 below, and Figure 6 on the next page.

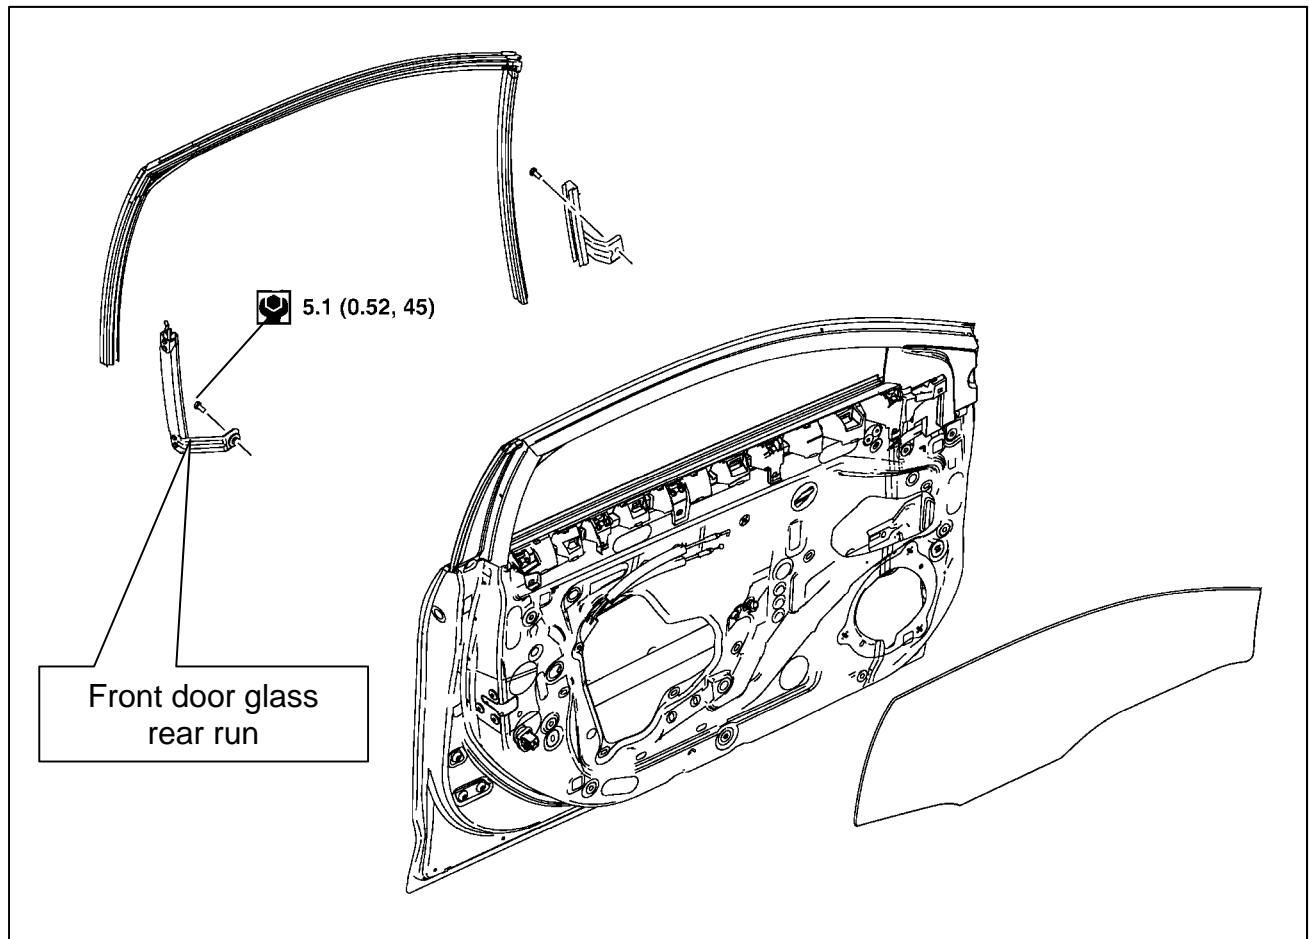
Figure 8

18. Remove the front door glass rear run.

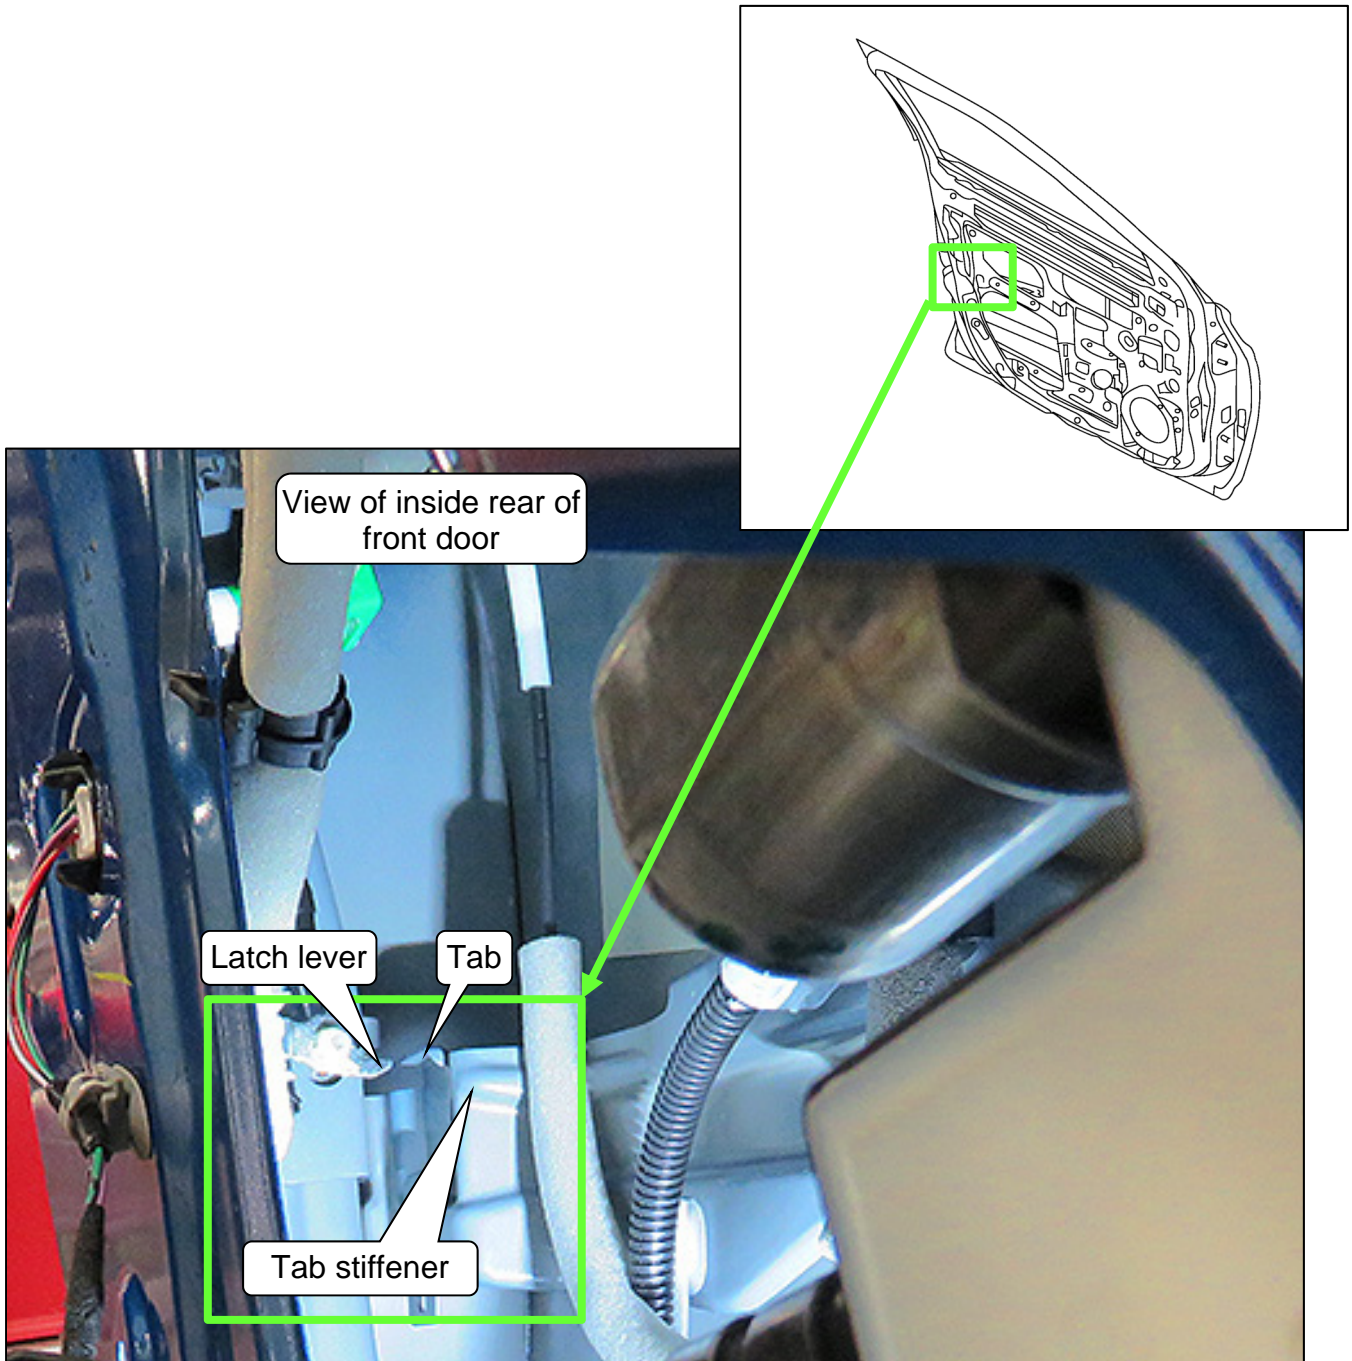
19. Access the tab stiffener and door latch lever.
- Refer to Figure 9 below, and Figure 10 on the next page.

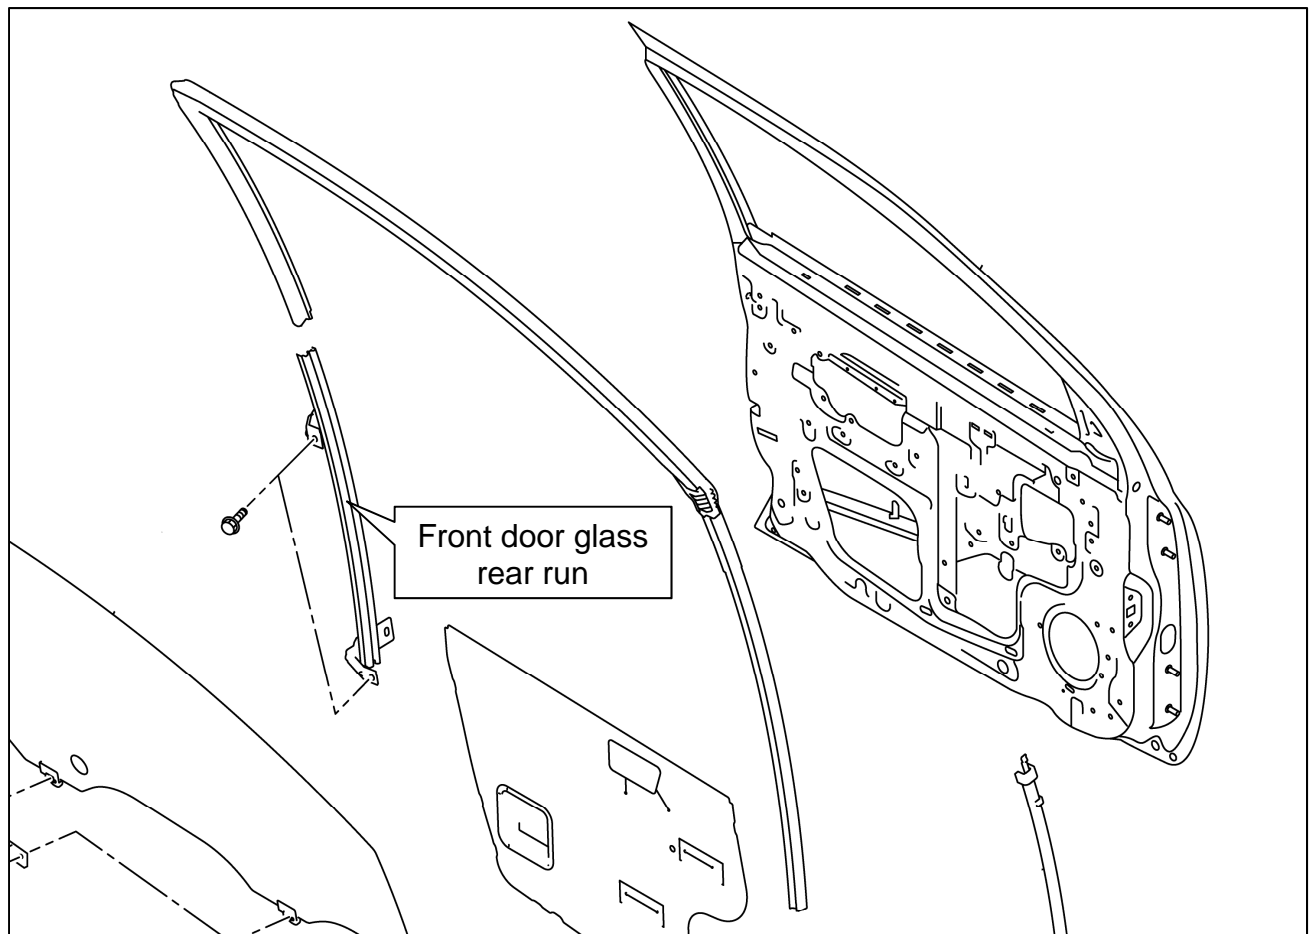
Figure 12

24. Remove the front door finisher of the affected door.
 - Refer to the Electronic Service Manual (ESM); section **BODY INTERIOR > INTERIOR > REMOVAL AND INSTALLATION > FRONT DOOR FINISHER.**
- NOTE:** It may be intermittent that the door will not open. Attempt to open the door multiple times with both handles. If the door does not open normally, follow normal repair procedures for consequential damage during front door finisher removal.
25. Connect the power window switch, and then close (roll up) the door glass.
 26. Remove the front door glass rear run.
 - Refer to the ESM; section **BODY EXTERIOR, DOORS, ROOF & VEHICLE SECURITY > GLASS & WINDOW SYSTEM > REMOVAL AND INSTALLATION > FRONT DOOR GLASS.**

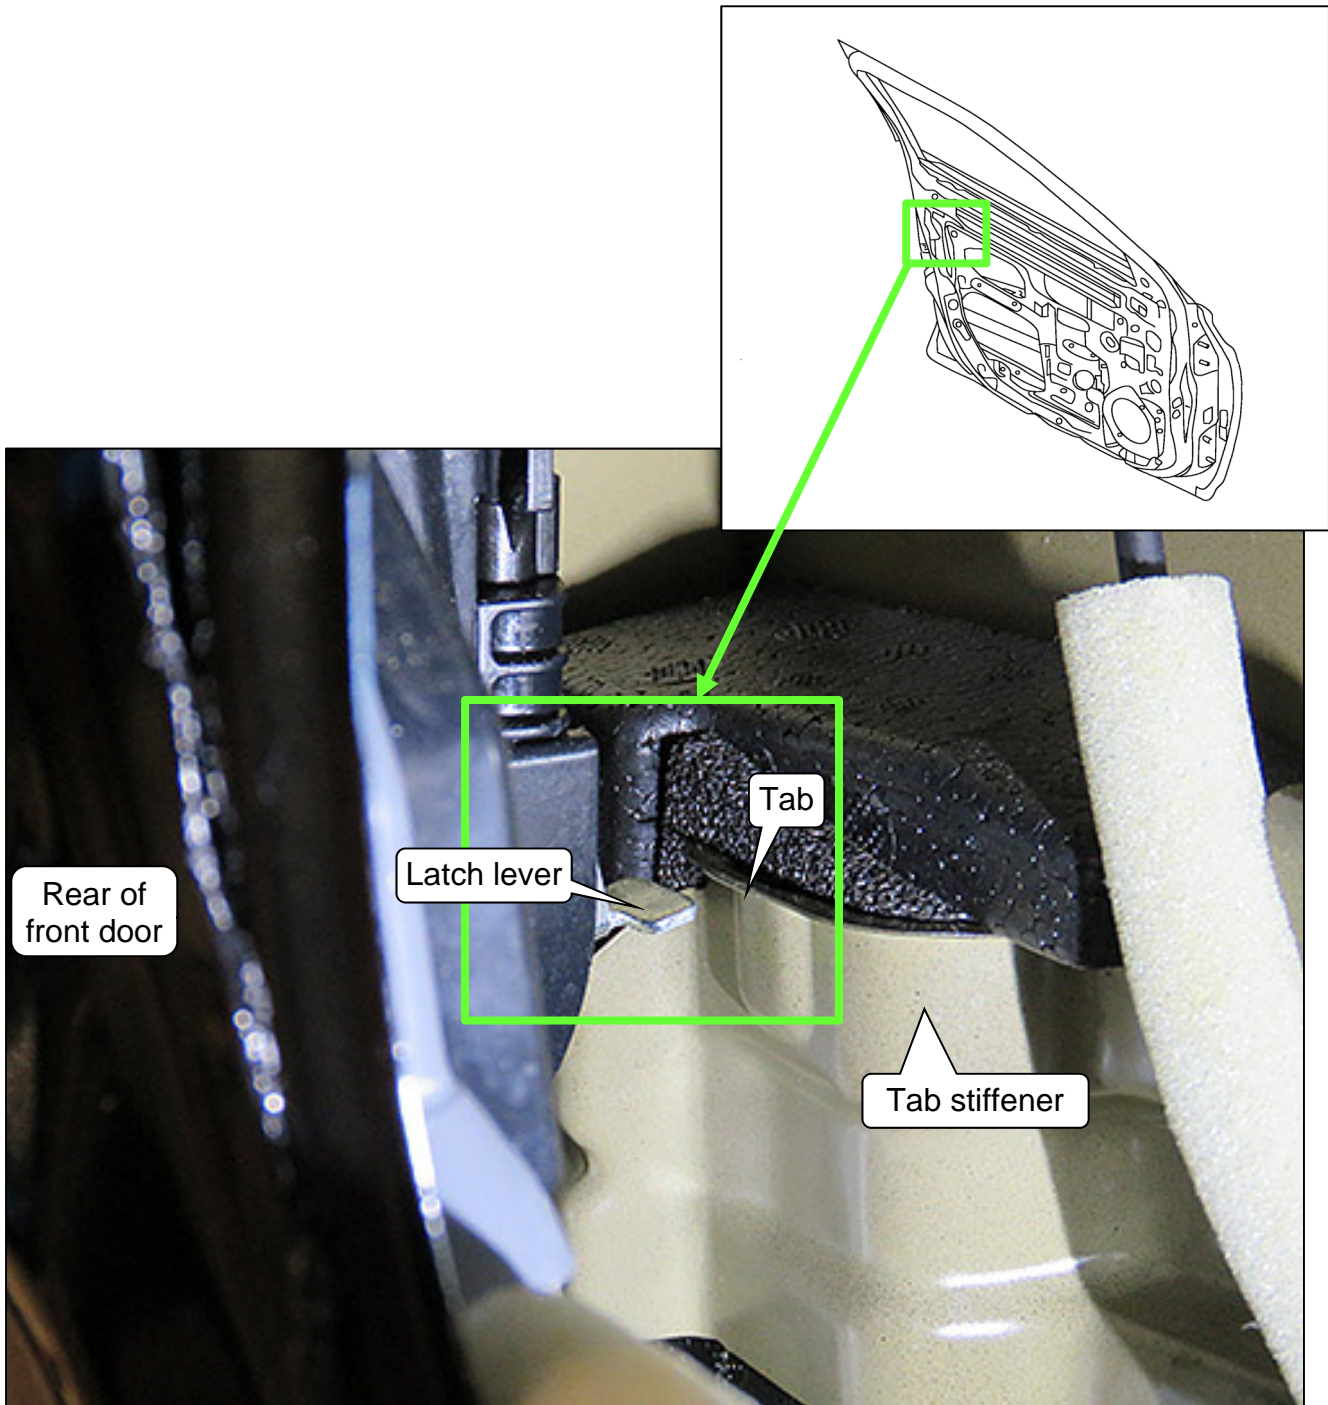
- Refer to Figure 13 below, and Figure 14 on the next page.
