Popping/Crackling from the Speakers; Display Blank

Supersedes 20-031, dated October 9, 2020, to revise the information highlighted in yellow.

Year	Model	Trim Level	VIN Range
2019-20	RDX	ALL	ALL

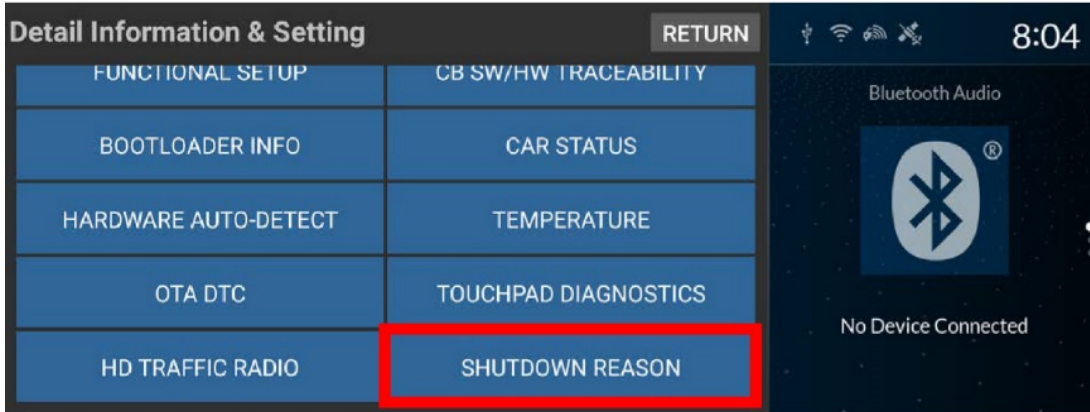
4. Scroll down the menu, and select **SHUTDOWN REASON**.

In this example, the cause of the failure can be identified as **Meter:SUDDEN_SIGNAL_OFF**.

5. Write down any failures as they will be collected on the warranty claim. Then, clear the data.
