Service Bulletin

20-049

2018-21 Odyssey: Popping or Crackling from the Speakers; No Sound from the Audio System; *Network Loss* Message and/or Display Issues Supersedes 20-049, dated October 12, 2020, to revise the information highlighted in yellow.

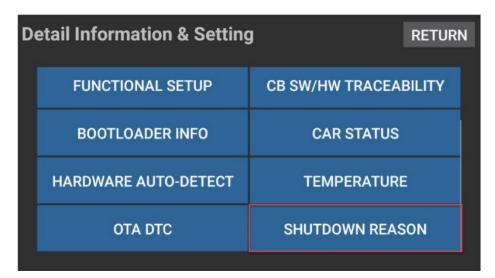
4. Scroll down the menu, and select **SHUTDOWN REASON**.

In this example, the cause of the failure can be identified as Meter:SUDDEN_SIGNAL_OFF.

Write down any failures; they will be collected on the warranty claim. Then, clear the data.
