February 18, 2021

Version 6

Popping/Crackling from the Speakers; Display Blank

Supersedes 20-031, dated February 10, 2021, to revise the information highlighted in **yellow**.

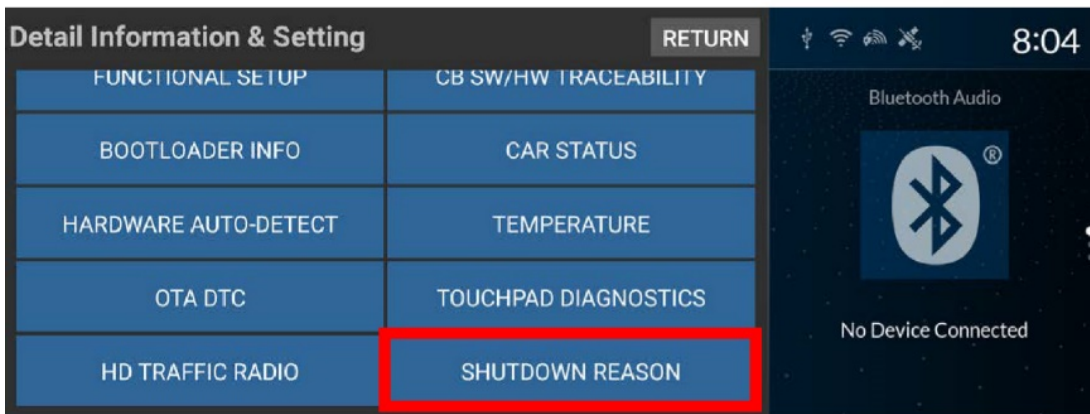
4. Scroll down the menu, and select **SHUTDOWN REASON**.

In this example, the cause of the failure can be identified as **Meter:SUDDEN_SIGNAL_OFF**.

5. Write down any failures as they will be collected on the warranty claim. Then, clear the data.
