MODEL
2019MY
Niro (DE HEV/PHEV)

NUMBER
211

TECHNICAL SERVICE BULLETIN

SUBJECT: AEW P PARTIAL REPLACEMENT FOR DTC P2600/P0C73

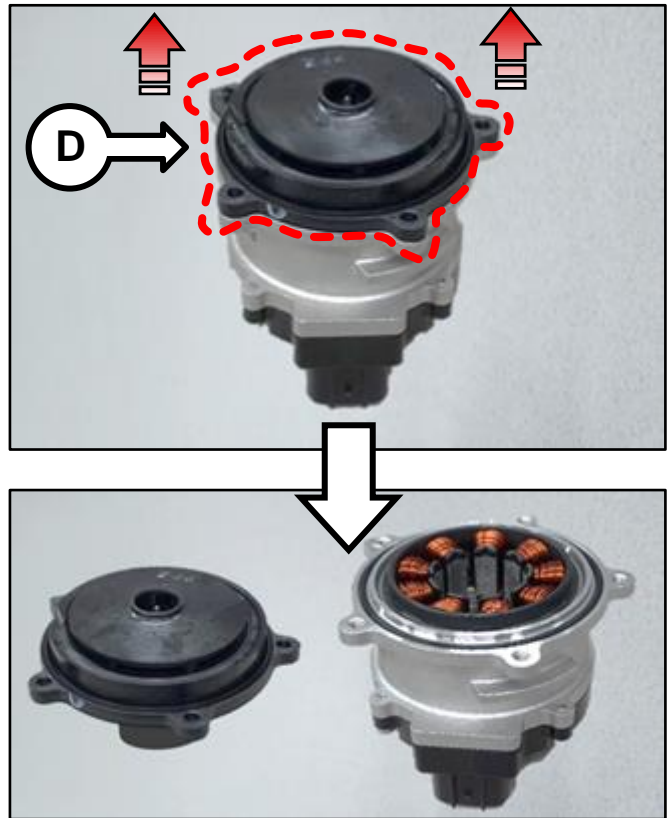
7. Check for coolant intrusion and terminal corrosion in the AEWP housing and take action according to the procedure and example photos.

6. Detach the Can Case (D) from the AEWP housing.

Note: Hold the AEWP housing and pull the can case (D) up, in the direction of the arrows, to detach it easily.

- a. Simple contamination of the stator coil and power terminal:
Clean and dry the inside and replace the Kit parts (can case, S-ring, O-ring).
- b. Severe contamination of the stator coil and terminal:
Replace the AEWP assembly.
