Service Bulletin

Bulletin No.: 18-NA-135

Subject: Water Leaks in Bed Area on Trucks Equipped with High Desert Package

Brand:	Model:	Model Year:		Date Breakpoint:		Engine:	Transmission:
		from	to	from	to		
Chevrolet	Silverado	2017	2018	SOP	Built Prior to March, 1, 2018	All	All

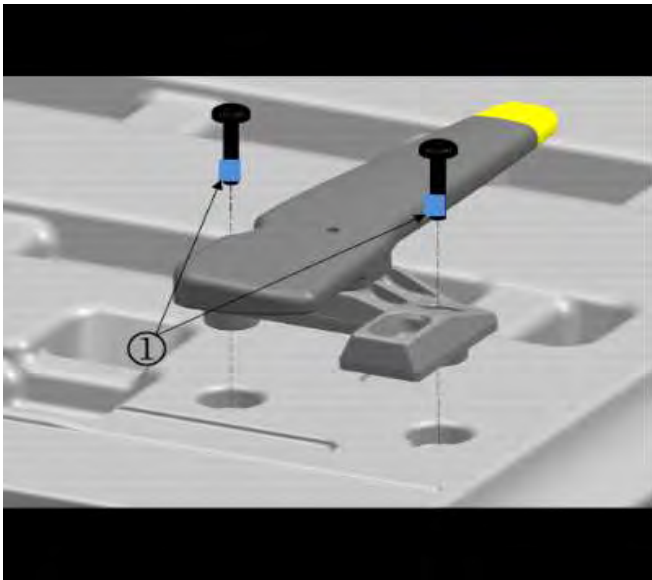
5727185

Note: The new replacement cargo box covers no longer come with the latches attached. Prior to installing the new cargo box covers it will be necessary to install the original latches and fasteners, removed previously from the original covers.

Important: Prior to installation of the screws, apply P/ N 19333511 blue threadlocker (1) to the screws.

29. Install T-25 Torx screws slowly, torquing by hand. Do not use high speed electric or pneumatic equipment

Tighten the screws to 6 Nm (53 lb in).
