Service Alert

CONNECTED VEHICLE SYMPTOM TROUBLESHOOTING

Service Alert No.: SA-013/21

Last Issued: 02/22/2021

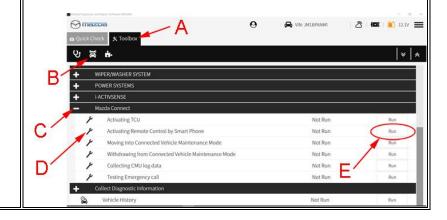
Is the TCU at the latest software level?

- 1. Yes Go to step 3.
- 2. No Update TCU software, then go to step 3.
- 3. Select the following:
- A. Toolbox
- B. Repair icon
- C. MAZDA CONNECT
- D. Activating Remote Control by Smart Phone
- E. RUN.
