MODEL
2021MY
K5 (DL3a)

NUMBER
094 (Rev 1, 02/24/2021)

TECHNICAL SERVICE BULLETIN

**SERVICE ACTION: A/C DISCHARGE HOSE AND
SUNVISOR CLIP CONFIRMATION (SA441)**

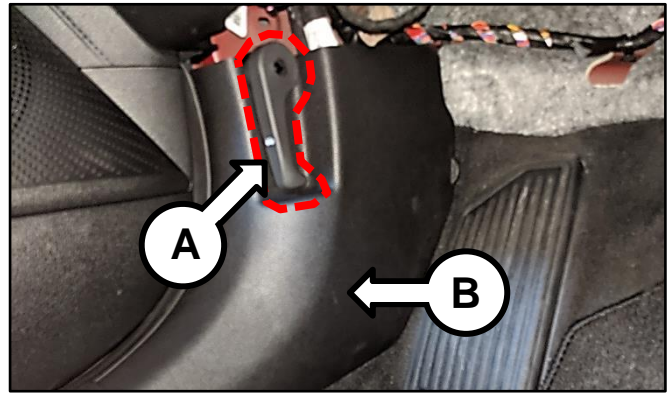
1. Pull the hood release lever (A) located on the lower left kick panel (B).

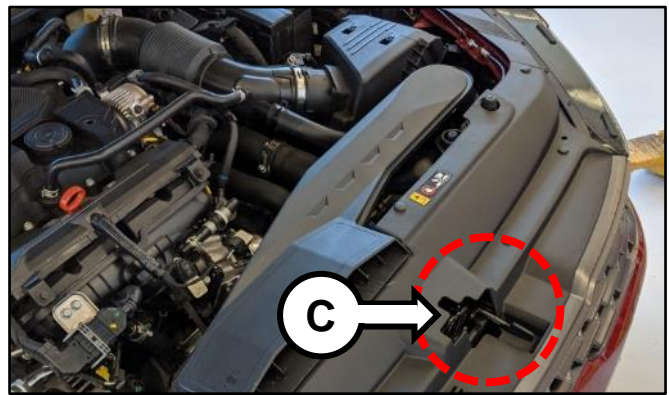
- 2a. In the front of the vehicle, locate the hood latch (C) and open the hood.

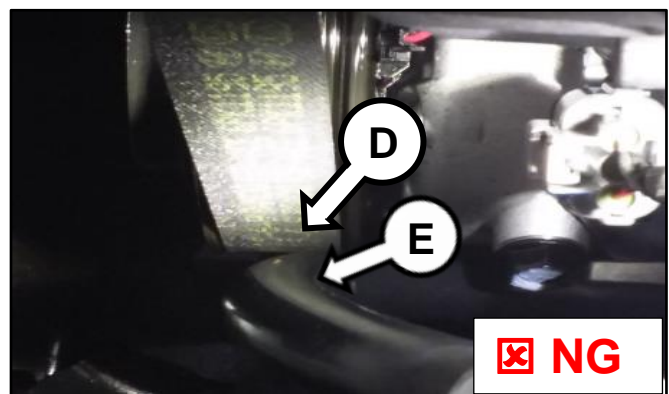
- 2b. Inspect A/C discharge hose for damage and confirm there is sufficient clearance (at least 15mm>) between the compressor pulley (D) and the discharge hose (E).

- 2c. If the clearance is not a minimum of 15mm proceed to Step 3.

If damage is present, replace A/C discharge hose by referring to the “Heating, Ventilation, and Air Conditioning → Air Conditioning System → Refrigerant Line → Repair procedures” chapter in the applicable Shop Manual on KGIS.

3. Locate crimp (F) and pull / push in direction of arrow until significant gap is created between the discharge hose and compressor pulley (15mm).

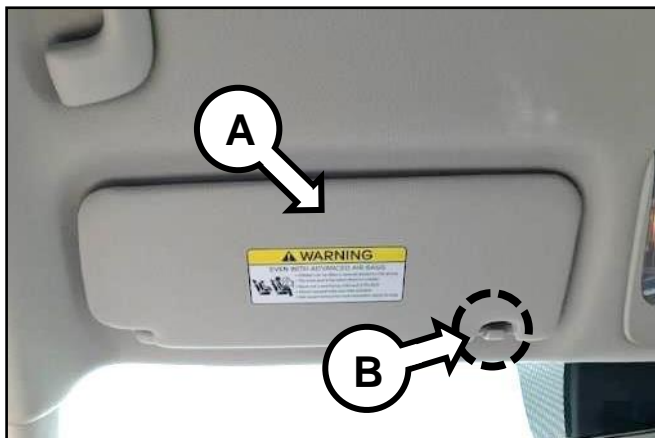
1. Inspect both driver and passenger sunvisor(s) (A) retainer clip(s) (B).

- 2a. Open and extend the sunvisor(s) and inspect the sunvisor retainer clip (B) for poor seating against the headliner.

- 2b. If the retainer clip is not seated correctly, re-install the retainer (B) to the headliner.

If the retainer clip is missing the retaining screw, install the missing screw using P/N: 85289 3V000.
