<b>HYUNDAI</b> <b>Technical Service Bulletin</b>	<b>GROUP</b> <b>BODY ELECTRICAL</b>	<b>NUMBER</b> <b>21-BE-002H</b>
	<b>DATE</b> <b>FEBRUARY, 2021</b>	<b>MODEL(S)</b> <b>ELANTRA (CN7, CN7a)</b> <b>SONATA (DN8)</b> <b>SONATA HYBRID (DN8 HEV)</b> <b>PALISADE (LX2)</b> <b>VENUE (QX)</b>
<b>SUBJECT:</b> WIRELESS CARPLAY SOFTWARE UPDATE

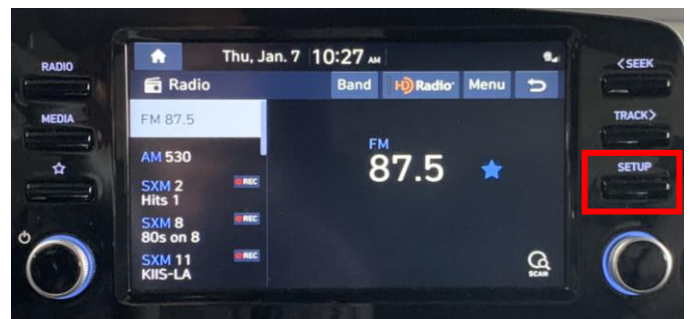
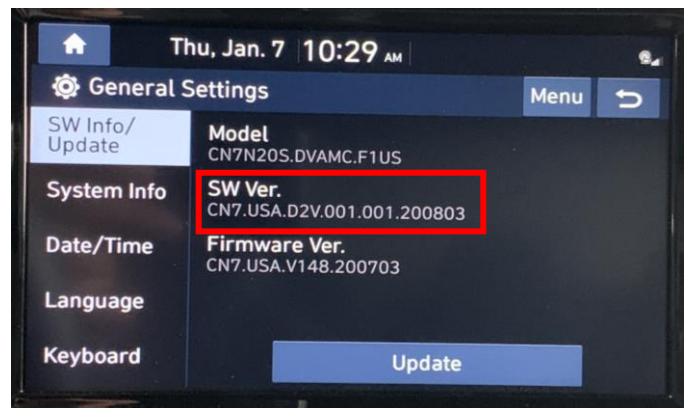
3. Refer to the software table from above. Verify the Software Version shown on the screen matches the older software version.

If the radio software version does not match with the older software version in the table, then do not perform the software update.
