SERVICE BULLETIN

Classification: AN19-069b	Reference: NTB20-002b	Date: February 4, 2021
------------------------------	--------------------------	---------------------------

2019 SENTRA; STEERING WHEEL AUDIO SWITCHES INTERMITTENTLY INOPERATIVE

APPLIED VEHICLE: 2019 Sentra (B17) – S model only
APPLIED VIN: Vehicles Built before 3N1(*)B7AP(*)K(*)432870
APPLIED DATE: Vehicles Built before October 10, 2019

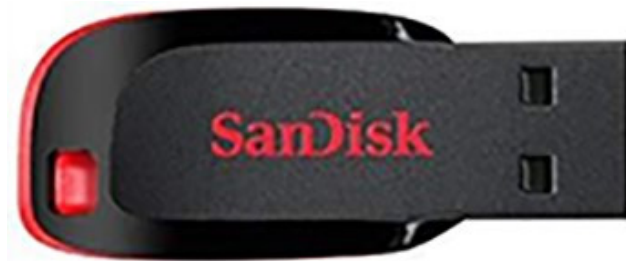
Figure 2

- One of special tool USB drive J-52727 has been shipped to each dealer (see Figure 2).
- Do not use any other USB drive to perform the procedure in this bulletin.
- Additional USB drives may be purchased from Tech•Mate: nissantechmate.com or 1-800-662-2001.

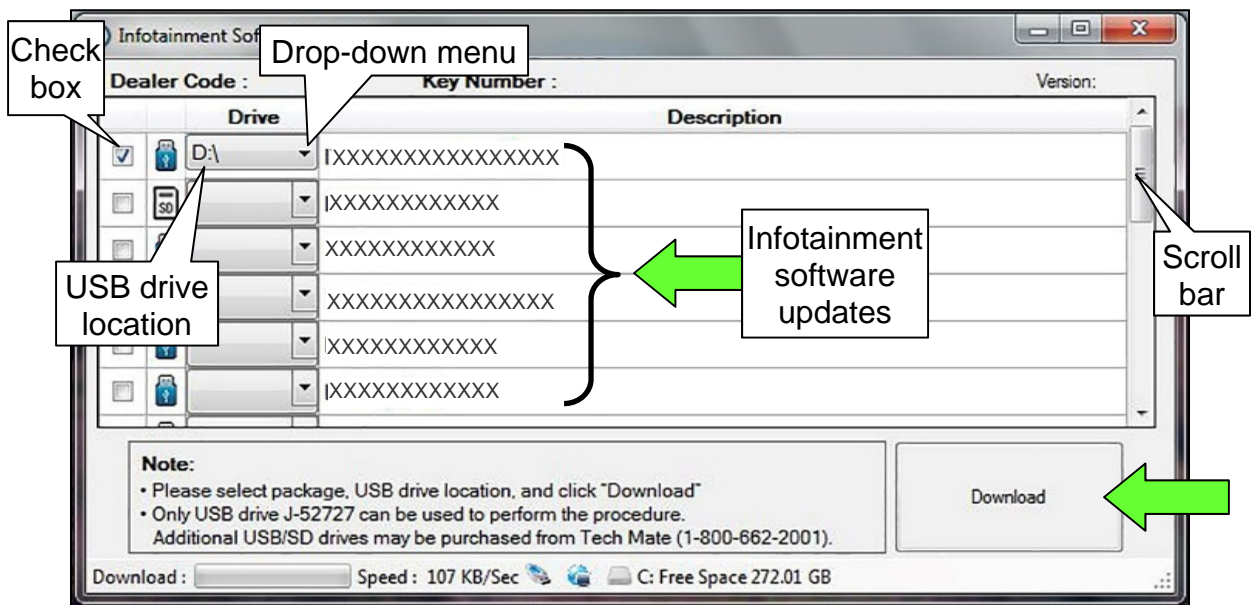
Figure 9

10. Select the check box next to the correct update software package (Figure 9).
 - Locate Update #1 (LD001) and Update #2 (LD002).
 - Only one (1) update will be loaded at a time, starting with Update #1 (LD001).

To avoid damage to the vehicle, ensure the correct update software package is selected. Failure to select the correct update software package may result in needing to replace the AV control unit.

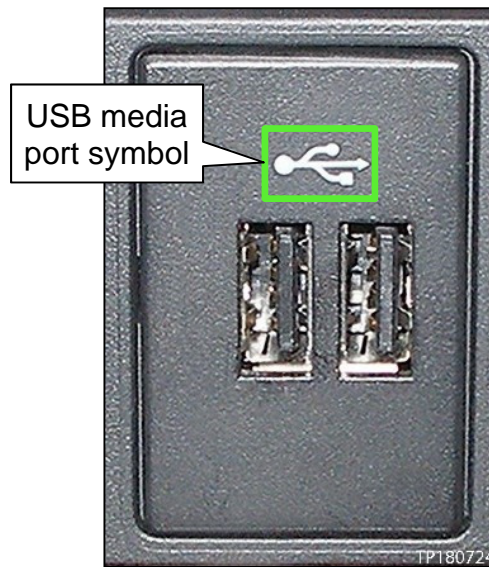
Figure 12

21. Insert the special tool USB drive J-52727 into the USB media port (Figure 12).

Do not insert the USB drive into a charging port (Figure 13). If used, the update software and/or USB drive may become damaged. Only insert the USB drive in a USB media port.

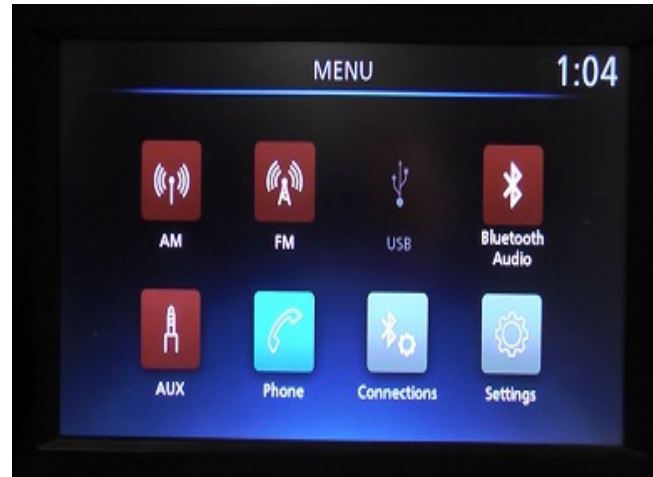
HINT: Reprogramming is not complete until the audio unit reboots and returns to the main MENU screen (Figure 15).

To prevent damage to the AV control unit, do NOT remove the USB drive unless the audio unit has rebooted and the main MENU screen as shown in Figure 15 is displayed.
