**HYUNDAI**
Technical Service Bulletin

GROUP Body Electrical	NUMBER 21-BE-005H
DATE March, 2021	MODEL(S) Santa Fe (TMa) Palisade (LX2)

SUBJECT: SURROUND VIEW CAMERA DISPLAY TROUBLESHOOTING GUIDE

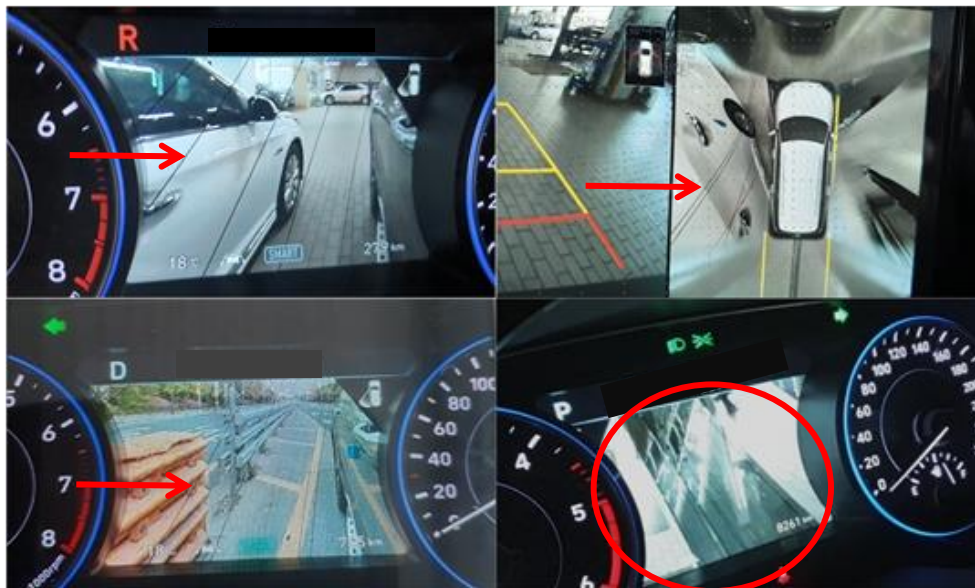
Description: Some 2020-2021 Santa Fe (TMa) and Palisade (LX2) may intermittently experience abnormal camera image display conditions on the instrument cluster when the turn signal is turned ON or the radio screen when transmission is in Reverse. The following conditions may occur; blurry image, line on the screen, fuzziness, or blue screen. This bulletin provides information to assist with troubleshooting the condition(s) above.
