# SERVICE BULLETIN

Classification: EC20-031A	Reference: NTB21-001A	Date: March 30, 2021
------------------------------	--------------------------	-------------------------

## 2020-2021 TITAN/TITAN XD; TCM COMMUNICATION ERROR CAUSING A NO START CONDITION

**APPLIED VEHICLES:** 2020-2021 Titan/Titan XD (A61)

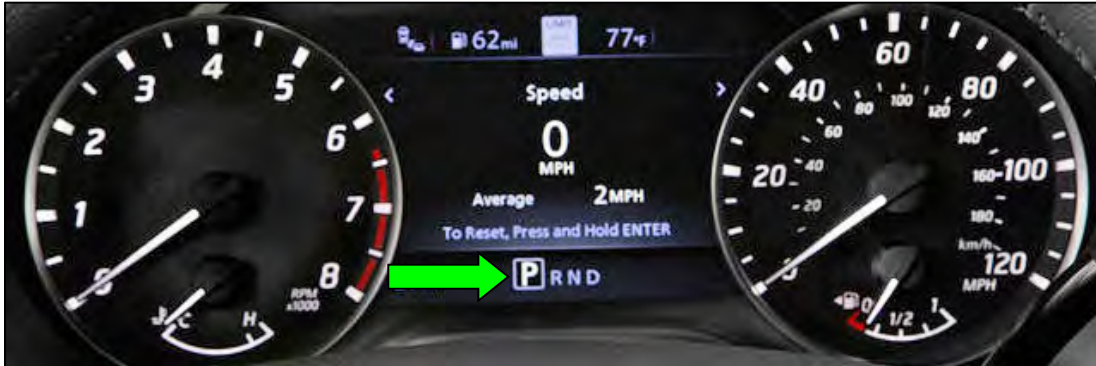
Figure 3

**NOTE:** If the Park indicator is not seen in the Driver Information Center (DIC) and C-III plus does not display the current TCM part number after a 2 minute wait with the ignition ON, engine OFF, this TSB **does not apply**. Refer to the ESM for further diagnostic information.

1. Confirm the current TCM part number.
