**NUMBER:** 08-046-21

UGQ Radio Enhancements

2019 (JL) Jeep Wrangler

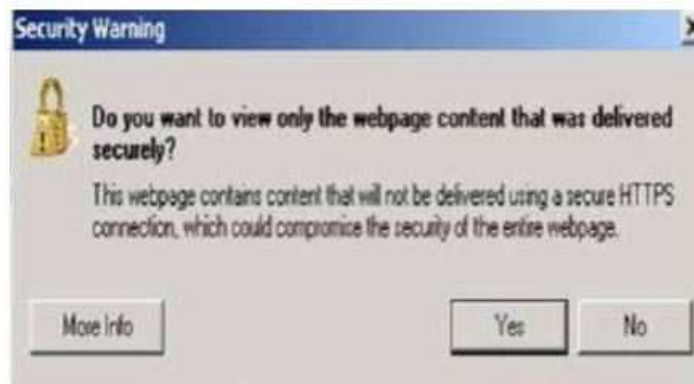
**Fig. 2**  
**Pop-Up Security Warning**

3. Go to DealerCONNECT>Service>Uconnect Command Center>Uconnect>More Information >Dealer software downloads to download the files.
4. If a security message appears “Do you want to view only the web page content that was delivered securely?” ([Fig. 2](#)) . Press “No” to continue.

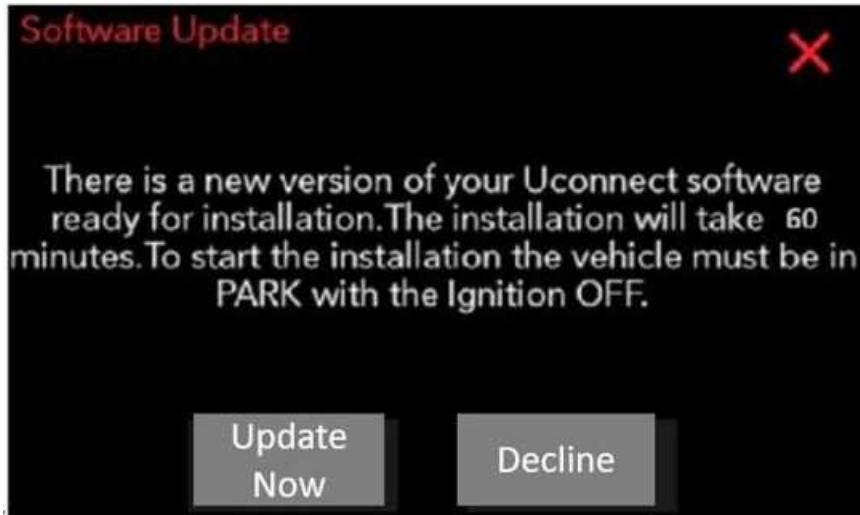
Fig. 7  
Software Update Is Available

13. Once the system has verified there is an available update, press the “Update Now” button. Make sure the vehicle is in park, **DO NOT turn the ignition off (Fig. 7)** .
