Subject: N202325461 - Service Update  
Automated Driving Mapping Module Software Update

Models: 2021 Cadillac Escalade

# Service Update

## N202325461 Automated Driving Mapping Module Software Update

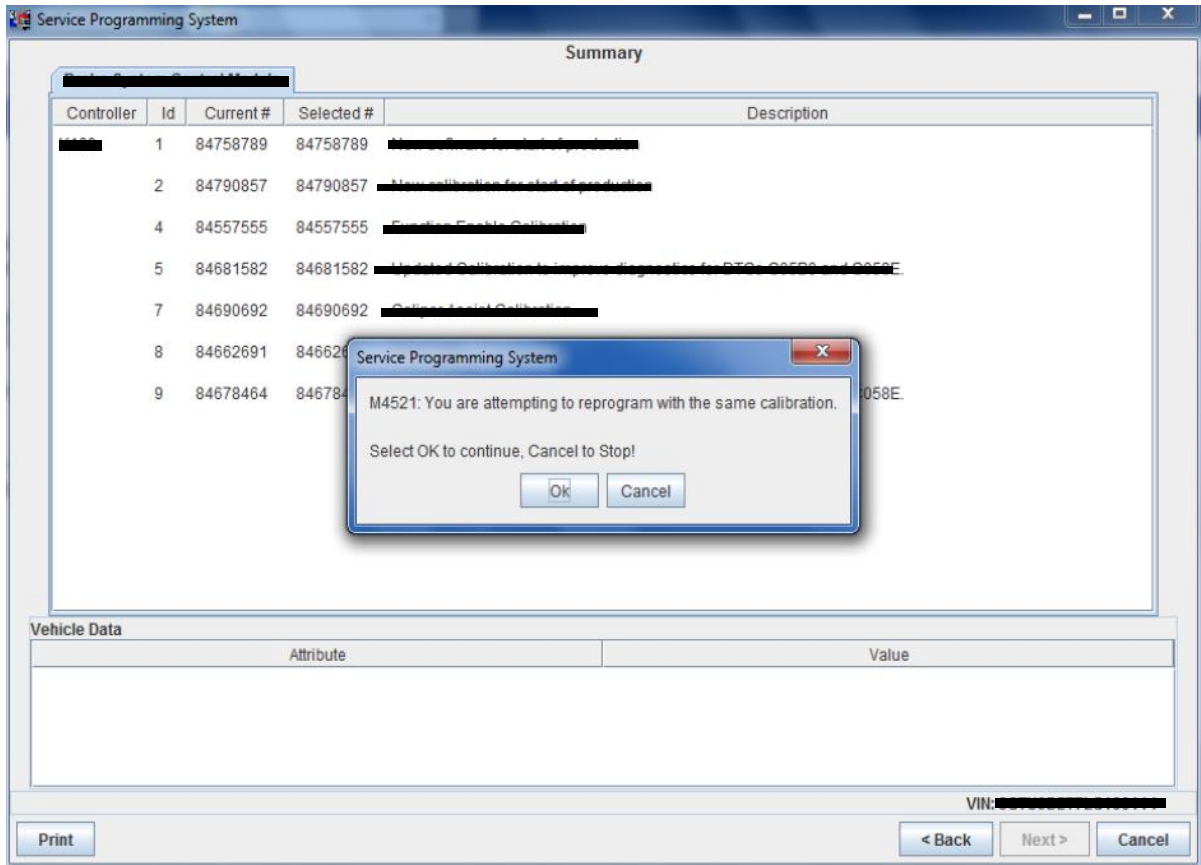
5431207

**Important:** Techline Connect and TIS2WEB screens shown above.

**Important:** If the same calibration/software warning is noted on the TLC or SPS Summary screen, select OK and follow screen instructions. After a successful programming event, the WCC is located in the Service Programming System dialogue box of the SPS Summary screen. No further action is required. Refer to the Warranty section of the bulletin.
