GLOBAL SAFETY FIELD INVESTIGATIONS
DCS5740
URGENT - DISTRIBUTE IMMEDIATELY

Subject: REVISION – N202325460-01 - Service Update
Radio Software Update
Revised the service procedure and the warranty information table.

Models: 2021 Cadillac Escalade and Escalade ESV

N202325460 Radio Software Update

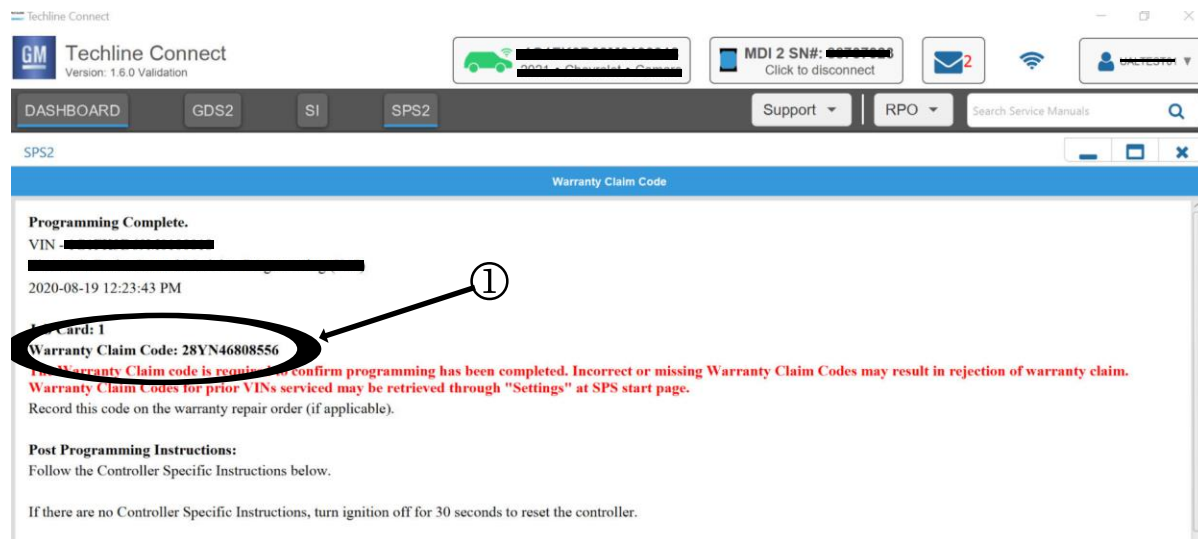
5644478

Important: It is important to ensure that the technician is inspecting the full information found within *Build Number*. To identify the current software installed in the radio requires the user to locate the *Build Number* to view the full software version file name. In the middle of this long file name look for 382. (The illustration below shows software version 377, thus that would be outdated.) The number would be numerically lower if the radio is not up to date, or numerically higher if newer versions were released and installed.

Important: Use the WCC generated by downloading software to the USB for warranty submission, otherwise the transaction will reject.

- Include the USB portion of the radio programming procedure.
