| Title: | TCU Module Software Patch | | | |
| Number: | SB_498 | Release Date: | 03/01/2021 | |
| Chassis Type: | All Command Zone III Chassis with a TCU | | | |

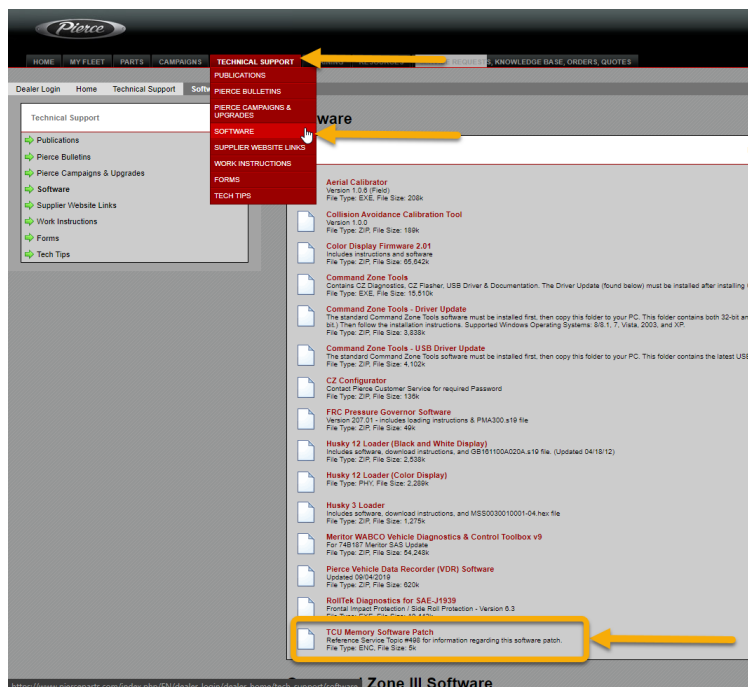
- Software Patch Installation Steps
  - Connect to the TCU using a PC web application
  - Navigate to PierceCZ.com using Incognito or Private browser window
    - If “HTTP ERROR 500” error below displays, proceed to **Step 3**
