David J. Johnson
 Director
 Service Engineering Operations
 Ford Customer Service Division

SUBJECT: **NEW VEHICLE DEMONSTRATION / DELIVERY HOLD**
Customer Satisfaction Program 21B03 - Supplement #2
 Certain 2020 Model Year Super Duty F250-F600 Vehicles Equipped with a 10R140
 Transmission - Number One Planetary and Ring Gear Assembly

Certain 2020 Model Year Super Duty F250-F600 Vehicles Equipped with a 10R140 Transmission
Number One Planetary and Ring Gear Assembly

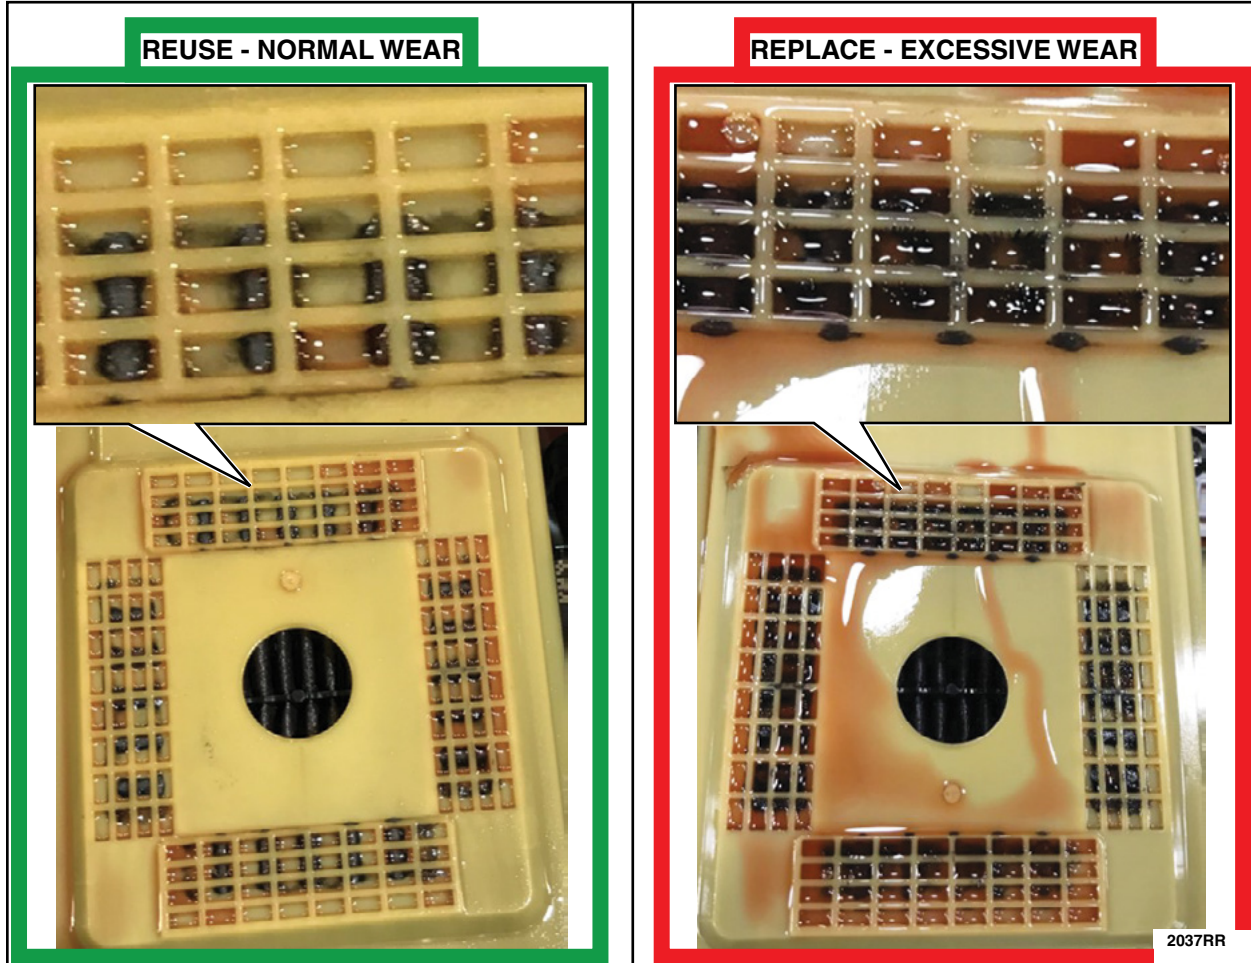
FIGURE 1

- For all **UNSOLD**/in-stock vehicles: reinstall and reuse the transmission fluid filter from the vehicle.
- For all **SOLD** vehicles - use the following table and See Figure 1.

Vehicle Mileage	Normal Wear	Excessive Wear
Less than 20,000 miles	Reuse Trans. Filter	Replace Trans. Filter
Greater than 20,000 miles	Replace Trans. Filter	Replace Trans. Filter
