Service Bulletin

Bulletin No.: 21-NA-047

Subject: Shake and/or Shudder During Light Throttle Acceleration Between 25 and 80 MPH (40 and 128 KM/H) at Steady Speed

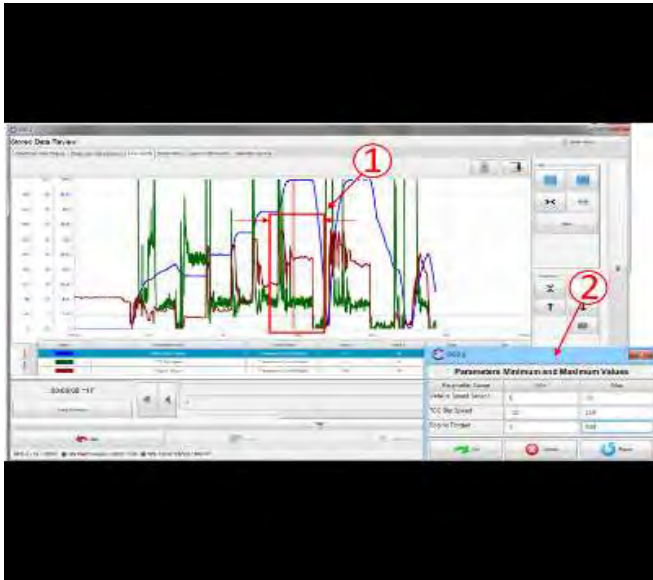
5751734

5. Zoom into 15 second window for analysis (1).
6. For line graph evaluation, set parameter minimum and maximum to values (2) stated for comparison (Fig 1).
