Subject: CONNECTED VEHICLE SYMPTOM TROUBLESHOOTING	Service Alert No.: SA-013/21
	Last Issued : 04/27/2021

2019-2021 Mazda3
2020-2021 CX-30
2021 CX-5
2021 CX-9

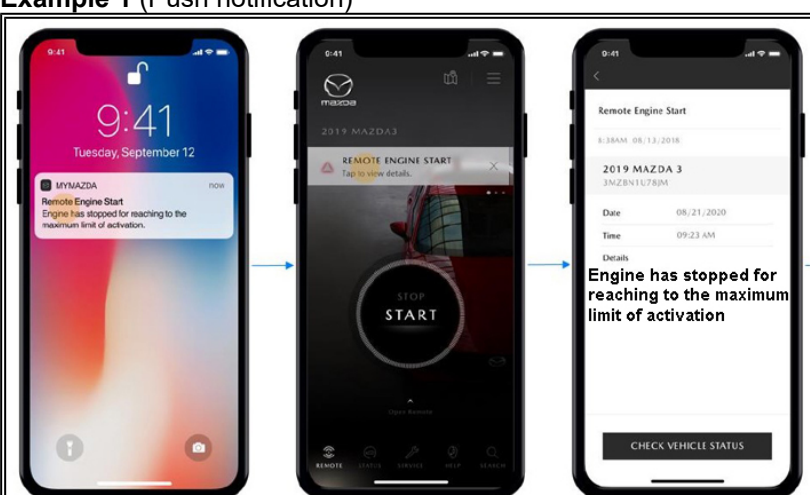
Customer Complaint	Action
<ul style="list-style-type: none"> Vehicle Center Display does not provide the Authorization Code during the MyMazda App Connected Vehicle enrollment. Remote function(s) inoperative. <ul style="list-style-type: none"> Engine Start / Stop Door Lock / Unlock Lights ON / OFF 	<p>Go to Step 2.</p> <p>NOTE: The customer can view the reason for remote function failure. Example 1 (Push notification)</p>
