SERVICE BULLETIN

Subject: **Accessory Port Power Supply Issue - Possible Inverted Wires at Vehicle Connector**

No. **2020-7**

REVISION 1
April, 2021

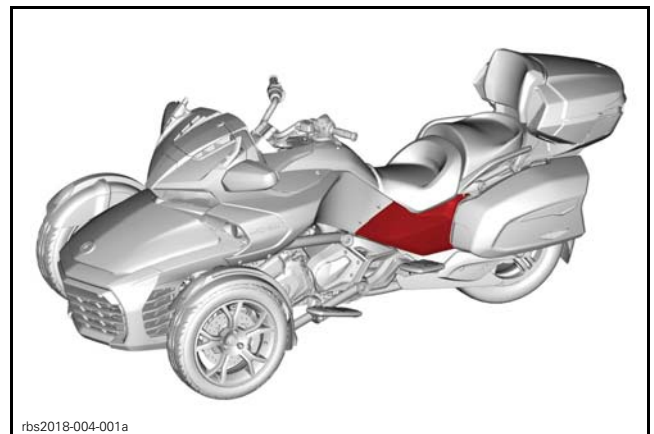
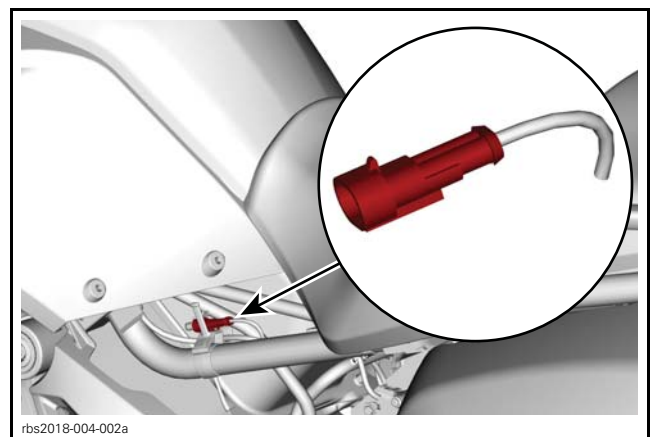
Spyder F3

Vehicles equipped with GPS kit may experience inner battery charging issues. One of the probable cause is inverted wires at vehicle connector

- ▶ Access the accessory connector. ◀

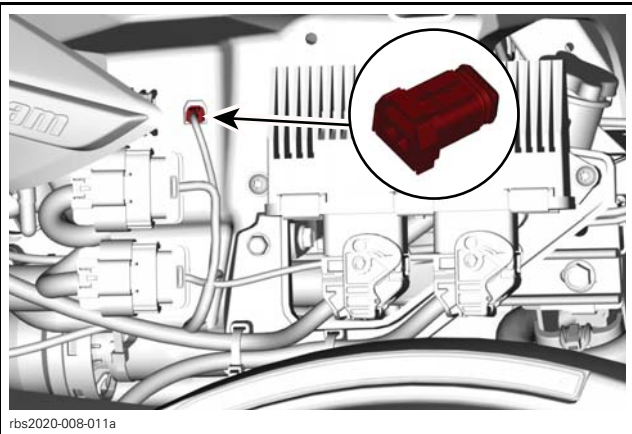
1. Black wire on female connector at the wrong location
2. Black wire on male connector
3. Black wire on female connector at the appropriate location

2. Make sure the black wire on the male connector is on the same side as the female connector.
