QUARANTINE NOTICE

Reference number:	QN-30-1497	Issued: 21 April, 2021
Subject:	Connector Repair Process for Weak GPS Signal	
Model(s):	DBX	
VIN Range:	Refer to the separately published list of affected Vehicle Identification Numbers (VINs)	
Applicable to:	All Dealers	
Distribute to:	After Sales Manager Executive Manager Service Manager Sales Manager	Warranty Staff Technician(s) Parts Staff

Reason for this Quarantine Notice

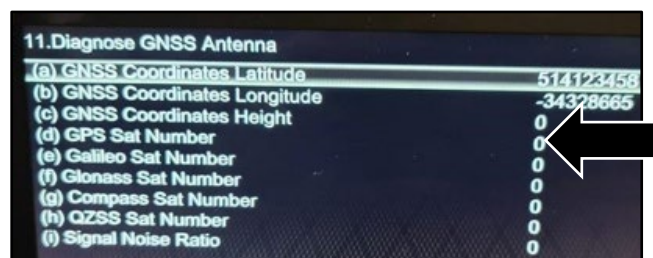
Figure 3

4. Do a check of the “GPS Sat Number” (refer to Figure 3) and confirm the number is correct with a mobile GPS app.

5. If the “GPS Sat Number” is more than 8 the workshop procedure is complete.
6. If the “GPS Sat Number” is less than 8 road test the vehicle in a clear open space for 30 to 40 minutes.
