SERVICE BULLETIN

Classification: AN17-024A	Reference: NTB17-067A	Date: March 11, 2021
------------------------------	--------------------------	-------------------------

2016-2017 MURANO; PHONE WILL NOT CONNECT WITH VEHICLE AND BLUETOOTH® AND PHONE BUTTONS ARE GRAYED OUT IN SETTINGS MENU

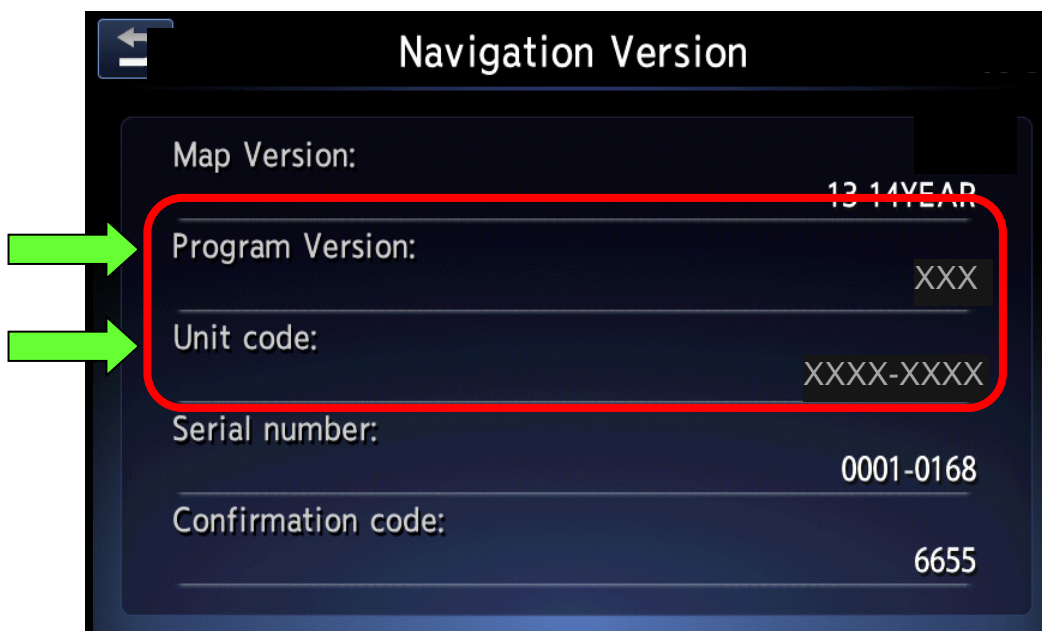
Figure 4

- For vehicles with Unit code QY84-**-NA or QY84-**-NB or QY84-**-NC:
A software update is needed if the Program Version is not 565.

7. Write down the **Unit code** and **Program Version** values on the repair order, and then go to page 5, **AV Control Unit Software Update with Software Update SD Card**.

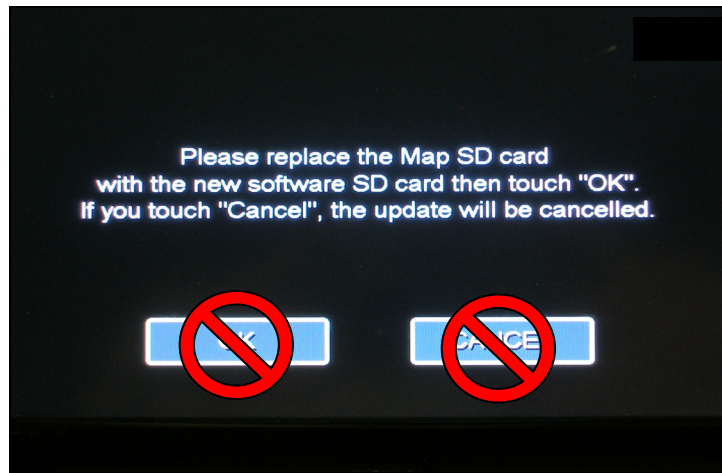
- **DO NOT select “OK” or “CANCEL”.**

NOTE: If the message in Figure 10 (page 8) displays instead of the message in Figure 11, above, perform step 11-13 again.
