PSB E265 EPA2017 PACCAR MX-13 Engines High Oil Flow Kit (HOFK) and Camshaft Inspection

E265

Selected engines have been identified to receive a camshaft inspection and an update for improved camshaft lubrication.

690 chassis (674 U.S. and 16 Canada) T680, T800, T880, W900, and W990 chassis built from 02/28/17 through 04/25/19, equipped with PACCAR MX-13 EPA2017 engines. See the attached chassis list for specific chassis.

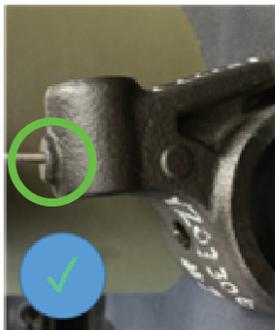
2157845 (12V NA)
2157846 (24V EU)

1. Remove the valve cover and valve train casing per RMI procedures.
2. Confirm the exhaust rocker arm has extra material on the drilling boss.

- If the exhaust rocker has the extra material, continue with this procedure.
 - If the exhaust rocker does not have the extra material, take a photo of the rocker and start a TCS365 case using the TCS365 Case Creation Guide below.
3. Remove the existing lash screw from each DEB rocker arm.

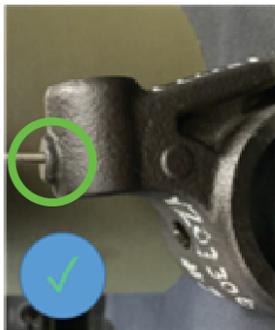
2157845 (12V NA)
2157846 (24V EU)

1. Remove the valve cover and valve train casing per RMI procedures.
2. Confirm the exhaust rocker arm has extra material on the drilling boss.

- If the exhaust rocker has the extra material, continue with this procedure.
- If the exhaust rocker does not have the extra material, take a photo of the rocker and start a TCS365 case using the TCS365 Case Creation Guide below.

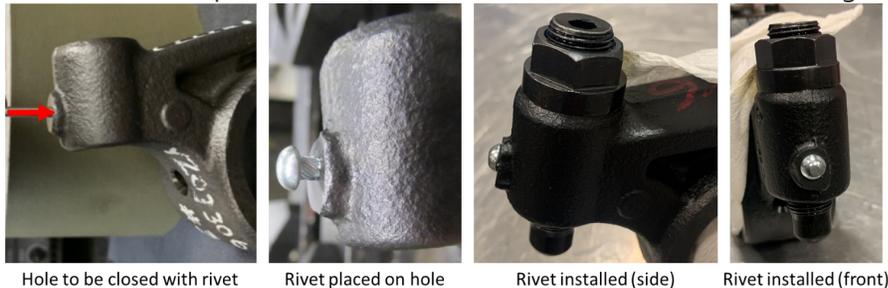
Hole to be closed with rivet

Rivet placed on hole

4. Cover the engine push tube openings with shop towels or similar to prevent the rivet from dropping into the engine.
5. Clean the small hole at the end of the DEB rocker arm by applying brake cleaner, see the red arrow in the figure below.
6. Apply Loctite® 620 onto the rivets before installation.

7. Install the rivets (p/n 2304858) the holes in the DEB rocker arms using a hammer and brass drift punch.
