### 992 / 982 (4.0 liter variants) – Diagnosing DMTL Leakage Faults

#### Condition

MIL (Check engine light) fault(s) for either an active or a passive tank leakage detection fault "P044200 (002EB3) – Fuel tank system leaking > 1 mm" or "P045600 (002EB2) – Leak (micro) in fuel tank system 0.5 to 1.0 mm." These faults also result yellow dash warning.

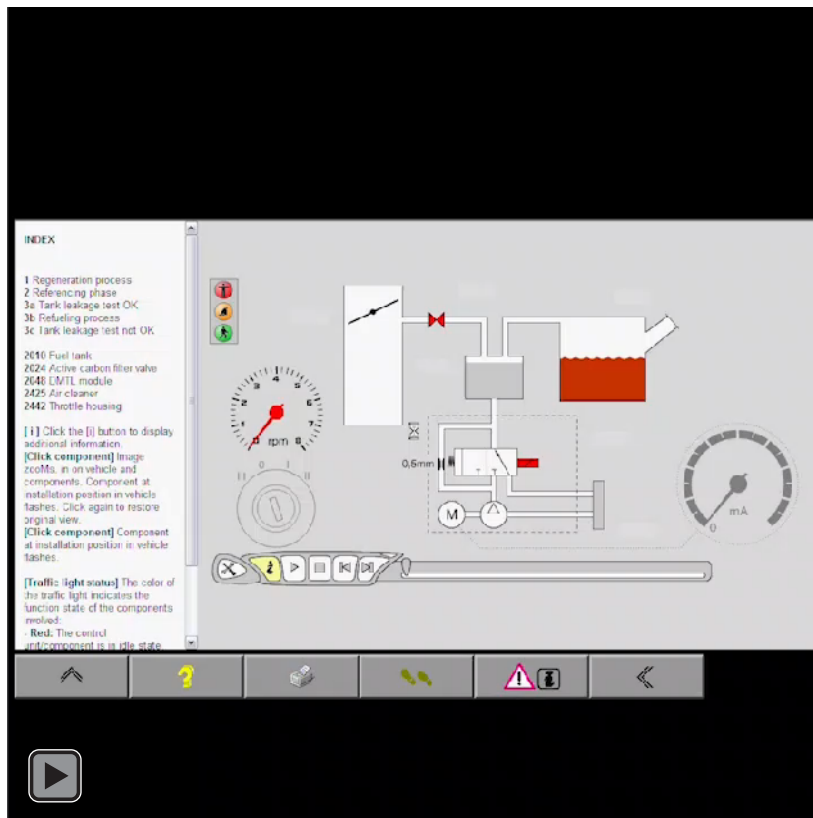
Figure 1 - Diagnostic Fault Tree for Leak Detection Faults

Please follow the fault tree presented in Figure 1 when diagnosing the aforementioned faults. Further background and reference for the Evaporative Emissions Leak Detection system in these vehicles is available in the attached film.

When running the 'Tank leakage short test' in PT3G (DME -> Maintenance repairs -> Tank leakage short test), the tester indicates a failed test with the text 'exited due to reasons of safety' in the result section.

\*Regardless of whether or not an exchange of the DMTL is deemed necessary in accordance with Figure 1, the rubber grommet seals of the DMTL at the mating instances to the carbon canister and fresh air filter require replacement following testing.
