**Special pre-delivery operation required:**  
**Horizontal and vertical head nut tightening check**  
Multistrada 950 Model Year 2021 (all versions)  
Service Repair Bulletin SRV-SRB-21-033

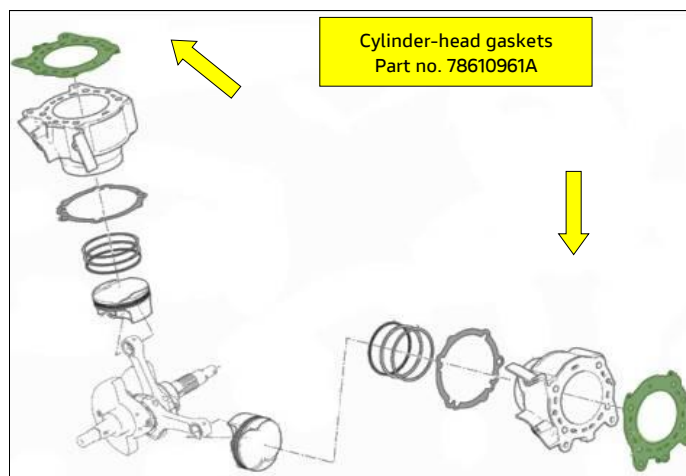
If the motorcycle has already been delivered and there is a coolant leak from the cylinder-head gasket, it will be necessary to replace the gasket Part no. 78610961A, as a simple tightening will not solve the problem.
