Tips & Tricks – All Models

no.	Symptom	Subject	Photo	Notes and Indications - Corrective action
1	<p><u>ONLY</u> <u>Monster 821</u> <u>Monster 1200</u> <u>SuperSport</u></p> <p>Possible engine popping sound during deceleration and/or irregular idling</p>	Airbox

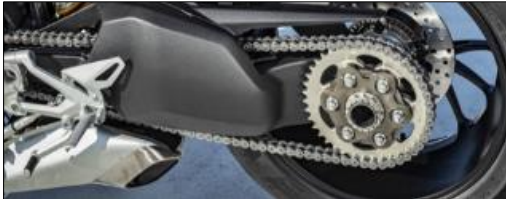
<p>We have received reports of some complaints about rough shifting with DQS, particularly at low rpm. In other words, rough shifting with uncomfortable torque cuts.</p> <p>We have checked that very often the cause is related to an incorrect chain tensioning, especially after the first settling of the chain which takes place at around 200/300 Km (new motorcycle or chain). We therefore invite you to always check the correct tensioning of the final drive chain before making further analysis.</p>

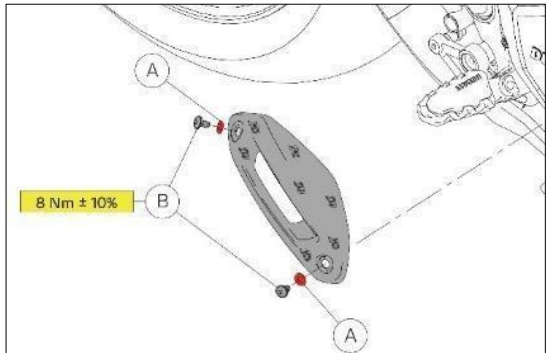
<p>We inform you that the assembly instructions for the carbon horizontal manifold heat guard kit by Ducati Performance part no. 96980251A have been updated. In particular, in order to install the part, <u>you must reuse the 2 washers (A) present on the original heat guard.</u></p> <p>Please always comply with the tightening torque of the 2 screws M6x12 (B) of 8 Nm ± 10%.</p>

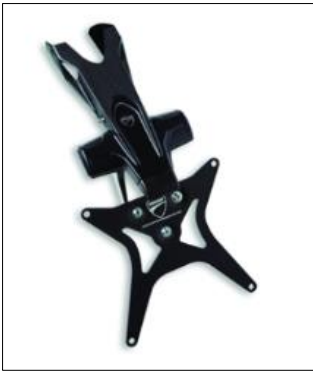
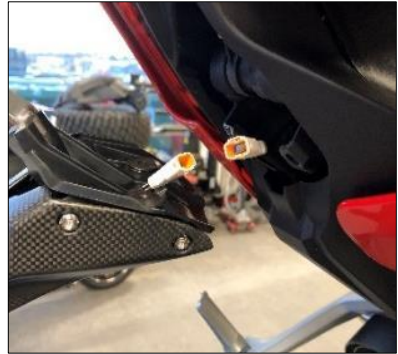
3	<p><u>ONLY Panigale V4 (all versions) Panigale V2</u></p> <p>Assembly precautions for Carbon number plate holder kit part no. 97380921A</p>	Carbon number plate holder kit part no. 97380921A

<p>We kindly inform you that <u>ONLY</u> when installing the carbon number plate holder kit part no. 97380921A to a Panigale V2 model, it is necessary to purchase wiring part no. 5101H931A to connect the number plate holder connector to motorcycle rear wiring harness connector.</p> <p>We also inform you that the new carbon number plate holder kit part no. 97381161AA is now available. It is specific for Panigale V2 and Streetfighter V4 and will include the above-mentioned wiring.</p>

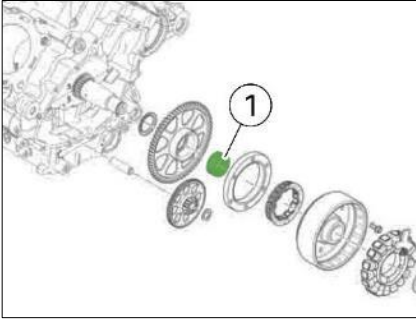
no.	Symptom	Subject	Photo	Notes and Indications - Corrective action
4	<p><u>ONLY</u> Panigale V4</p> <p>Starting system update</p>	Starting system	-	<p>To ensure a better starting operation of the engine, we inform you that from engine serial number:</p> <ul style="list-style-type: none"> - ZDM1100W4#007612# for EUR version, - AGNK007652 for CAL version, <p>the roller bearing (1) has been introduced instead of the bushing.</p> <p>Please, note that the spare part catalogue has been updated.</p>

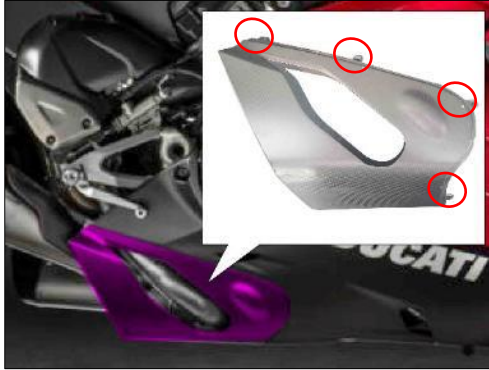
<p>We have received some isolated reports about an incorrect coupling between the silencer covers and the side half fairings in case the complete Akrapovic racing titanium exhaust system, supplied with the motorcycle, is installed. In fact, it is possible to find a misalignment between the mounting holes of the components.</p> <p>To improve this coupling, it is possible to slot-drill the 4 mounting holes of the silencer covers by using a column drill with a <u>6 mm drill bit</u> and setting a high rotation speed to prevent the fiber from flaking off.</p>

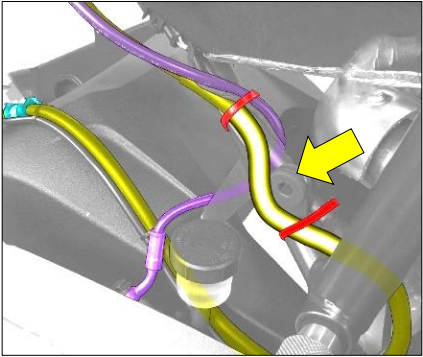
no.	Symptom	Subject	Photo	Notes and Indications - Corrective action				
1	<p><u>ONLY Scrambler 800 (all model versions and MY, excluding Desert Sled model version)</u></p> <p>Precautions when routing the rear brake caliper hose</p>	Rear brake hose	-	<p>We have found that sometimes, during maintenance operations, the rear brake caliper hose is not correctly positioned along the frame due to incorrect installation by the technician during service.</p> <p>Make sure that the rear brake caliper hose (yellow), passes outside the left side cover mounting bracket with respect to the motorcycle centerline and is fixed with the two self-locking ties (red) as shown in the figure.</p> <p>The operation of inspection and possible repositioning is very simple and involves the disassembly of the left side cover only.</p>

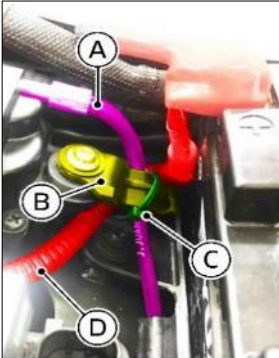
4	<p><u>ONLY</u> <u>Scrambler 1100</u> <u>Model Year 2020</u> <u>(all model versions)</u></p> <p>Precautions during PDI: installation of the battery on the vehicle</p>	Battery assembly	-	<p>During the installation of the battery on the vehicle and, in any case, when the motorcycle first comes to the workshop for a service, we ask you to always check the correct positioning of the exhaust butterfly valve cable (A) under the retainer (B) and the presence of the self-locking tie (C).</p> <p>Make sure the motorcycle positive cable (D) is positioned under the exhaust butterfly valve cable (A).</p>

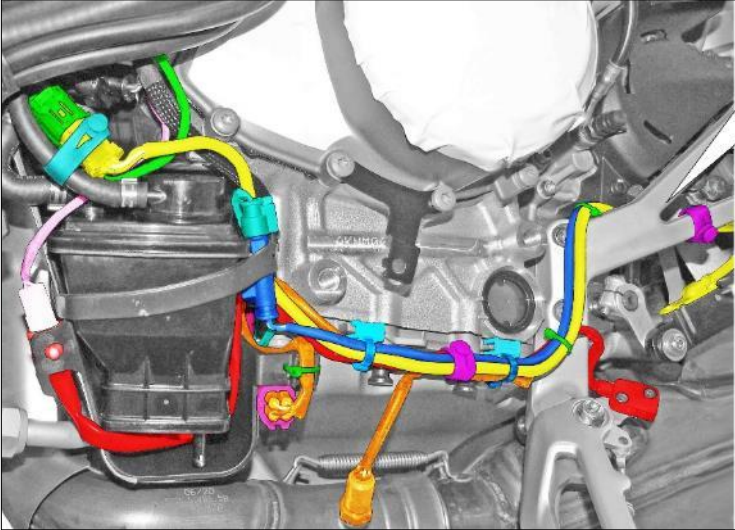
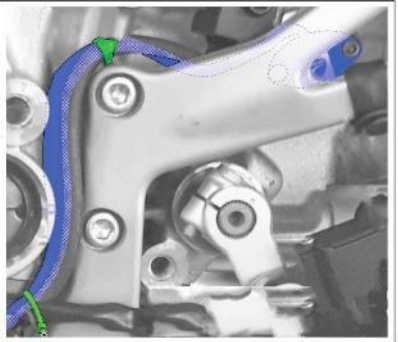
no.	Symptom	Subject	Photo	Notes and Indications - Corrective action
1	Updated layout of motorcycle wiring	Wiring	-	<p>We would like to inform you that the layout of the side stand cable - gear sensor cable - Ducati Quick Shift cable - lambda sensor cable and of the gear sensor connector and cable at the lower crankcase, on the left side of the motorcycle (as shown in the figure) has been updated starting from frame number ZDMFA00AALB003932.</p>

<p>We ask you to respect the new layout of the cables and the gear sensor connector in case of servicing of the mentioned parts.</p>

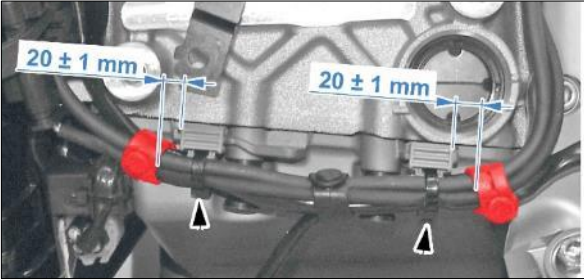
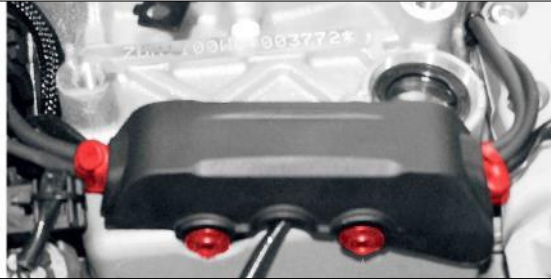
<p>Before installing the wiring cover, apply two L=39mm button ties respecting the dimensions shown in the figure:</p>

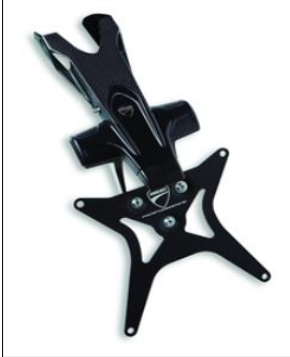
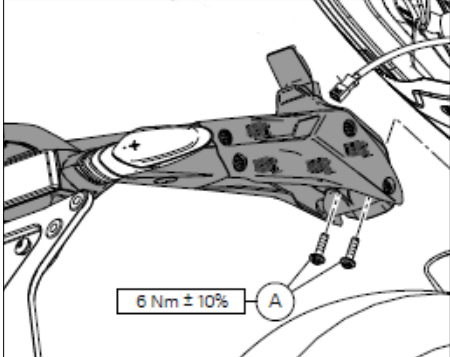
no.	Symptom	Subject	Photo	Notes and Indications - Corrective action
7	Precautions for the assembly of Ducati Performance carbon number plate holder kit part no. 97381161CA	Ducati Performance carbon number plate holder kit part no. 97381161CA

<p>When assembling the Ducati Performance carbon number plate holder unit part no. 97381161CA, we remind you to always apply LOCTITE 243 on the threads of the 2 screws (A) for fixing the unit to the rear subframe and tighten them to the specified torque of 6 Nm ± 10% as indicated in the relevant instructions.</p>
