QUARANTINE NOTICE

Reference number:	QN-30-1497V2	Issued: 04 June, 2021
Subject:	Connector Repair Process for Weak GPS Signal	
Model(s):	DBX	
VIN Range:	Refer to the separately published list of affected Vehicle Identification Numbers (VINs)	
Applicable to:	All Dealers	
Distribute to:	After Sales Manager Executive Manager Service Manager Sales Manager	Warranty Staff Technician(s) Parts Staff

Reason for this Quarantine Notice

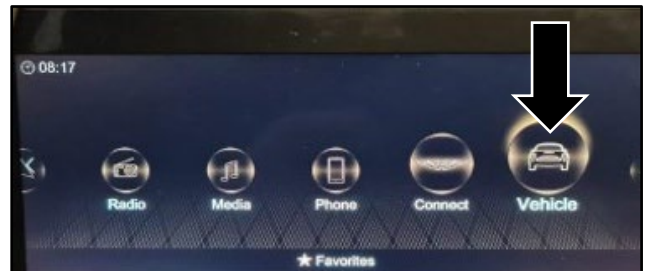
Figure 1

1. Drive the vehicle to a clear open area outside, but do not turn the engine off.
2. In the infotainment menu select “Vehicle” and hold the rotary selector down for 15 seconds (refer to Figure 1).

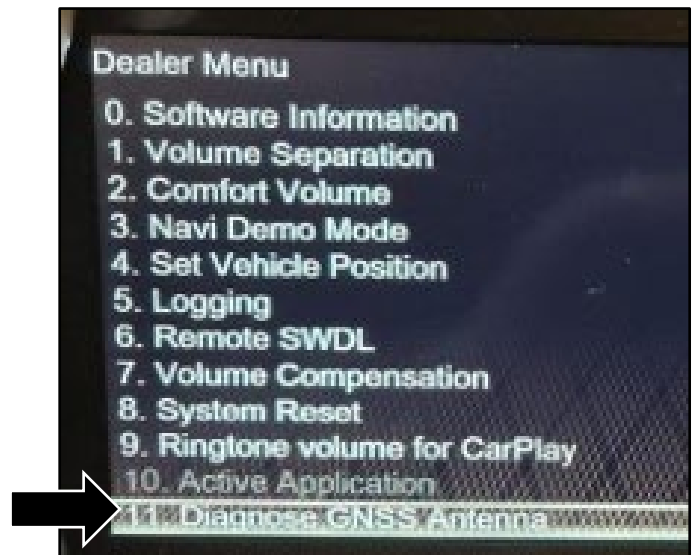
Figure 2

3. In the “Dealer Menu” scroll down and select “Diagnose GNSS Antenna” (refer to Figure 2).

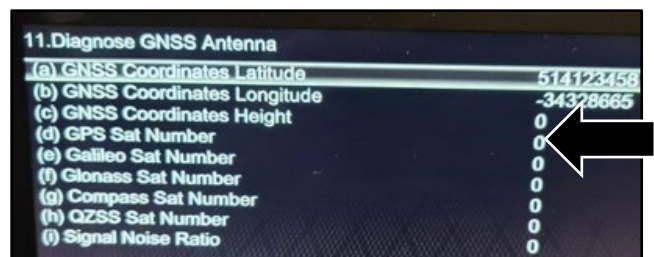
Figure 3

4. Do a check of the “GPS Sat Number” (refer to Figure 3) and confirm the number is correct with a mobile GPS app.

5. If the “GPS Sat Number” is more than 8 the workshop procedure is complete.
6. If the “GPS Sat Number” is less than 8 road test the vehicle in a clear open space for 30 to 40 minutes.
