HYUNDAI Technical Service Bulletin

GROUP Campaign	NUMBER 21-01-039H
DATE May, 2021	MODEL(S) Elantra (AD/ADa)

SUBJECT: TCU UPDATE AND IVT REPLACEMENT
(SERVICE CAMPAIGN 963)

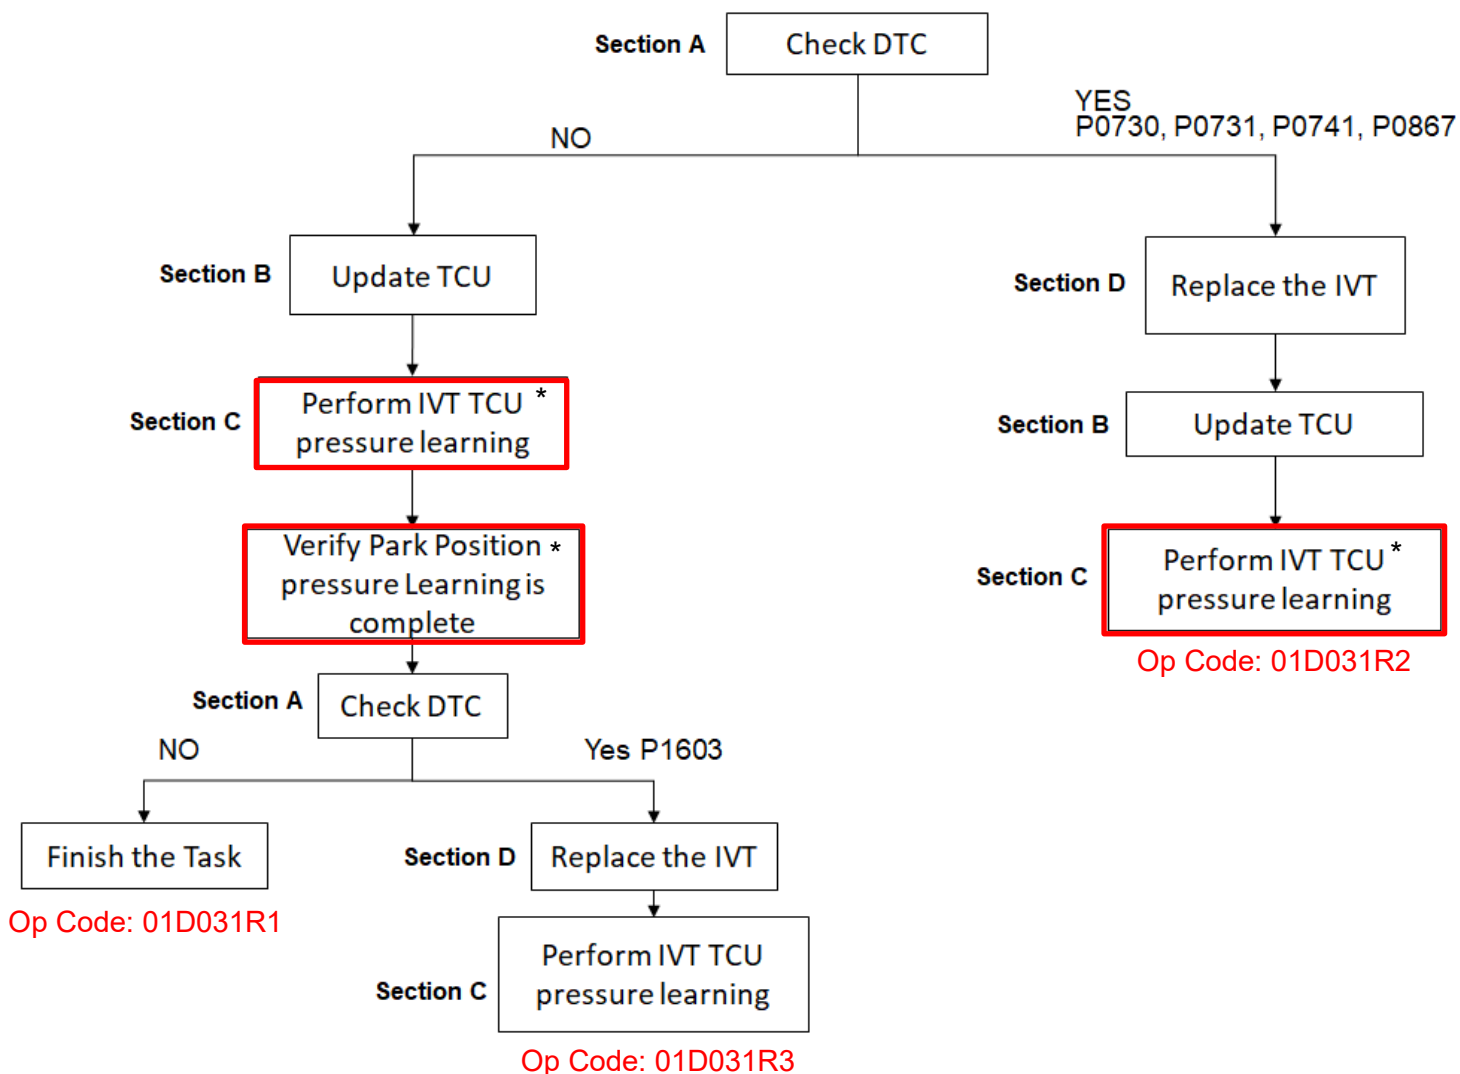
TCU Update Flow (AD/ADa with IVT)

1. Refer to the flowchart below to update the procedure.

*Section C is **required** to complete the service procedure. The transmission may fail from not performing IVT, TCU Pressure Learning, and is subject to warranty debit.
