HYUNDAI Technical Service Bulletin	GROUP BODY ELECTRICAL	NUMBER 21-BE-008H
	DATE May, 2021	MODEL(S) Santa Fe (TMa), Sonata (LFa)
SUBJECT: SOFTWARE UPDATE FOR MODEM INFORMATION DISPLAYING ALL ZEROS

Description: Certain vehicles may experience 504 Time Out errors when using the Blue Link Mobile App. When asked to provide Modem Information (IMEI/USIM), the Head Unit (HU) displays all zeros. This bulletin describes the procedure to update the Head Unit Software to correct this condition.

Applicable Vehicles: All 19MY & 20MY Santa Fe (TMa), 18MY & 19MY Sonata (LFa) Equipped with Standard AVN 5.0 or Display Audio.

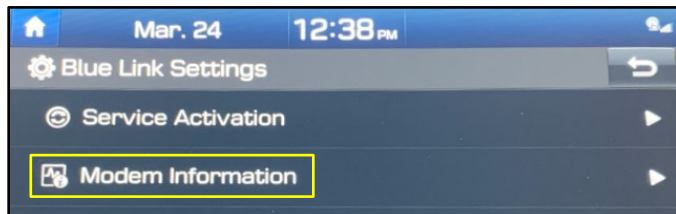
5. Select Modem Information.

6. USIM & IMEI information will display all zeros.

You must attach a picture of the head unit displaying all zeros in order to submit the warranty claim. Claims submitted where the picture does not have the head unit displaying all zeros will be subject to charge back.

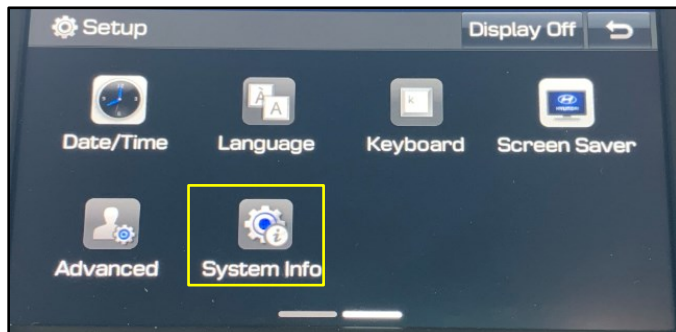
7. Return to the **Setup** screen and select the **System Info** icon.

For AVN 5.0, the **System Info** icon will change to the **General** icon after the update is complete.

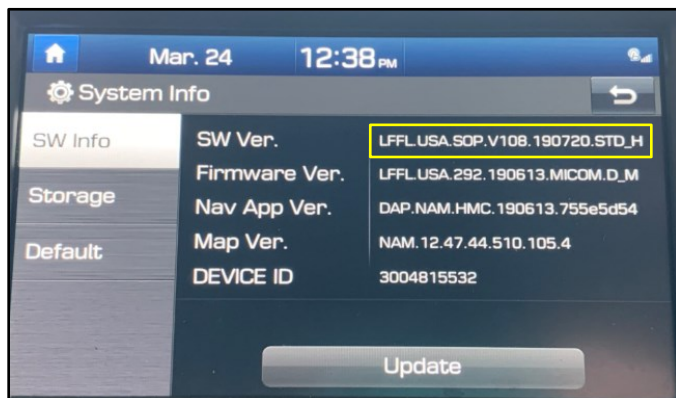
8. Confirm the current vehicle SW version is older than the update.

If the vehicle SW and update SW are the same – replace the Head Unit.

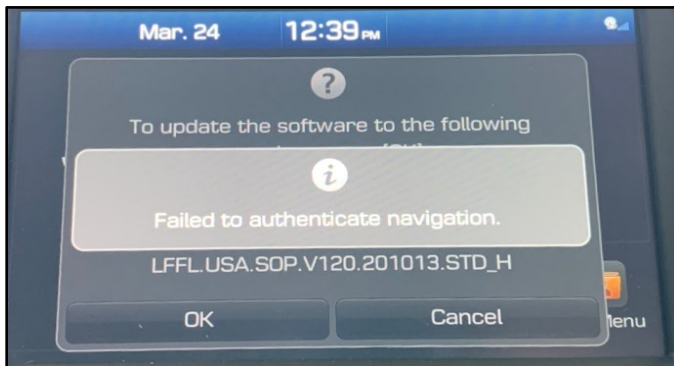
User may receive error message
“Failed to authenticate navigation”.

9. Insert the SD Card Back into the vehicle SD Port.

Please ignore and proceed to update the device by pressing OK or returning to **System Info**.
