GROUP	MODEL
BOD	2021MY K5 (DL3a)
NUMBER	DATE
215	June 2021

## TECHNICAL SERVICE BULLETIN

### SERVICE ACTION: PANORAMA SUNROOF INSPECTION AND REPAIR (SA481)

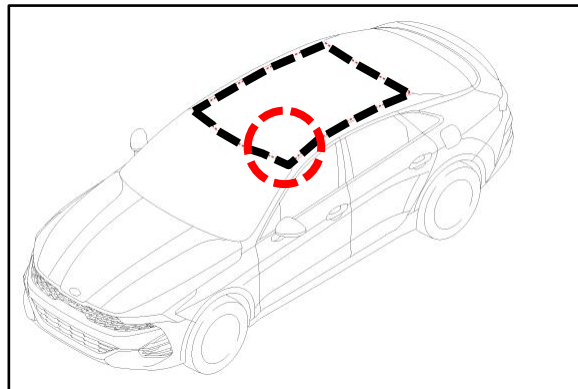
This bulletin provides the procedure to inspect and if necessary, repair a left front bolt of the Panorama Sunroof tracking system on some 2021MY K5 (DL3A) vehicles produced between March 16, 2021 through April 22, 2021, in which the bolt may not have been properly installed during vehicle assembly and cause a creek noise as the body flexes. Before conducting the procedure, verify the vehicle is included in the list of affected VINs.
