# Service Action

## Code: 72M1

<b>Subject</b>	<b>Backrest Remote Release Mechanism</b>																																		
<b>Release Date</b>	June 15, 2021																																		
<b>Affected Vehicles</b>

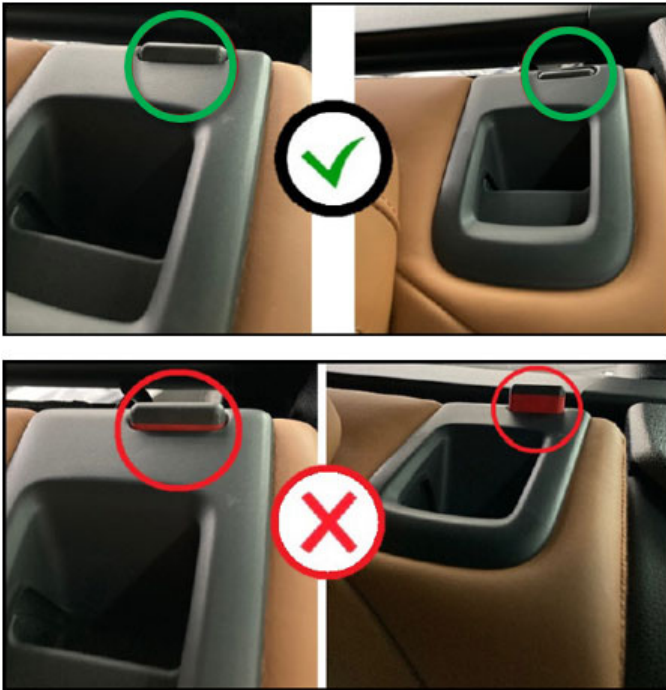
- Check rear seat backrest lock operation and rework release cable (if necessary).

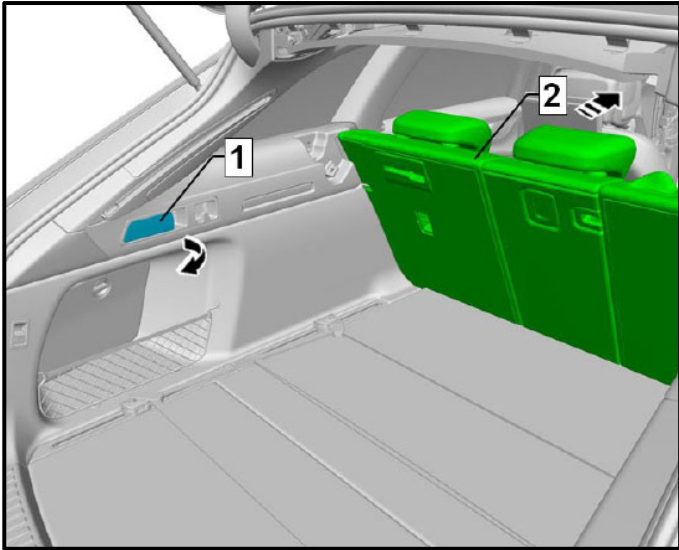
## Section B – Rear Seat Backrest Lock Inspection

- The left and right lock indicators must be checked.
- When rear seat backrest is locked completely in place, check whether indicator is flush with backrest latch trim.
- The red section of the indicator must not be visible.
- Repeat check 5 times (fold down the backrest and then fold it back up) and check each time that the backrest locks into place correctly.
- If both backrest remote release mechanisms lock into place as described and the indicator is flush with the backrest latch trim:
  - No further work is necessary.
  - Proceed to Section D.
- If either indicator does not lock into place so that it is flush with the backrest latch trim:
  - The affected release cable must be reworked.
  - Proceed to Section C.

- Operate backrest remote release lever <1> until rear seat backrest <2> folds down.
- Then fold rear seat backrest back up until it locks into place.

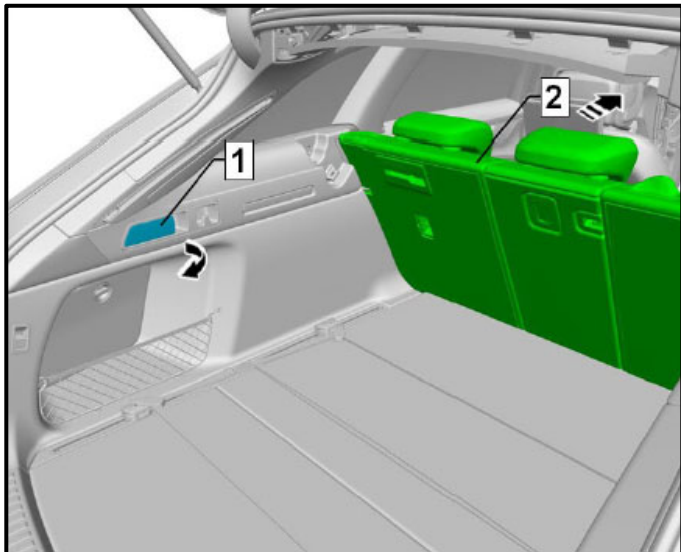
- Before opening the cover for the backrest release mechanism for repair work, the rear seat backrest <2> must be **unlocked**.
- If the rear seat backrest is locked, the Bowden cable will jump out of the idler roller at the connector point and will be damaged.
- The rear seat backrest may only be locked again once the Bowden cable has been taken out of the idler roller.

### Fold down rear seat backrest:

- Operate backrest remote release lever <1> and fold rear seat backrest <2> down.

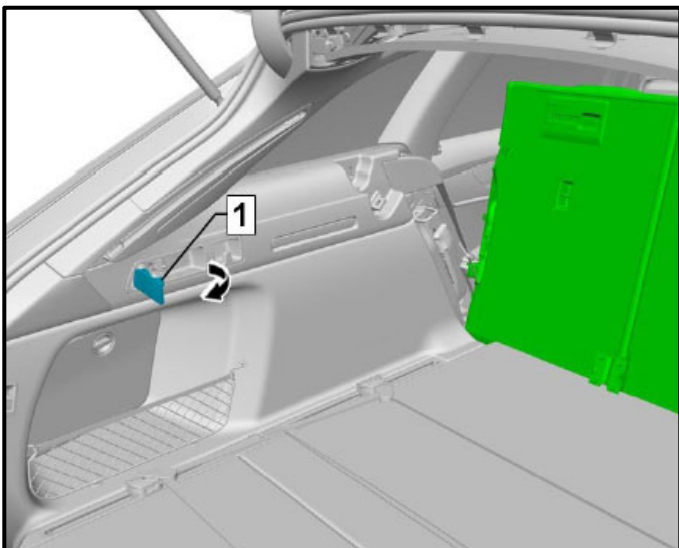
- Before the Bowden cable is attached, the rear seat backrest must be unlocked -1-. If the rear seat backrest is locked, the idler roller will jump out of the connector point and will be damaged.
- The rear seat backrest may only be locked again once the Bowden cable has been fitted in the idler roller.

### Reassemble cable connection point:

- Before attaching Bowden cable <1>, check it for damage such as kinks and straighten these out.
- Bowden cable must be fitted properly (flush) in idler roller.
- Then close cover for connector point.

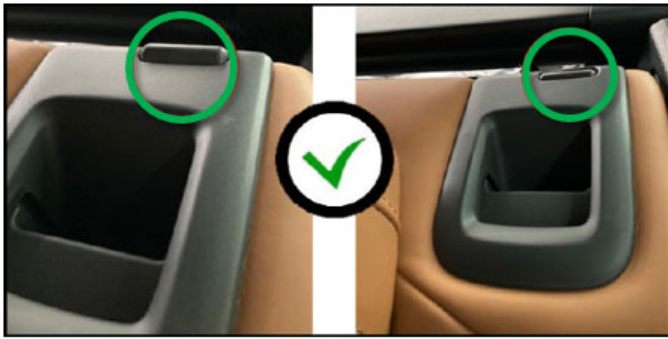
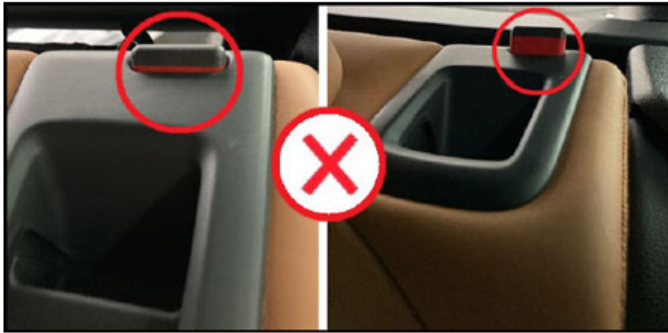
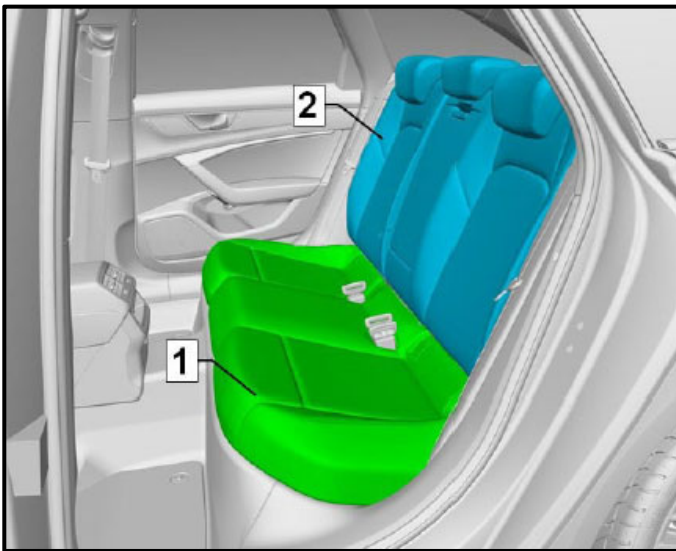
- Operate backrest remote release lever until rear seat backrest folds down.
- Then fold rear seat backrest back up until it locks into place.
- When rear seat backrest is locked completely in place, check whether indicator is flush with backrest latch trim. The red section of the indicator must not be visible.
- Repeat this procedure 5 times.

**Recheck backrest remote release mechanism on both sides:**

- After the check has been performed successfully, reassemble vehicle in the reverse order of disassembly.
- Replace seat grommets.
