June 17, 2021

Version 6

2021 Passport/Pilot: Popping or Crackling from the Speakers; No Sound from the Audio System; Network Loss Message and/or Display IssuesSupersedes 20-058, dated May 03, 2021, to revise the information highlighted in **yellow**.**AFFECTED VEHICLES**

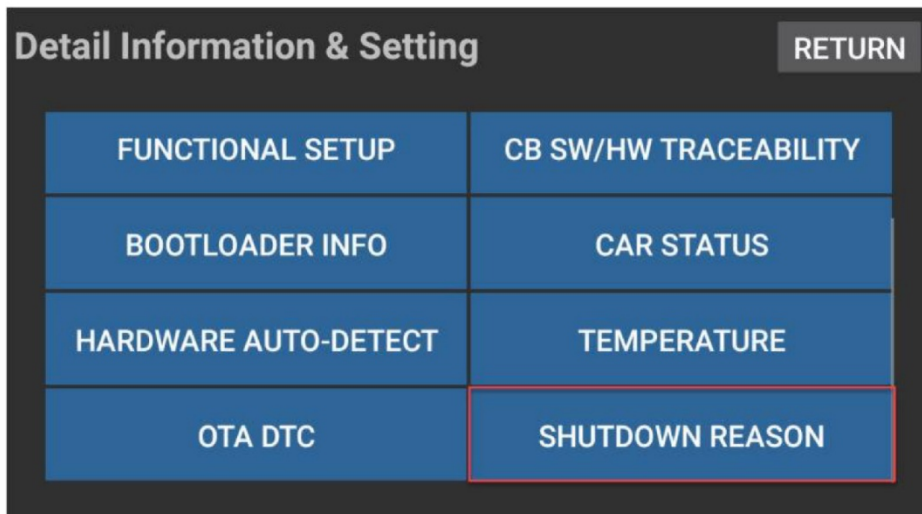
4. Scroll down the menu, and select **SHUTDOWN REASON**.

In this example, the cause of the failure can be identified as **Meter:SUDDEN_SIGNAL_OFF**.

Write down any failures; they will be collected on the warranty claim. Then, clear the data.

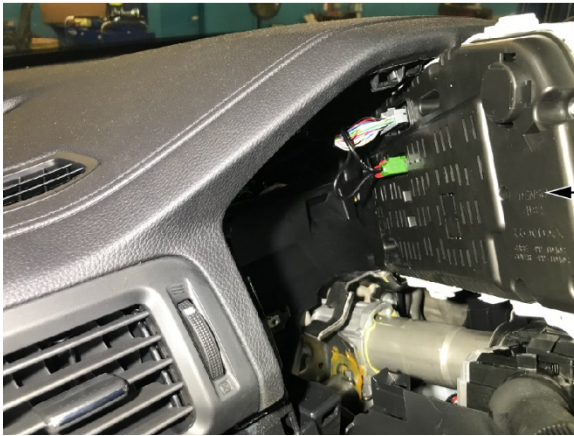
GAUGE
CONTROL
MODULE

There is a loose connection in the MOST bus network.

Disconnect the red and green FAKRA connectors at the gauge control module, infotainment unit, DVD player (if equipped), and tuner unit(Touring, Elite) using the straight FAKRA puller.

NOTE: Disassemble the connectors one at a time to avoid swapping the green and red wires.
