# Service Alert

<b>Subject:</b>  <b>CONNECTED VEHICLE SYMPTOM TROUBLESHOOTING</b>	<b>Service Alert No.:</b> SA-013/21
	<b>Last Issued :</b> 06/02/2021

2019-2021 Mazda3  
2020-2021 CX-30  
2021 CX-5  
2021 CX-9

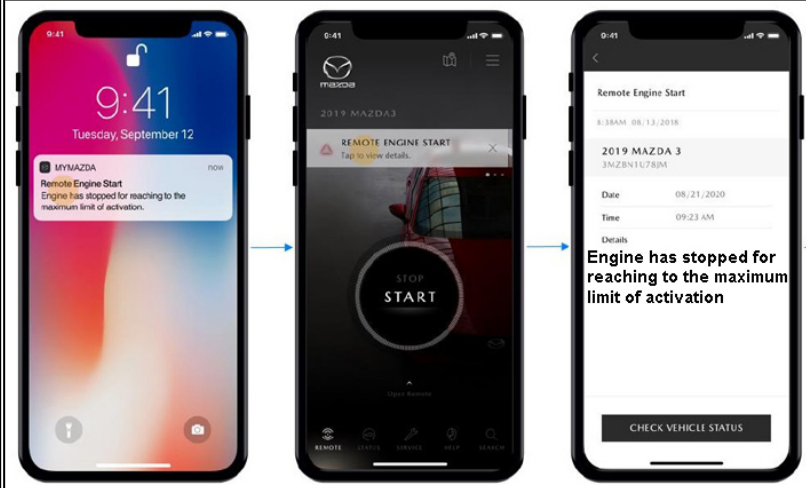
Customer Complaint	Action
<p>Remote function(s) inoperative.</p> <ul style="list-style-type: none"> <li>• Engine Start / Stop</li> <li>• Door Lock / Unlock</li> <li>• Lights ON / OFF</li> </ul>	<ol style="list-style-type: none"> <li>1. Go to the MyMazda App INBOX -&gt; ACTIVITY HISTORY -&gt; to view reason for remote function failure.</li> <li>2. If necessary, use MDARS to ID the vehicle and check for DTC's stored.</li> </ol> <p><b>Are DTC(s) stored?</b></p> <ul style="list-style-type: none"> <li>• <b>Yes:</b> Go to MGSS for normal DTC diagnosis..</li> <li>• <b>No:</b> Contact Hotline for technical support if needed.</li> </ul> <p><b>NOTE:</b> The customer can view the reason for remote function failure.</p> <p><b>Example 1 (Push notification)</b></p>

Tap the push notification    Tap the alert card    Tap "check vehicle status"
