# Service Alert

Subject:	
APPLE CARPLAY™ / ANDROID AUTO™ FREQUENTLY ASKED QUESTIONS (FAQ)	Service Alert No.: SA-029/21
	Last Issued : 06/04/2021

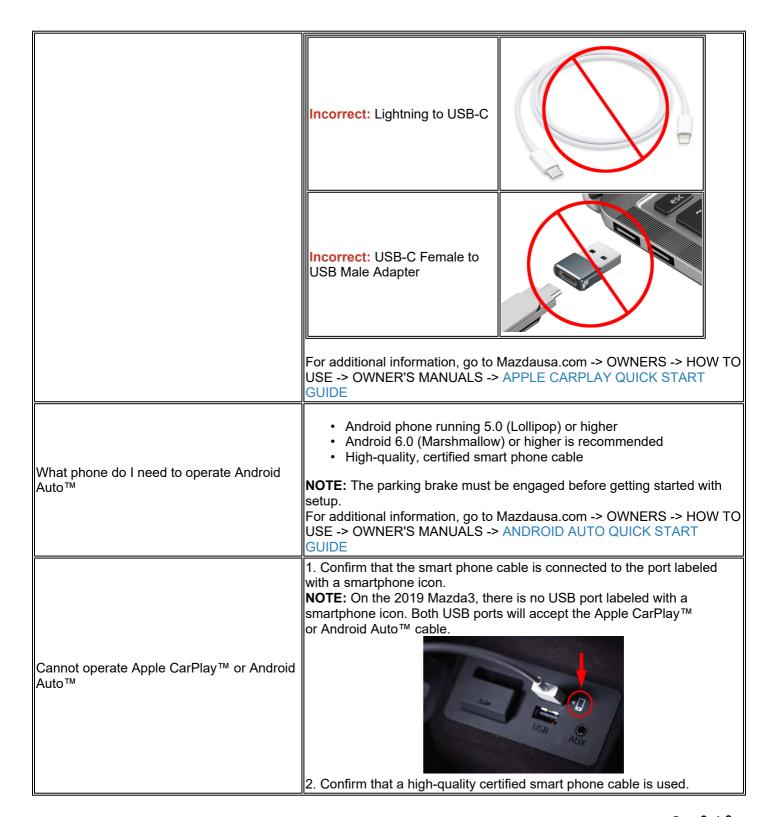
Where do I find support for Android Auto™	Go to Android Auto Help	
	iPhone 5 or above     For best performance, update iPhone to the latest iOS version     Siri® must be enabled to use Apple CarPlay     Apple Lightning® to USB smart phone cable or a high-quality, certified smart phone cable	
What phone do I need to operate Apple CarPlay™	Correct: Lightning to USB
