SERVICE BULLETIN

APPLICABILITY: All 2015-17MY Vehicles with Fujitsu TEN (F10) 7in. Multimedia Navigation (AVN) & Display Audio Units
SUBJECT: “Gen 2” & “Gen 2.1” Operating Tips
NUMBER: 15-177-14R
DATE: 10/16/14
REVISED: 06/25/21

INTRODUCTION:

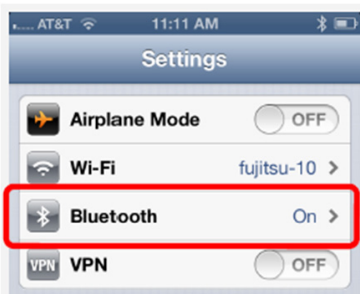
CONDITION #1: Cannot receive incoming text messages on the head unit when using an iPhone.

“Show Notifications” is not activated in the iPhone’s Bluetooth Settings menu.

2. From the Settings menu, select “Bluetooth”.

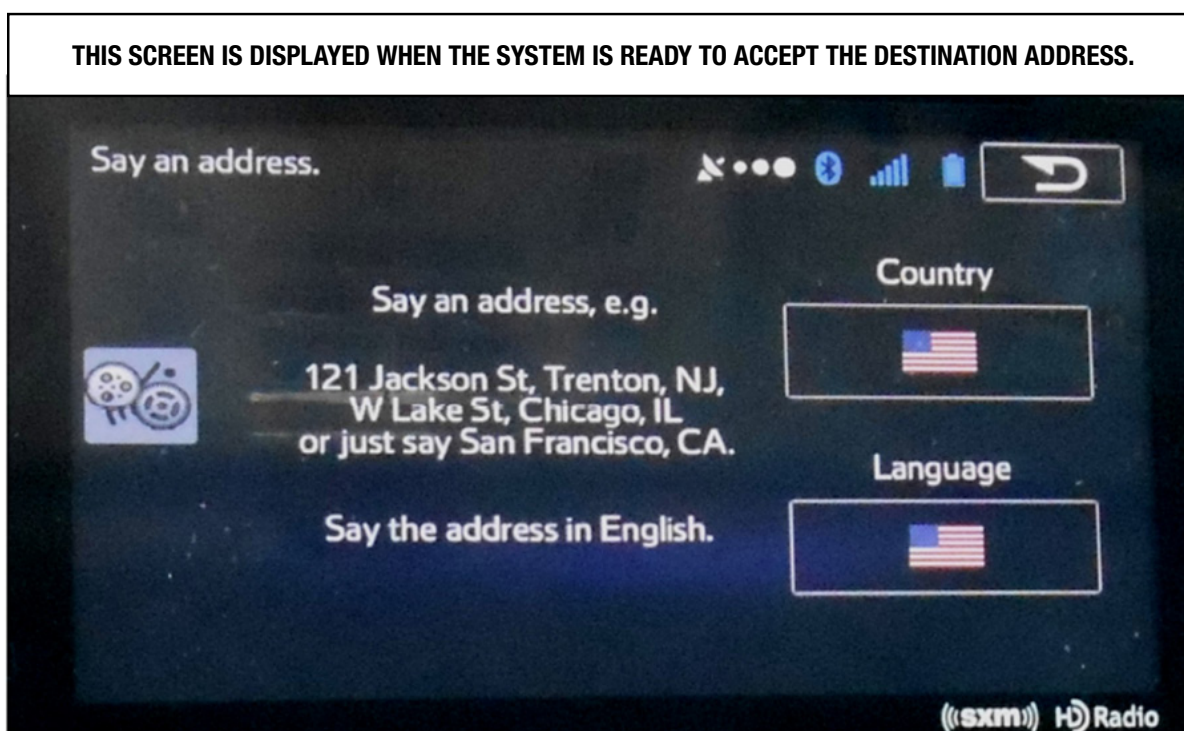
CONDITION #3: Unable to set up the “Destination Address” using voice command.

Incorrect command: 121[pause] Jackson [pause] Street [pause] Trenton [pause] NJ

Correct command: 121JacksonStreetTrentonNJ

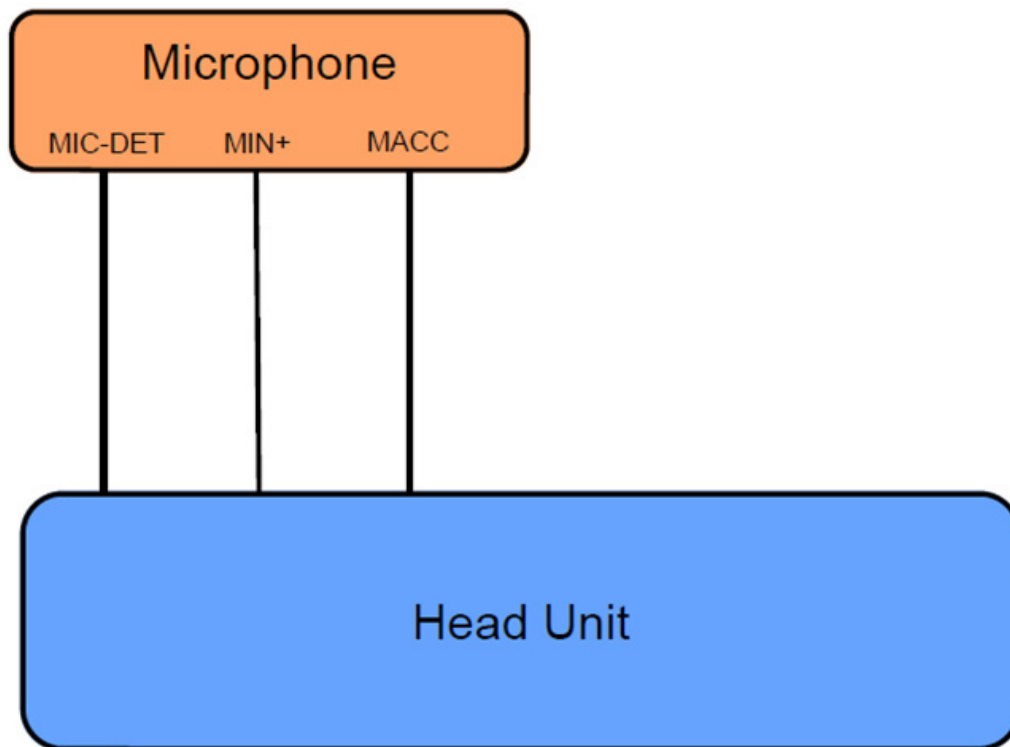
CONDITION: #5: A “Phone” button is not displayed on the HOME screen.

- Microphone is not properly connected to the head unit
- Microphone detection wiring (MIC DET) is open
- Microphone unit is defective

- Confirm the microphone wiring is securely connected to the head unit.
- Confirm there is not an open circuit or short in the Microphone detection (MIC DET) wiring.
- After the wiring has been confirmed to be OK, replace the microphone if necessary.

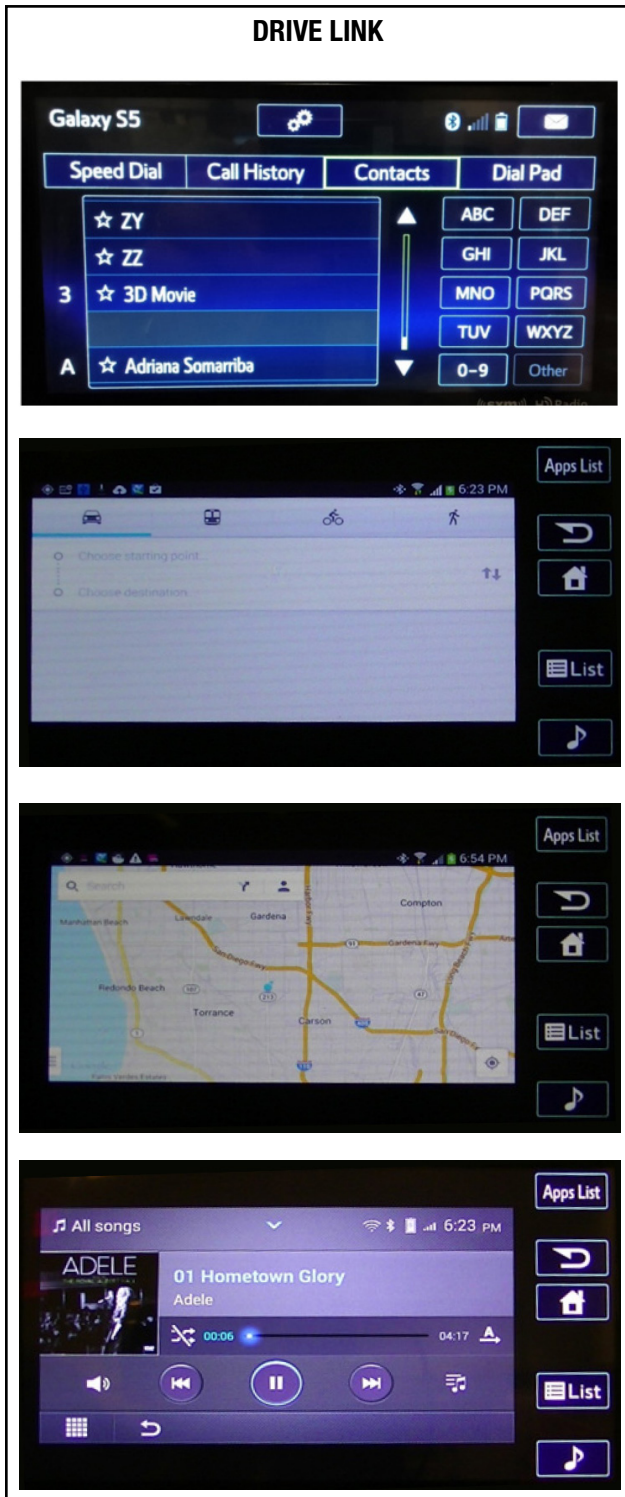
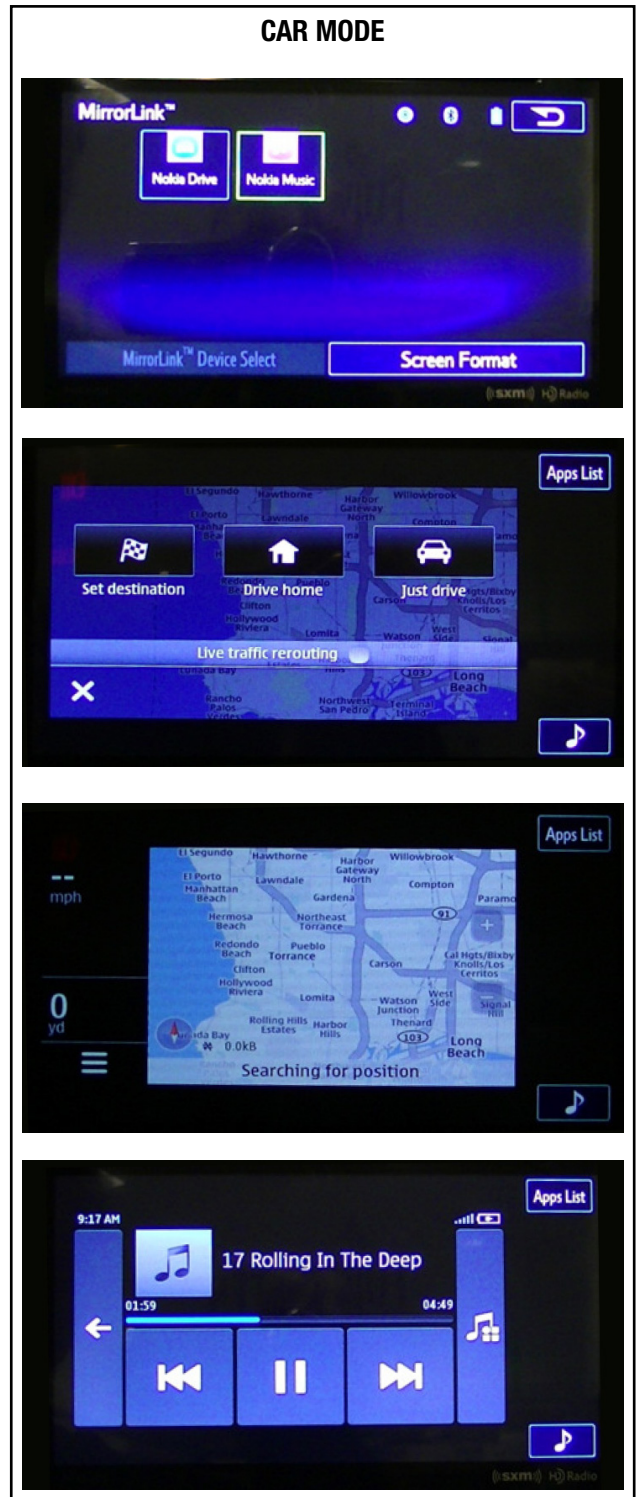
CONDITION #6: MirrorLink screen does not look the same when using “Drive Link” and “Car” mode.

Explain to the customer, Drive Link and Car modes will display information differently when accessing the MirrorLink feature of the head unit. Examples of each are shown in the screen shot photos below.

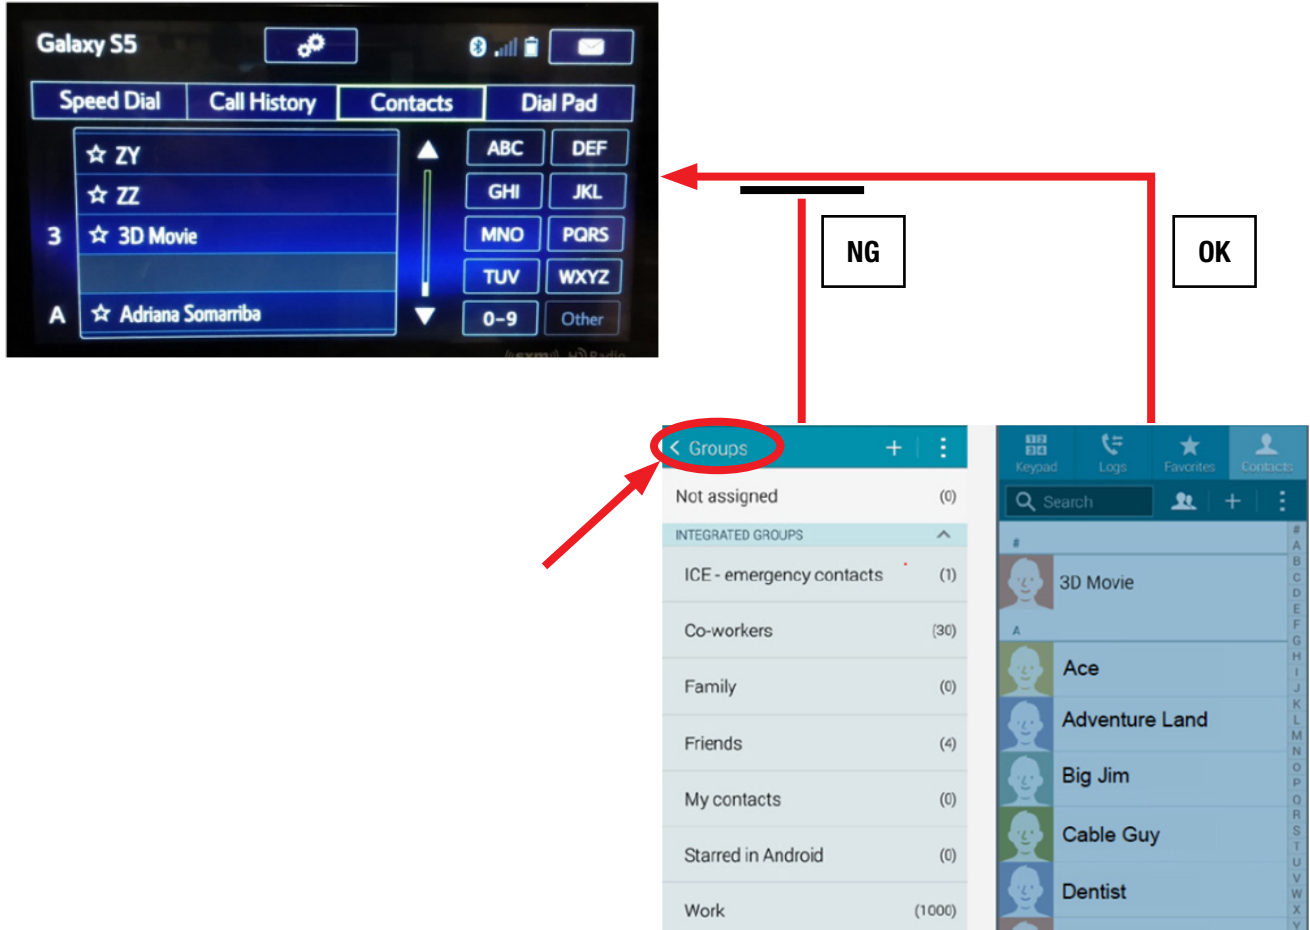
CONDITION #7: Individual contacts will transfer to the head unit from the smartphone, but group folders will not.

Although the head unit can retrieve individual contacts, it does not have the capability to retrieve group folders from the smartphone.

Explain to the customer, the head unit does not support the transfer of group folders from their smartphone.

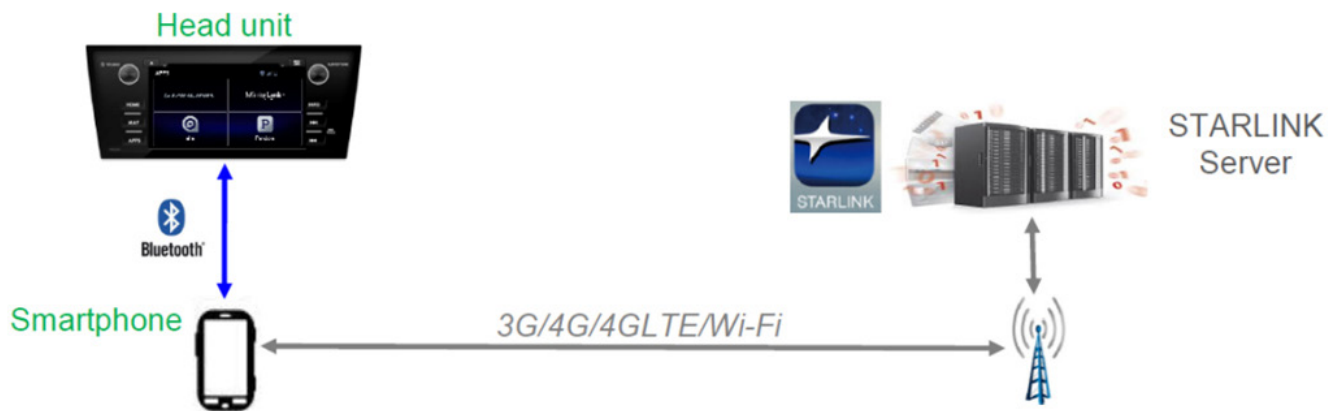
CONDITION #8: When selecting the STARLINK function on the head unit, an error message appears on the screen as shown below.

- STARLINK application on the Smartphone was not loaded and/or launched on the Smartphone prior to selecting the STARLINK function on the head unit. Therefore, Smartphone cannot communicate with STARLINK Server.
- Smartphone has not been paired with the head unit for Bluetooth connection

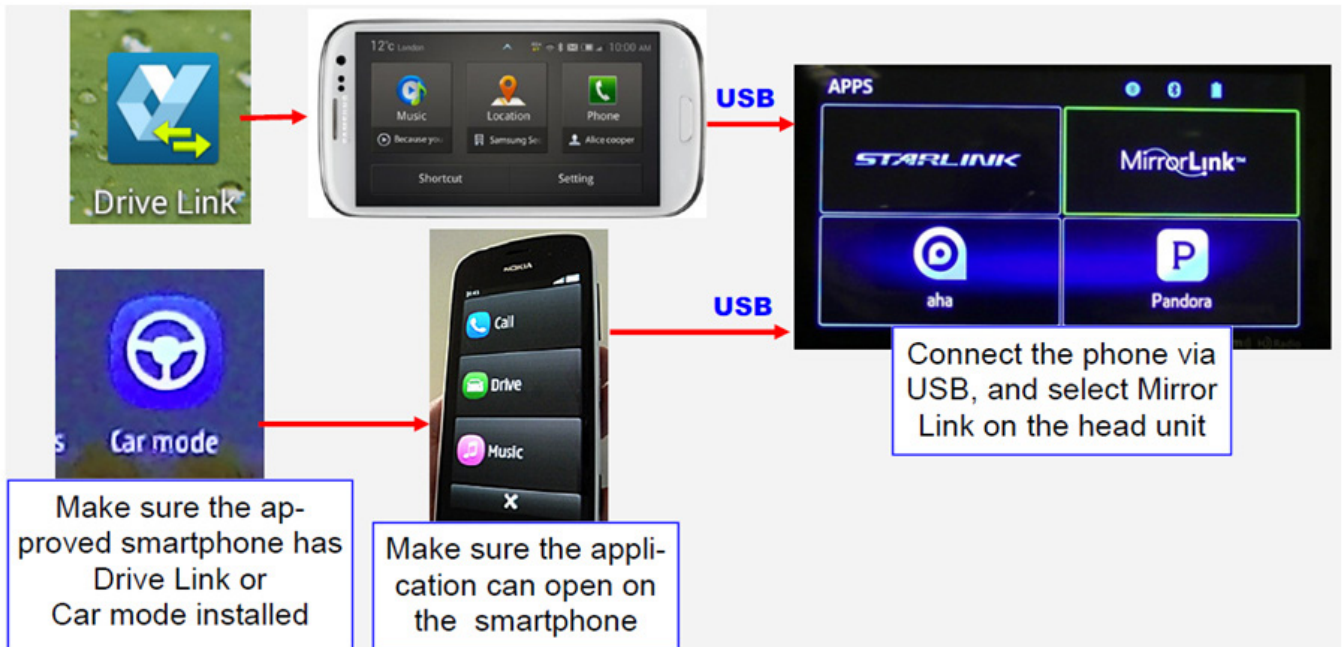
CONDITION #9: MirrorLink does not work with my Samsung or Nokia Smartphone.

- Make sure the Smartphone is compatible with MirrorLink (see Owner Manual Pg. 141.)
- Make sure the “Drive Link” application is installed on the approved Samsung Smartphone (See Owner Manual Pg. 141).
- Make sure the “Car mode” application is installed on the approved Nokia Smartphone (See Owner Manual Pg. 141).
- Once applicability has been confirmed and the application properly installed on the Smartphone, follow the steps below:
 1. Open/Launch the application on the Smartphone.
 2. Connect the Smartphone to the vehicle with a USB interconnect cable.
 3. Press the “APPS” button on the head unit.
 4. Select MirrorLink on the head unit.

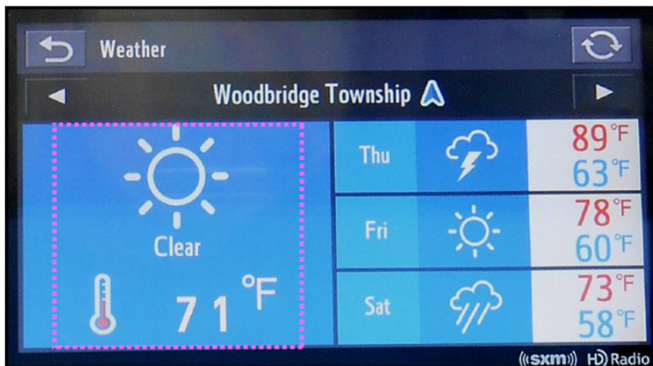
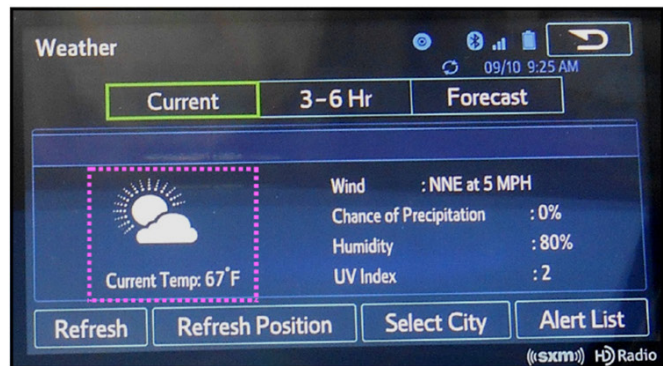
CONDITION #11: Weather information from the “STARLINK” and “INFO” function appears to be different even when the time of day and location are exactly the same.

In the examples shown below, the temperature displayed is different even though the time of day and location are the same.

The source of the weather information is different between STARLINK and INFO. STARLINK utilizes weather information provided by Weather Underground while INFO utilizes Sirius XM.

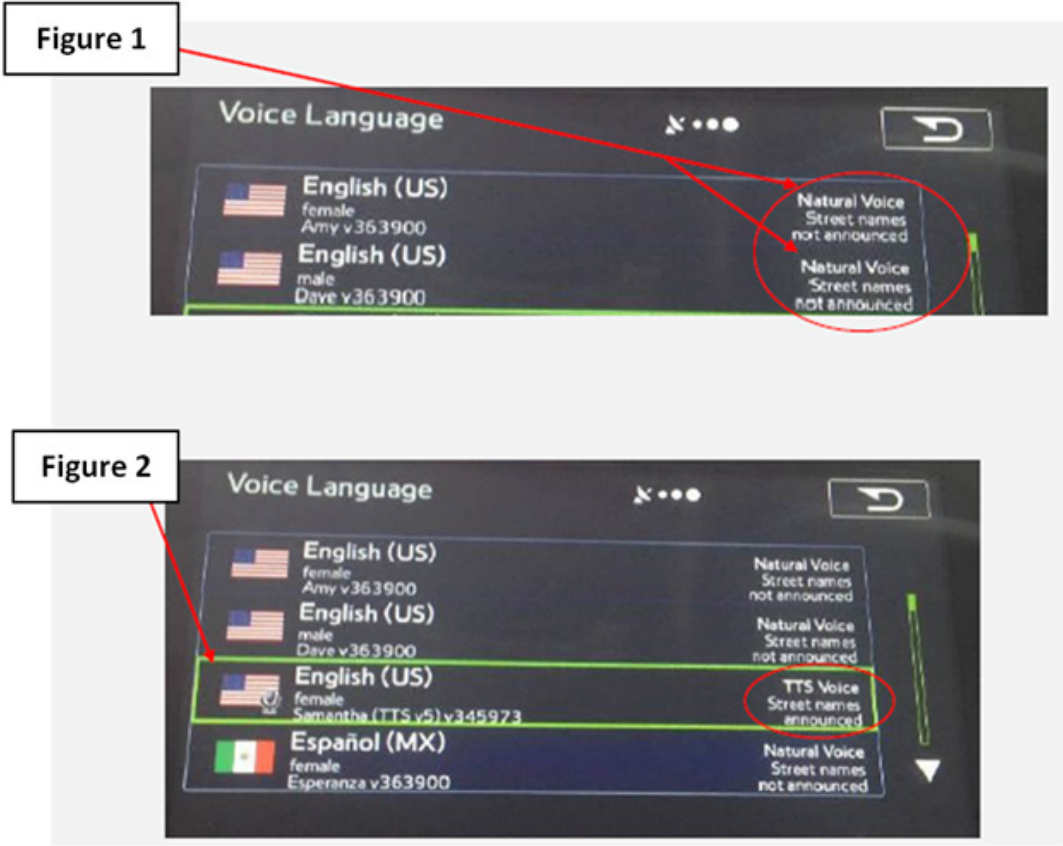
CONDITION #12: When using the voice command to operate navigation system functions, the following message is displayed: “This feature cannot be used with the selected guidance voice profile”.

“Natural Voice” (Figure 1) is selected from the Voice Language menu when “Text To Speech” (TTS) is required (Figure 2) for proper voice command operation.

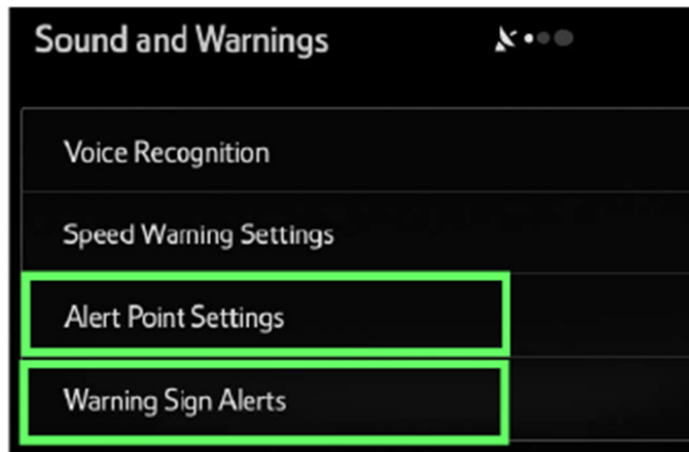
CONDITION #14: A chime is heard while driving.

- If the chime is unnecessary when approaching alert points, disable (uncheck) “Alert Point Warnings” or “Warning Sign Alerts” settings by following the steps below:
 1. Select “Menu” on Map screen.
 2. Select “More”.
 3. Select “Settings”.
 4. Select “Sound and Warnings”.

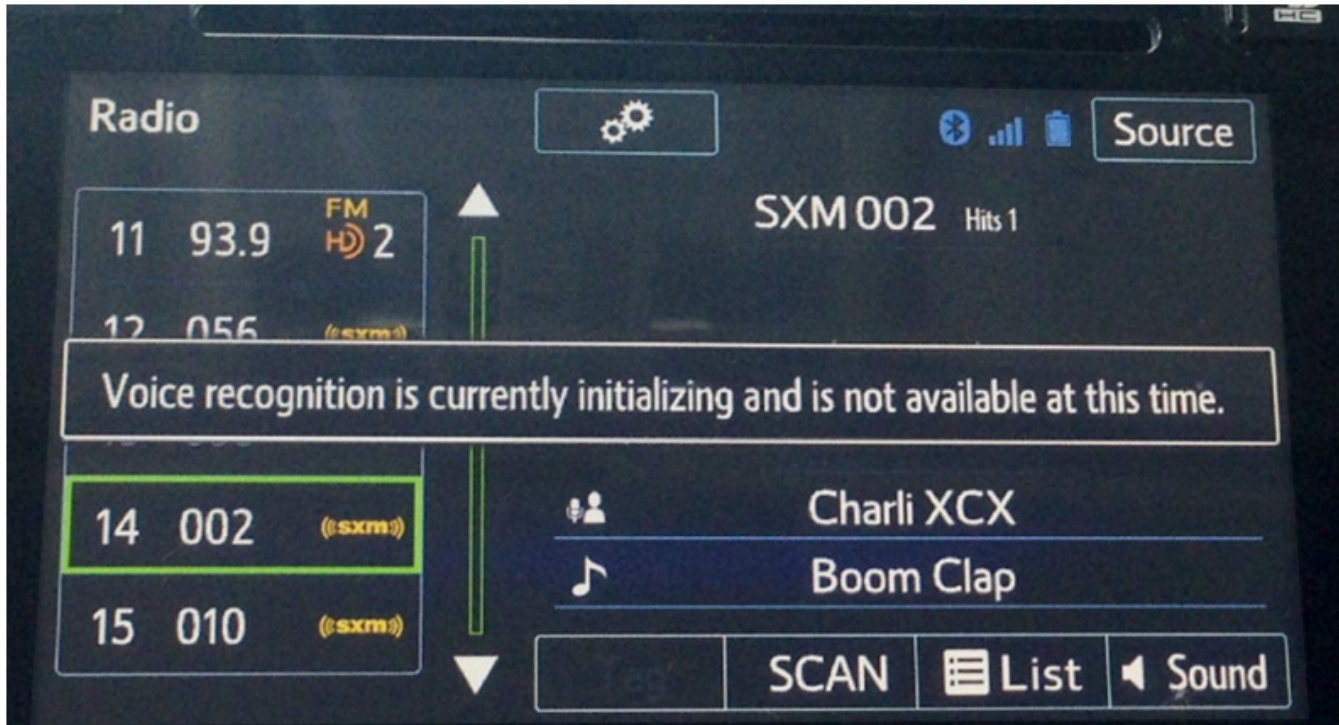
CONDITION #15: The message “Voice recognition is currently initializing and is not available at this time” appears on the screen.

When the head unit is turned on, the system scans XM stations along with every song (digital file) on the currently loaded CD, connected USB device and / or Bluetooth Audio player. It also scans the phone contacts stored on all Bluetooth-connected Smartphones. The system then creates voice tags for all the XM station names, artists, songs, albums, playlists, podcasts, genres, and contacts. During this process, the head unit will also display “Voice Recognition is currently initializing and is not available at this time” (see picture below).

Wait a few minutes then try using the Voice Recognition System again. Once the system has had enough time to complete the procedures described above, normal operation should resume.

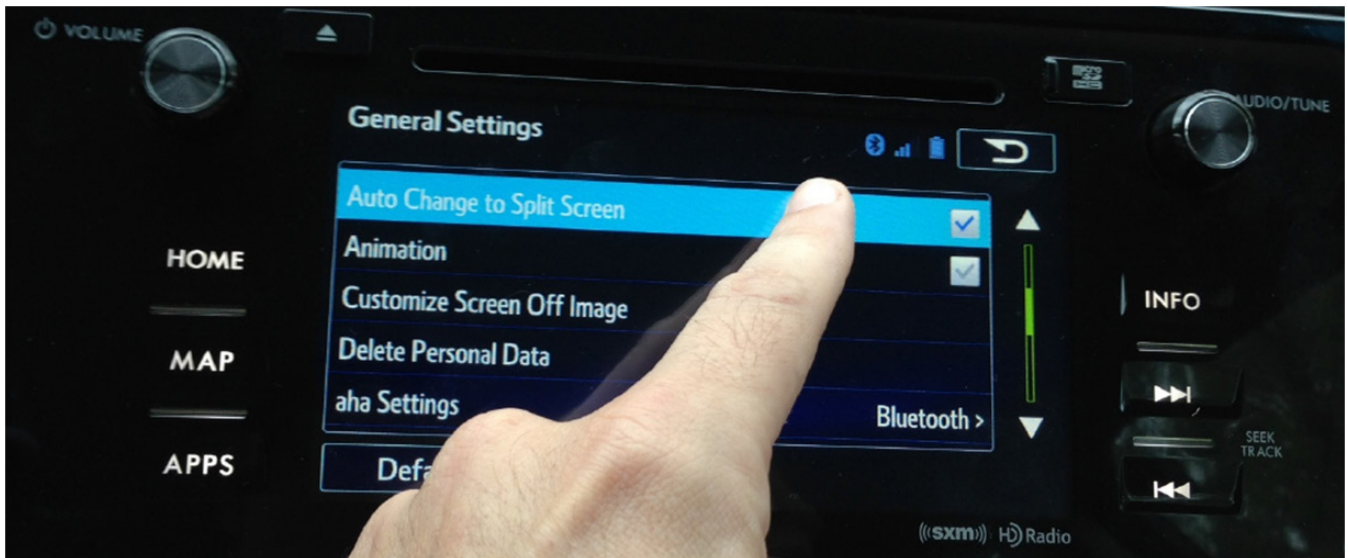
CONDITION #16: After 30 seconds of not pressing any buttons, the screen automatically displays a split screen view

- Follow the procedure below to turn off the “Auto Change to Split Screen” setting:
 1. Select “Home”
 2. Select “Settings”
 3. Select “General”
 4. Scroll down to “Auto Change to Split Screen” and uncheck the setting.

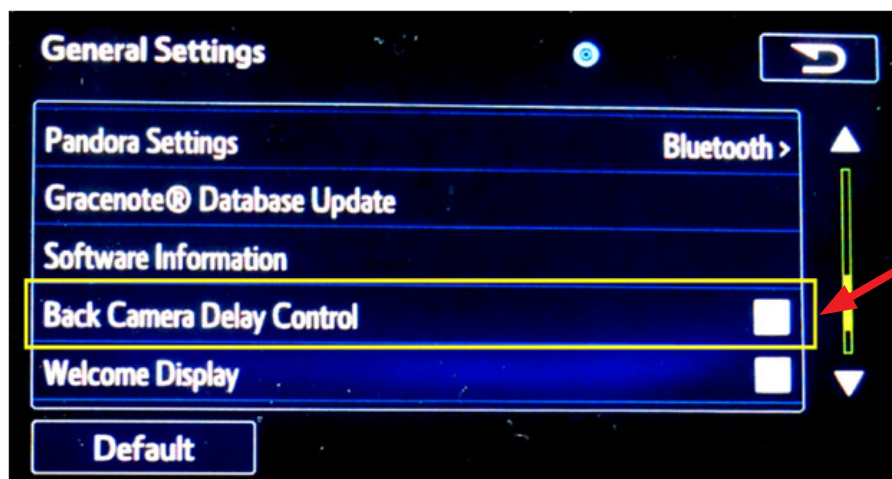
CONDITION #17: Back-up camera image remains displayed after shifting out of Reverse

1. Touch “HOME” button.
2. Touch “SETTINGS” button.
3. Touch “General”.
4. Unselect the “Back Camera Delay Control”.

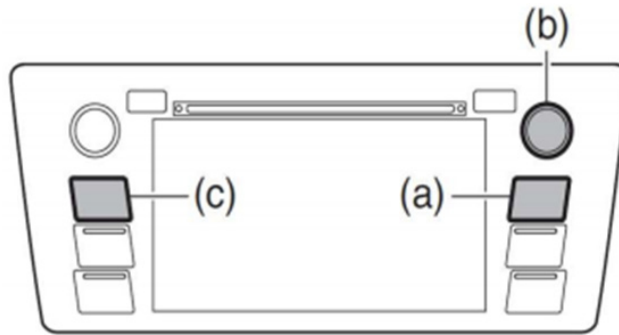
CONDITION #18: When in Diagnostic Mode, AUX, USB1 and USB2 all show as being NG

- Turn the ignition switch to ACC (or press the Engine Start Stop button).
- While pressing and holding the “a” button, press the button “b” twice.

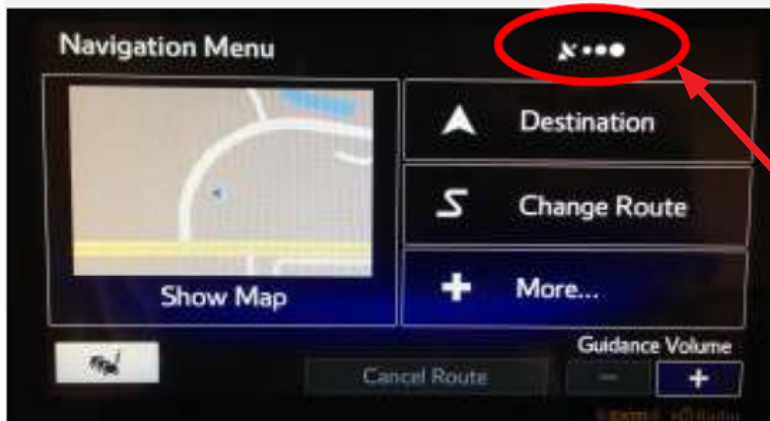
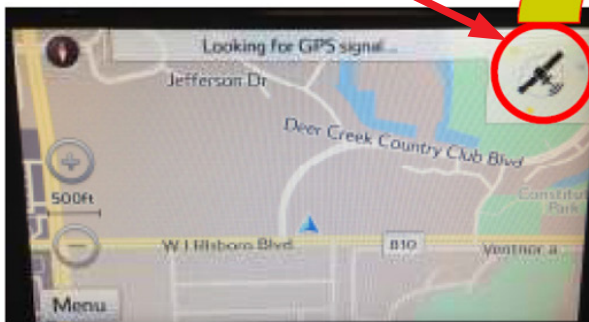
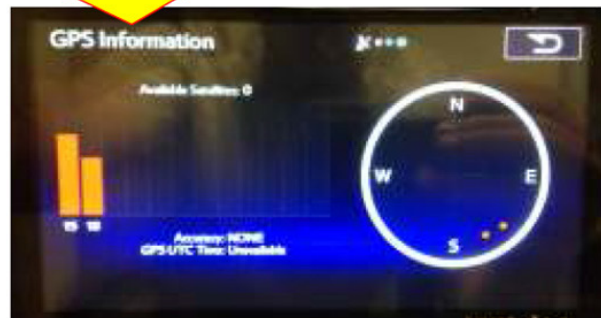
CONDITION #19: Unable to Locate the GPS Information Screen

On the “Navigation Menu” screen, the GPS signal strength indicator is always available at the top right of the screen as shown below. In addition, if the GPS signal strength becomes weak, a Satellite icon will show when the MAP screen is displayed. If this Satellite icon (also a soft key) is pressed, the GPS information screen will be displayed which indicates how many satellites are currently being received along with the accuracy of the GPS signal.

The GPS Signal strength indicator is always available for reference in the upper right of the “Navigation Menu” screen.

If the GPS signal becomes weak, a Satellite icon will appear in the upper right corner of the MAP screen. Touch the icon to show the GPS information.

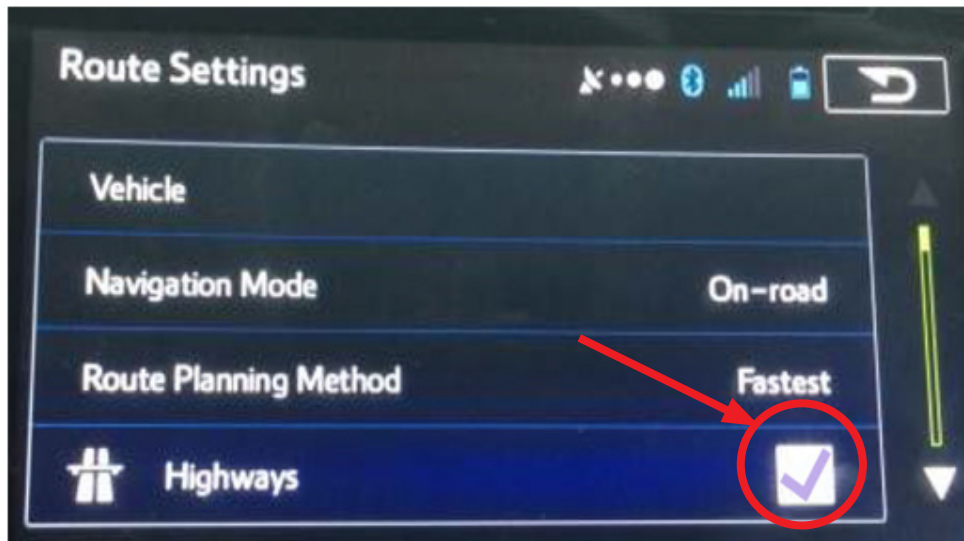
CONDITION #20: The Navigation system often routes the user off the highway, and onto rough surface (dirt / gravel) roads.

Check the **Highways** selection box by following these steps:

- Select “**Menu**” on the Map Screen
- Select “**More**”
- Select “**Settings**”
- Select “**Route Settings**”
- When “**Highways**” is checked the navigation system will always consider using highways first when planning routes.

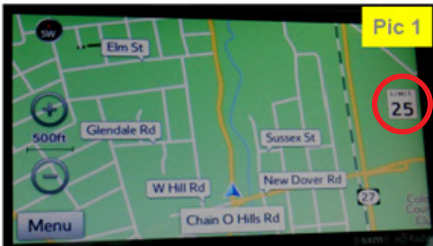
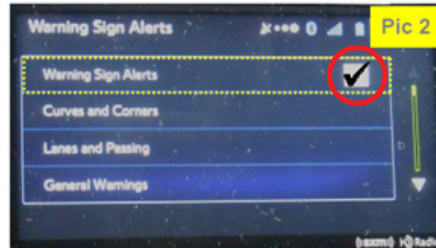
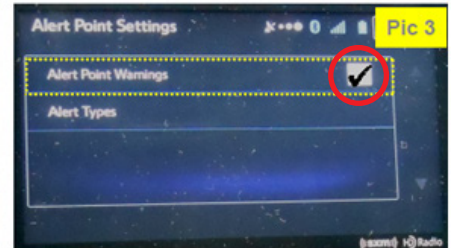
CONDITION #21: When the Speed Limit is displayed, “Alert Signs” are not displayed, even when “Warning Sign Alerts” and Alert Point Settings” are enabled.

Display of the Speed Limit takes priority over Warning Sign Alerts and Alert Point Warnings. If the Speed Limit is being displayed as shown in Pic 1 below, the other warnings will not be displayed.

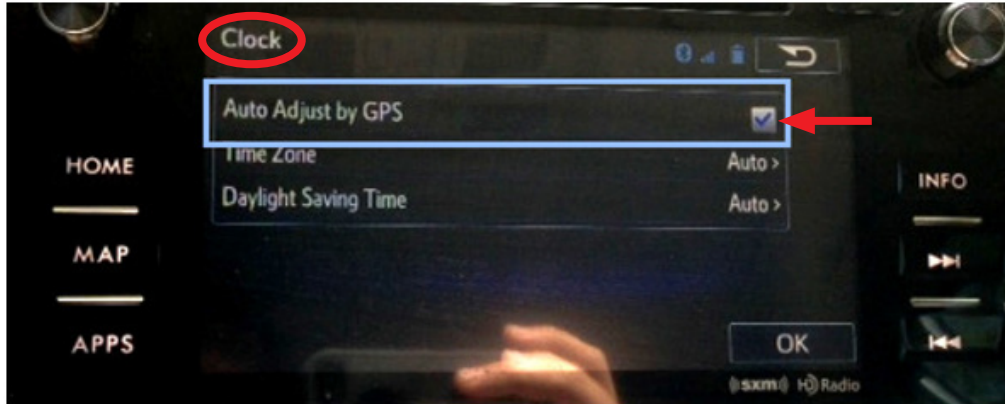
CONDITION #23: The clock display on HVAC panel is incorrect even when “Auto Adjust by GPS” is selected on the Clock settings menu.

The correct time is 4:59 pm but HVAC display shows 8:59 pm.

When a map SD card is removed from the AVN unit or the map SD card cannot be read properly by the AVN unit, the time displayed on the HVAC panel will automatically default to Greenwich Mean Time (GMT). In this case, the GMT is 4 hours “ahead” of local time.

1. If the user wants to operate the AVN unit without the map SD card installed and still have the correct time shown on the HVAC panel, access the Clock settings menu, uncheck “Auto Adjust GPS” then manually reset the correct time using “+” and “-” buttons to the left of the clock display as shown below.

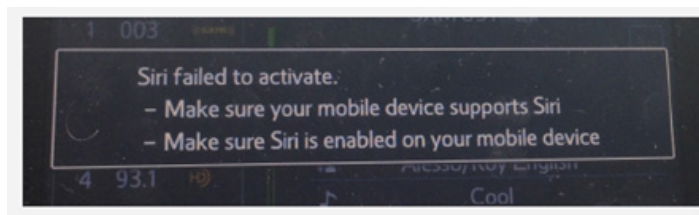
Pic 3

3. The message shown in (Pic 3) will display when a Siri-compatible phone is paired but “Siri” has not been enabled on the phone.

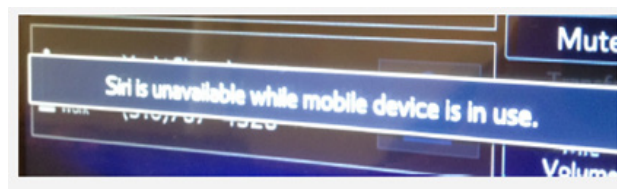
Pic 4

4. The message shown in (Pic 4) will display when Siri is initiated during a call. Siri will not operate while a call is in progress.

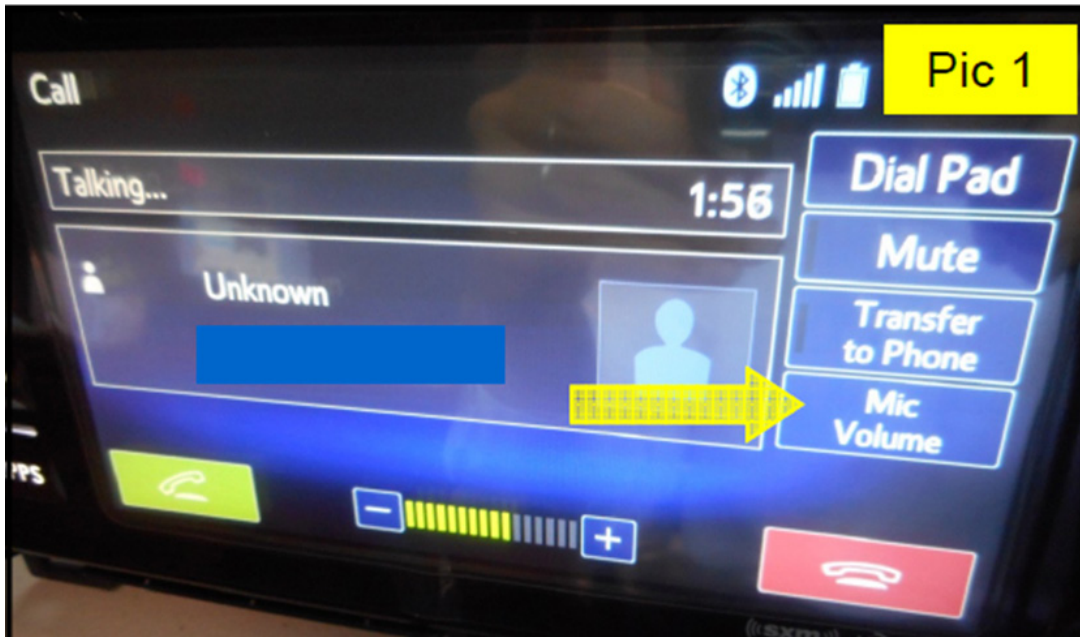
CONDITION #26: Bluetooth hands-free outgoing voice quality is poor. Call recipient cannot understand the caller in the car clearly.

1. Access “Mic Volume” function by touching the soft key during a hands-free call (**Pic1**).

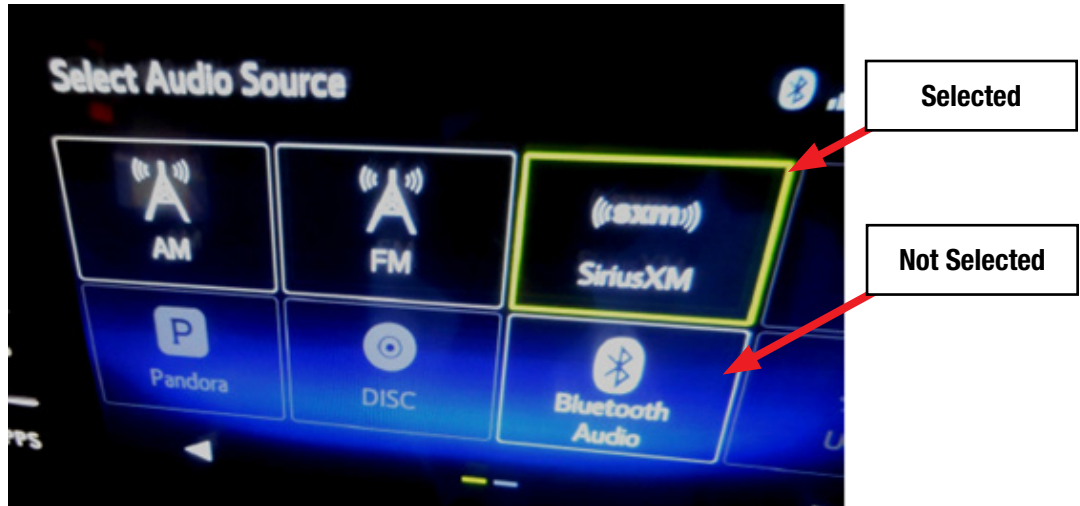
CONDITION #27: Navigation voice guidance cannot be heard from the vehicle speakers when the destination was requested by Siri (iPhone App) (2016 MY vehicles equipped with Gen 2.1 Navigation / Display Audio system)

Bluetooth Audio is not selected as an Audio Source.

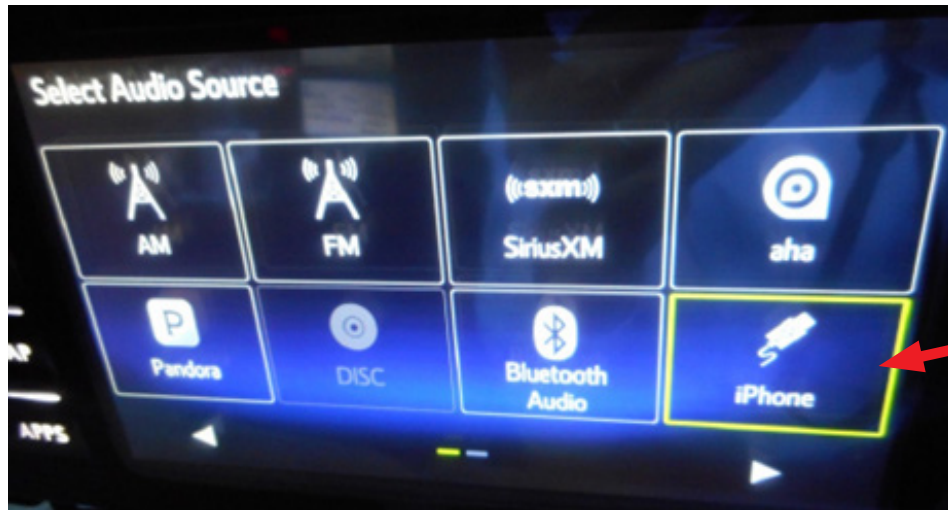
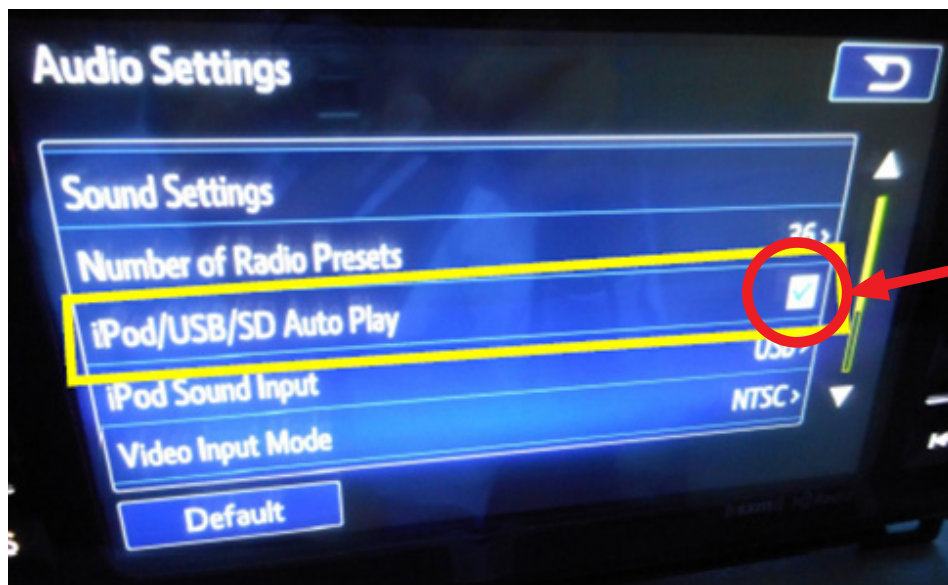
CONDITION #28: When connecting an iPhone to the USB port to charge it, the Audio Source automatically switches to iPhone.

If the unit automatically “defaults” to iPhone mode, the “iPod/USB/SD AutoPlay” setting is selected (activated / checked) on the Audio Settings screen.

If the user does not want the unit to switch to an “iPhone” mode automatically when an iPhone is connected to the USB, disable the “iPod/USB/SD Auto Play” setting by following the steps below:

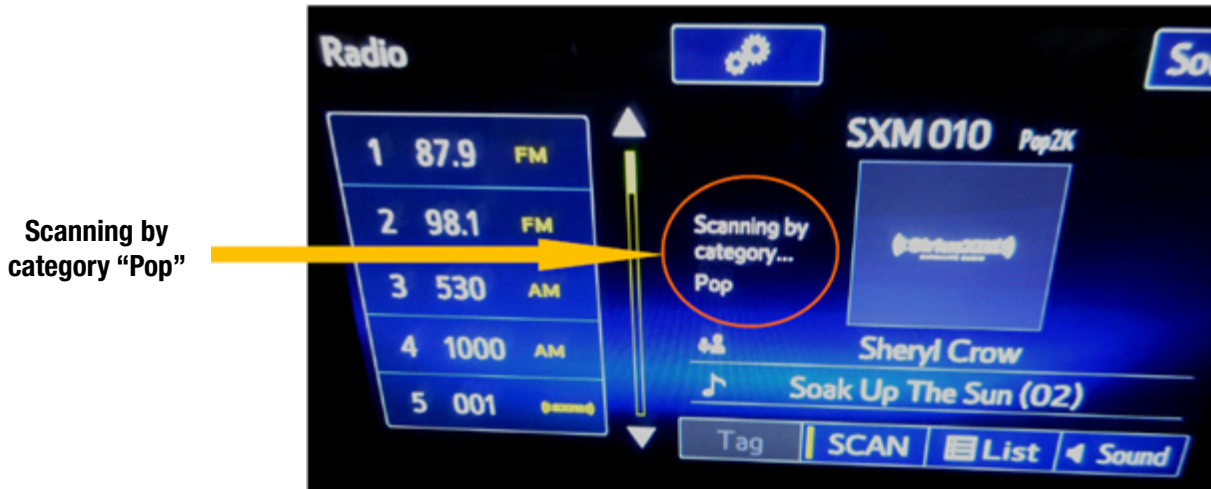
CONDITION #32: Cannot scan or seek through all SXM channels using the Seek, Scan and / or Steering Wheel buttons (2016 MY vehicles equipped with Gen 2.1 Navigation / Display Audio system)

The unit will only scan or seek through the category being listened to when it is in the SXM mode.

EXAMPLE: If you are listening to CH2, which is under a “Pop” category, and press the scan button, it will only scan channels (CH3, 4, 5, 6, 7, 8, 9, 10, 13, 14, 15, 16, 17, 18, 158, 300, 301, 302 and 2) which are under the Pop category, not all channels or categories.

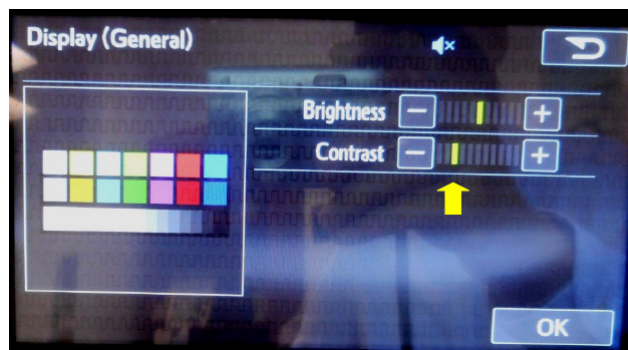
CONDITION #40: Display background color uneven, a “smile” -type image appears.
(Applicable to 2015-16MY Impreza, 2015-17MY Crosstrek, 2016-18MY Forester and 2015-17MY Legacy / Outback)

This condition is NOT a defect. It is actually a background image of Subaru STARLINK which becomes visible when the contrast is set to the highest setting as shown in the screen shot below.

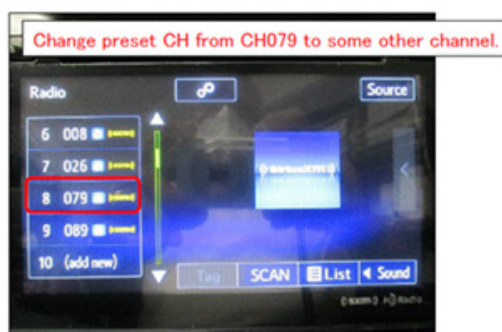
CONDITION #41: SXM operation freeze: not able to select SXM source or preset SXM channel.
(Applicable to 2015-16MY Impreza, 2016-2018 WRX/STI, 2015-17MY Crosstrek, 2016-18MY Forester and 2015-17MY Legacy / Outback)

- ⇒ SXM discontinued CH079 (the Radio Disney) since Jan/7/2021 from SXM CH lineup.
- ⇒ If CH079 is set in a preset, change it to some other channel (any of AM, FM or XM). Similarly, if a channel that was previously set to a preset by customer and is not currently in SXM lineup, change it to some other channel as well.
