<b>HYUNDAI</b> <b>Technical Service Bulletin</b>	GROUP	NUMBER
	<b>CAMPAIGN</b>	<b>21-01-053H</b>
	DATE	MODEL(S)
	<b>JUNE, 2020</b>	<b>SANTA FE HYBRID (TM HEV)</b>
<b>SUBJECT:</b>	<b>INSTRUMENT CLUSTER SOFTWARE UPDATE  (SERVICE CAMPAIGN T6T)</b>

**Applicable Vehicle: Certain 2021MY Santa Fe Hybrid (TM HEV)**

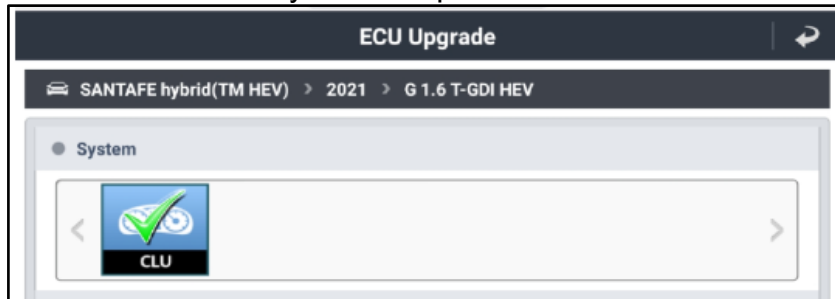
1. Select CLU as the system to update.

2. Check the current version of the instrument cluster ROM ID and compare it to the ROM ID Information Table listed above before attempting to perform the software update.
3. Perform GDS software update. Refer to TSB **15-GI-001** for the tablet-based Mobile GDS ECU update procedures.
4. After the software has updated, check for Diagnostic Trouble Codes in the **ALL** menus and erase any DTC.
5. Confirm the Auto-Shut Off countdown for 30 and 60 minutes are correct.
