MITSUBISHI MOTORS

TECH TALK - VOLUME 262

May & June 2021

TECHNICAL INFORMATION

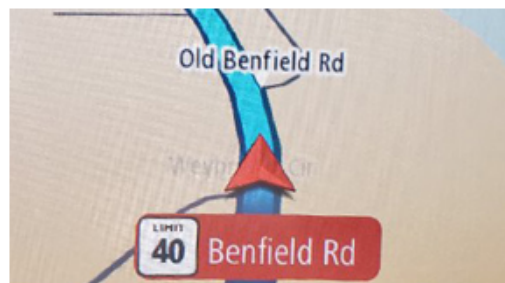
Tech Line has had several inquiries about a dinging sound of an unknown source on MY22 Eclipse Cross. Some customers reported that the sound occurs randomly, while others stated it occurs at the same place during their commute, or after a given amount of time driving. The source of the warning sounds may be coming from the Navigation System's "Sounds & Warning". When customers are driving their vehicle and the Navigation Map screen is not active, there are no visual cues on the Audio Unit's Display. However, when the speed warning is heard and Navigation Map is displayed: the border around the current speed limit will change from clear to yellow as the speed limit is approached and then turn red as the speed limit is exceeded.

There are several different types of warnings in three subcategories. The volume of the Navigation System can also be adjusted from the audio system's volume settings.

To customize the Navigation "Sounds & Warning", enter "Settings" from Navigation and select "Sounds & Warnings".
