# Service Bulletin

Bulletin No.: 21-NA-085

**Subject:** MIL Illuminated with DTC P16F3 Set

Brand:	Model:	Model Year:		VIN:		Engine:	Transmission:
		from	to	from	to		
Chevrolet	Colorado	2021	2021			LGZ	
GMC	Canyon	2021	2021			LGZ

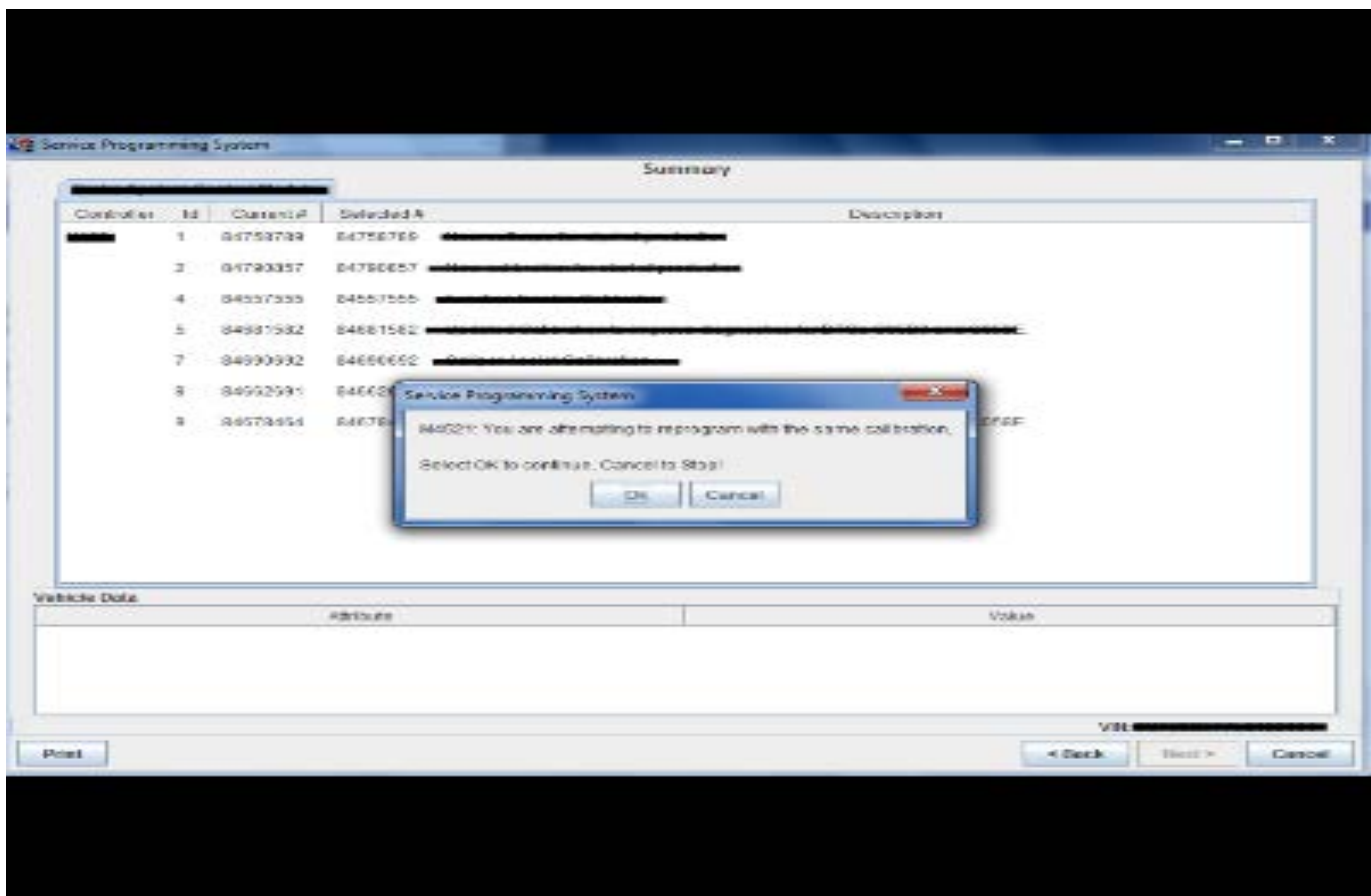
5431207

**Important:** Techline Connect and TIS2WEB screens shown above.

**Important:** If the same calibration/software warning is noted on the TLC or SPS Summary screen, select OK and follow screen instructions. After a successful programming event, the WCC is located in the Service Programming System dialogue box of the SPS Summary screen. No further action is required. Refer to the Warranty section of the bulletin.
