SIB 52 09 20

## HEAD RESTRAINT AND/OR BACKREST OF 3RD ROW SEATS CANNOT BE FOLDED DOWN

E-Series	Model Description
G07	X7 Sports Activity Vehicle

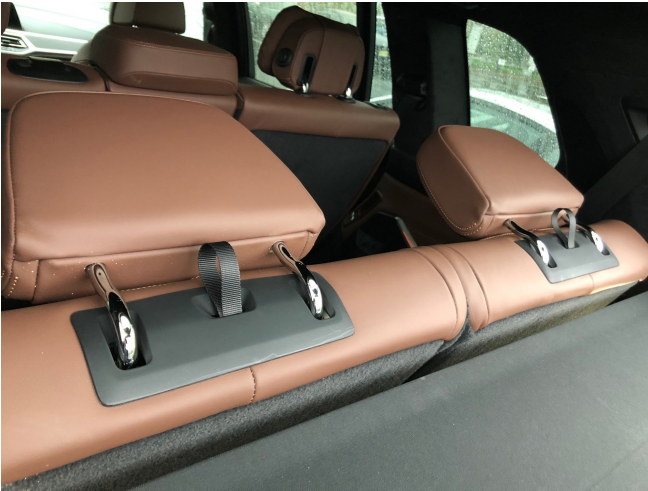
1. Head restraint cannot be folded down:

Can the head restraint be manually unlocked using the release loop beneath the headrest (see picture) and thus folded down?

Replace the folding module of the head restraint (#2 in picture).

See REP 52 30 118 Remove and install/replace folding module of left or right head restraint

If the Bowden cable is mounted and correctly routed, replace the Bowden cable for the headrest (shown in yellow in picture).

See REP 52 30 253 Replace Bowden cable for left or right head restraint
