Service Bulletin

20-049

July 12, 2021 Version 6

2021 Odyssey: Popping or Crackling from the Speakers; No Sound from the Audio System; *Network Loss* Message and/or Display Issues

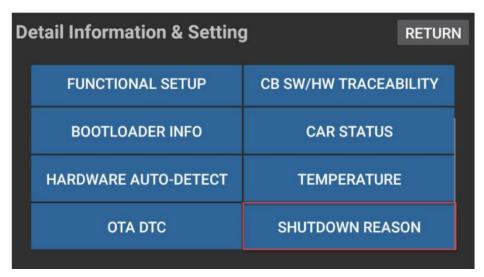
4. Scroll down the menu, and select SHUTDOWN REASON.

In this example, the cause of the failure can be identified as Meter:SUDDEN_SIGNAL_OFF.

Write down any failures; they will be collected on the warranty claim. Then, clear the data.
